# Palmer Station Site Visit Report

May 2, 2008 to May 21, 2008

Robert Newsome

In May 2008, Robert Newsome visited Palmer Station, Antarctica for the Stanford University VLF Group's annual NSF grantee visit for contract A-306-P: Stanford University VLF Antenna. This report summarizes the objectives of the visit, the status of the equipment at the beginning of the visit, and the accomplishments made during the visit. Recommendations for future work are made.

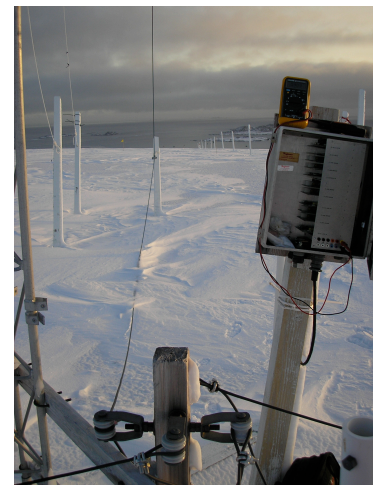
The Antenna mast was not tilted in any direction (due to melting of the ice foundation over summer). There was a moderate amount of slack on the Antenna cables, and the bottom part of both the east and west sides of the Antenna were frozen into the ground.

Figure 2 – The bottom of the Antenna cable frozen into the ice in the west direction. The same was true of the east direction, but not the north or the south directions.

At the Antenna, the bottom parts of both the east and west halves of the E/W loop were slack enough to be frozen into the ice of the Glacier. Rather than digging out the two cables (risking inadvertent damage in the process) and adjusting the slack of all the Antenna cables, the cables were left as is and the Antenna area was measured. The area was estimated (using Morris Cohen's method from 2006) to be  $A_{ANT} = ?? \text{ m}^2$ . However, this method<sup>2</sup> overestimates the area as it does not account for droop in the cable between the top and the outside edges of the Antenna.

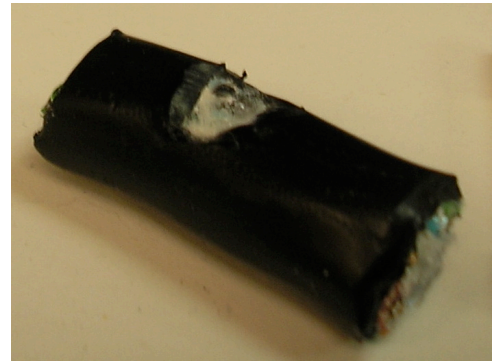
The cable and junction boxes required the most attention. On the JB2-JB3 cable, about 300 feet (give or take 100 feet) from JB2, two breakings of the cable jacket were found about five (5) feet apart from each other. The breakings were roughly as deep as the jacket width itself, but one of the

breakings also involved the severing of the wire associated with Pin S (of the power triplet) on the connectors. The breakings did not look natural (like cracks due to cold and ice), and may have been introduced artificially (perhaps the cable got snagged on sharper pieces of ice on the glacier during its initial rollout, or it got stepped on by a crimp-on spike during someone's maintenance of the cable or posts) and then exacerbated over time with weather.

Figure 3 – The damage to the JB2-JB3 cable, cut out from the rest of the cable.

1. Both of the damaged areas on the JB2-JB3 cable had been taped over (although not in a weatherproof way) and taped to the supporting guy wire. Very few other locations on the cable had been taped in this way. This suggests that the damaged areas had been previously noticed (before they actually became points of failure). Perhaps the cable had sustained this damage awhile ago – someone stepped on the cable with their crimp-on spikes while maintaining the posts, or the cable got snagged on a sharper piece of glacial ice during its initial rollout – and then wind and weather worked the damage into a failure point.

To address the problems with the JB2-JB3 cable, the entire cable was replaced with a brand new cable. The cable's downhill connector at the JB3 end was preserved (that is, the connector on the old cable was cut off and used in the same location on the new connector). The cable's uphill connector at the JB2 end (which had been damaged) was replaced with what appeared to be an old

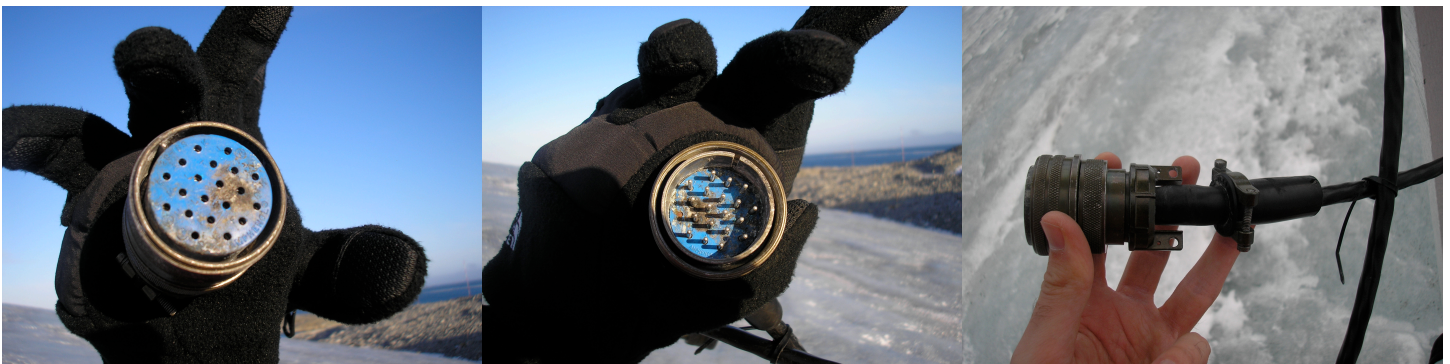
Additionally, both the uphill and downhill connectors in JB2 exhibited burn marks on their mating surfaces. The uphill connector was missing Pin H (of the power triplet) altogether, as if it had burned out. Inside the uphill connector, even more burn markings were observed and six (6) of the wires did not make electrical contact with their pins. In testing two connectors, the downhill connector still seemed to function correctly.

Figure 4 – The connectors at JB2. (a) Burn marks on the downhill connector. (b) Burn marks (and a missing pin) on the uphill connector. (c) Improper weatherproofing of the uphill connector.

2. At JB2, the uphill connector – which suffered the majority of the damage (the one with the most intense burn marks, the altogether missing Pin H, and the multiple damaged wire-to-pin contacts) – had not been assembled correctly. The system that clamps the weatherproofing jacket to the cable had not been tightened and was not actually located in the position that it should have been located.

3. The burn marks on the uphill connector at JB2 were centered around the pins of the H-R-S triplet, which delivers the power from the Receiver setup at TerraLab up to the Preamp at the top of the Glacier. On the downhill connector, the burn marks on the mating face are in the same location and seem to merely be a result of more serious burning that happened on the uphill connector.

connector no longer being used that I found in storage at TerraLab. The downhill connector at JB2 (also damaged) was replaced with a brand new connector. At JB1, two (2) of the three (3) wire-to-pin contacts damaged by the twisting motion of opening the connectors were repaired. These were the contacts associated with Pin C on the downhill connector and with Pin H on the uphill connector. The wire-to-pin contact associated with Pin P on the downhill connector was not repaired it was located in the middle of the 18 connections (very hard to get to with a soldering iron in the wind and snow/rain) and was only apart of the spare triplet (which is neither connected to the Preamp or to the Receiver).

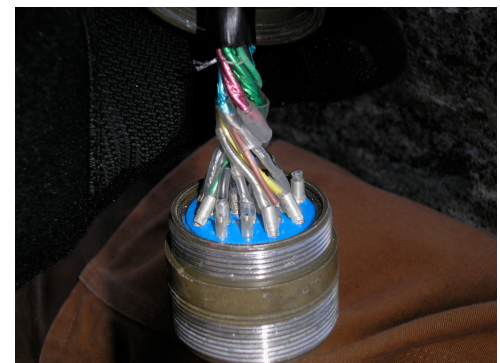
In the course of examining the connectors at each junction box, problems in safely separating two joined connectors (without damaging the wire-to-pin contacts inside) were encountered. Normally, one separates connectors by unscrewing the attachment ring that joins the connectors. However, if one is holding the wrong connector backend while attempting to do this, the backend may begin to unscrew before the attachment ring does (perhaps due to the cold). Because the backend is clamped to the cable but not to the pin header, this action can begin pulling the wires off the pins. This tendency was observed at JB1, JB2, and JB3, although it was not observed at JB4 or at the Preamp.

This problem resulted in damage (likely incurred after the VLF antenna failed and investigation began) to the connectors at JB1. In the downhill connector at

Figure 5 – The twisting damage exhibited on one of the JB1 connectors.

JB1, Pin C (of the NS triplet) and Pin P (of the spare triplet) had been disconnected from their wires. In the uphill connector, Pin H (of the power triplet) had been disconnected from its wire.

- Clean the Hero Inlet ground. It was recently replaced altogether (February 27, 2008) and should not have to be cleaned until the austral summer of 2008-2009. Cleaning the ground in winter may be difficult due to ice freezing to the ground.
- Replace the connectors at JB1, which were damaged by the twisting motion of opening the connectors. At the very least, the wire-to-pin contact associated with Pin P of the downhill connector at JB1 should be repaired (if only for completeness' sake, as that wire is only a spare wire and does not actually play a functional role in the Antenna/Receiver system).

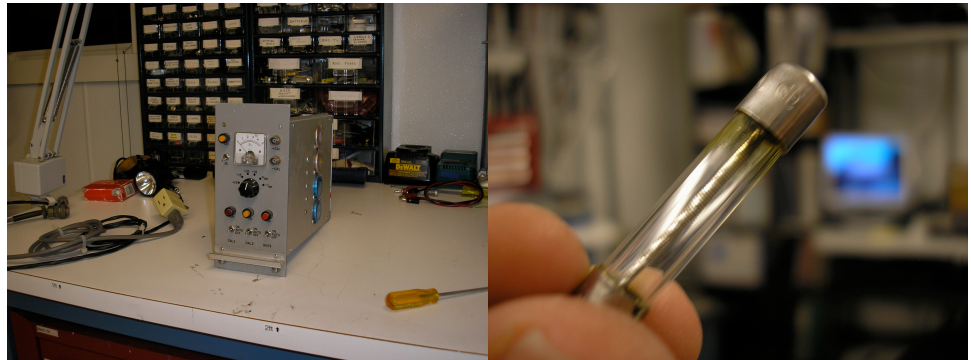
Figure 6 – (a) The power supply box and (b) the blown fuse found inside of it.

the Power Supply Box (which also houses the calibration injection circuitry), which did not properly generate the  $\pm 35$  VDC that is sent up the VLF cable to power the Preamp. This was due to a blown  $\frac{1}{2}$  amp fuse inside the Power Supply Box.

In the Receiver setup in TerraLab, a ½ amp fuse inside the power supply box (which generates the  $\pm 35 \text{ VDC}$  power) had been blown causing power not to be delivered to the Preamp. The fuse was the middle fuse of the five (5) fuses in the power supply box. The fuse was replaced.

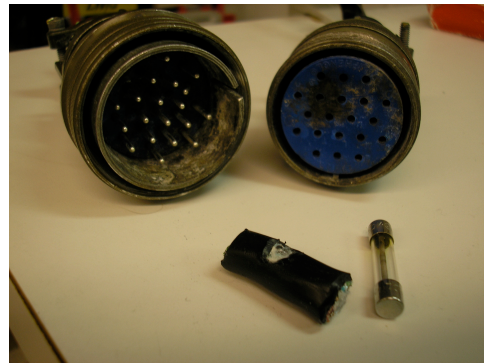
1. The severed wire (associated with the connectors' Pin S) in the middle of the JB2-JB3 cable.
2. The damaged uphill connector at JB2.
3. The blown fuse in the power supply box at TerraLab.

Figure 10 – The elements that caused the Antenna/Receiver system to fail.
