**STRAW-BALE AS A VIABLE, COST EFFECTIVE, AND SUSTAINABLE
BUILDING MATERIAL FOR USE IN SOUTHEAST OHIO**

Leanne R. Marks

June 2005

Marks, Leanne R. M.S. June 2005. Environmental Studies.

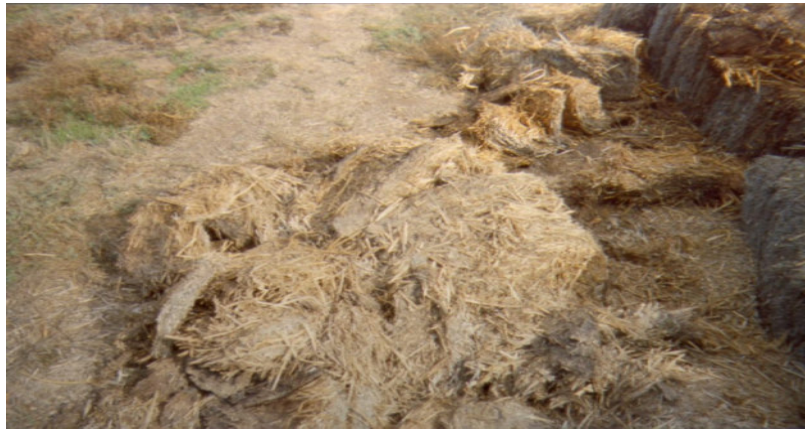
Figure 7. Degraded straw-bales.

Like wood, straw-bales are at the mercy of weather conditions when unprotected.

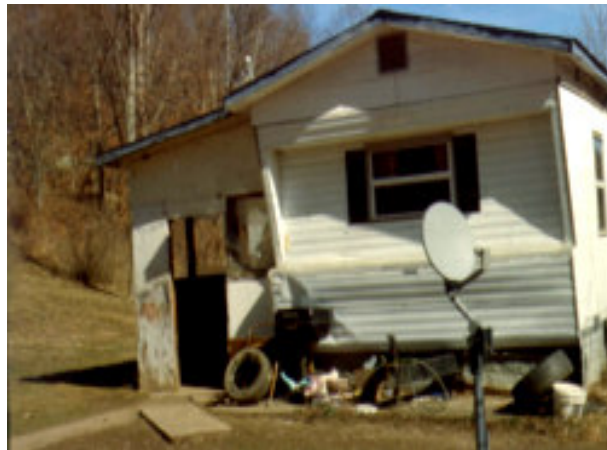
Figure 9. Deteriorating home of Addie.

With the roof caving in, gas leaks, unrepaired and broken windows, and constant plumbing problems, Addie Gould had raised and continues to raise children within this residence.

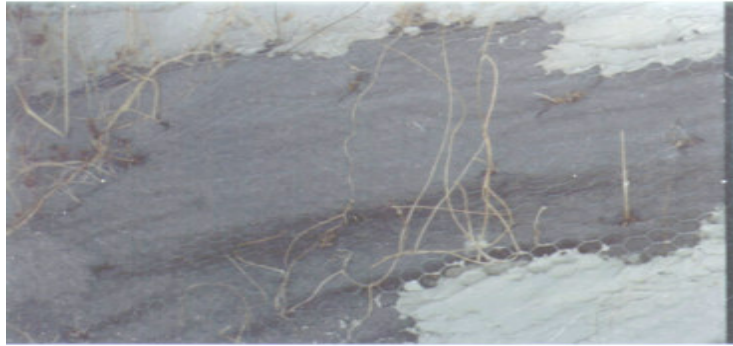
Figure 14. Moisture barrier use.

House No. 2 -an example of what NOT to do or use – chicken-wire, tarpaper, loose straw, exposed walls.

It has been found that moisture barriers inhibit a straw-baled walls’ ability to “breathe” or to “perspire” and therefore are not recommended. In fact the Building Codes established for straw-bale buildings prohibit their use (City of Tucson and Pima County Arizona Building Code). This means that if a moisture barrier were used and water were to penetrate a straw-baled wall moisture would then be trapped within the wall system (like we’ll see later in House No. 2), rather than seeping through porous lime and earth (and cement to a lesser extent) wall coverings. The decision to use a sheet membrane over bales not only affects the permeability of the baled wall, but the strength and integrity of the plaster coating

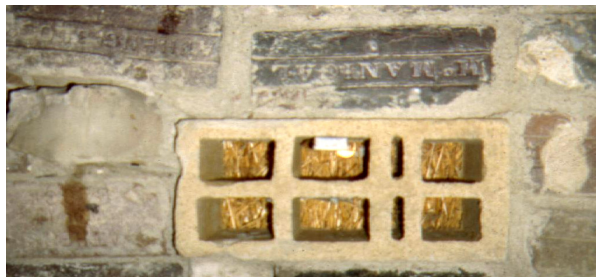
Figure 15. A straw-bale “truth window”

Often placed within a straw-bale home to prove to disbelieving visitors that the house is made of straw. In my opinion, it is just another unnecessary detail vulnerable to moisture intrusion.

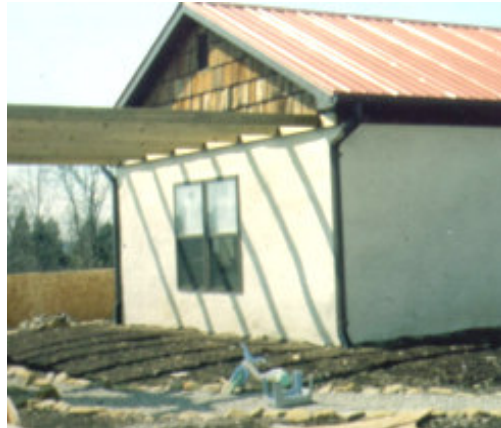
Figure 21. Overhangs

The purpose of larger overhangs is to protect the southwest wall from direct precipitation influence. Note: Walls are undesirably plastered all the way to the ground.

- i. Protect materials during construction;
- ii. Build substantial overhangs (two feet);
- iii. Incorporate the use of verandahs;
- iv. Use splash-back protection - either gravel on ground to diffuse water molecules, a garden, or moisture barrier on the lower wall section;
- v. Drip-edge window sills;
- vi. Adequate sealant for windows;
- vii. Maintenance of stucco and sealants.

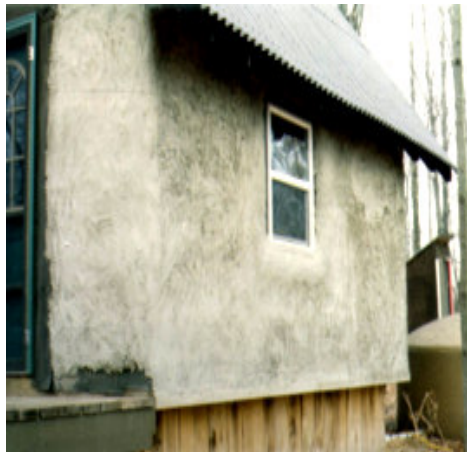
Figure 22. Southern and western walls of House No.1.

Note unplastered section.

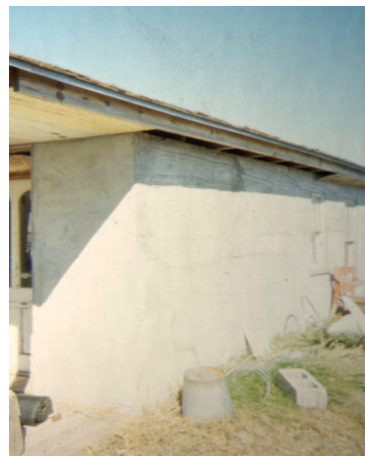
Figure 26. House No.3 western wall with more appropriate overhang length

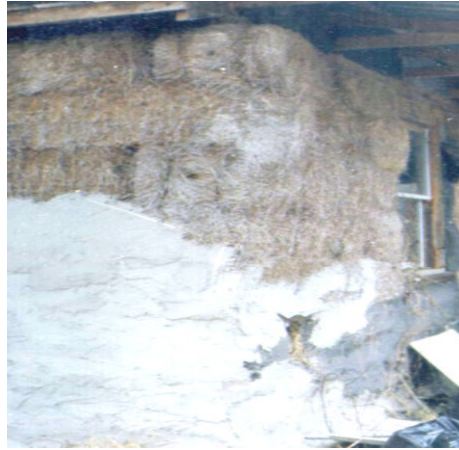
Figure 29. Northwest wall section of House No.2
- remains unfinished for 3yrs now.

significantly higher moisture content readings than that of House No. 1 or House No. 3 - particularly when comparing the lower sections of the house. The largest difference can be seen when comparing below window readings from all three houses. The average window reading (WB) from House No. 2 was 20%, compared to 10.7% and 13.4% from House No. 1 and No. 3 respectively. The first two months of no windowsill or other window protection affected the overall average below window readings for House No. 3. During the first two months of sampling below window readings were 15.5% and 17.2% for January and February respectively. After caulking the seals and installing a drip sill, the average monthly moisture readings fell to between 11-13% (see section D – Wall Altitude Comparisons for more information). The high moisture content readings of House No. 2 may be caused by drainage problems and/or foundation problems. It is difficult to pinpoint one specific cause when it probably has multiple causes, such as:

- The foundation;
- The lack of sealing of the window;
- The holey tarpaper wrapping the first two courses of bales;
- Poor drainage;
- Exposed bales.
