Preservation Plan
for the
Crosley Carriage House
(Garage and
Servant's Quarters)

at the
Crosley Museum
Sarasota, Florida

April 26, 2006

RENKER-EICH-PARKS
ARCHITECTS

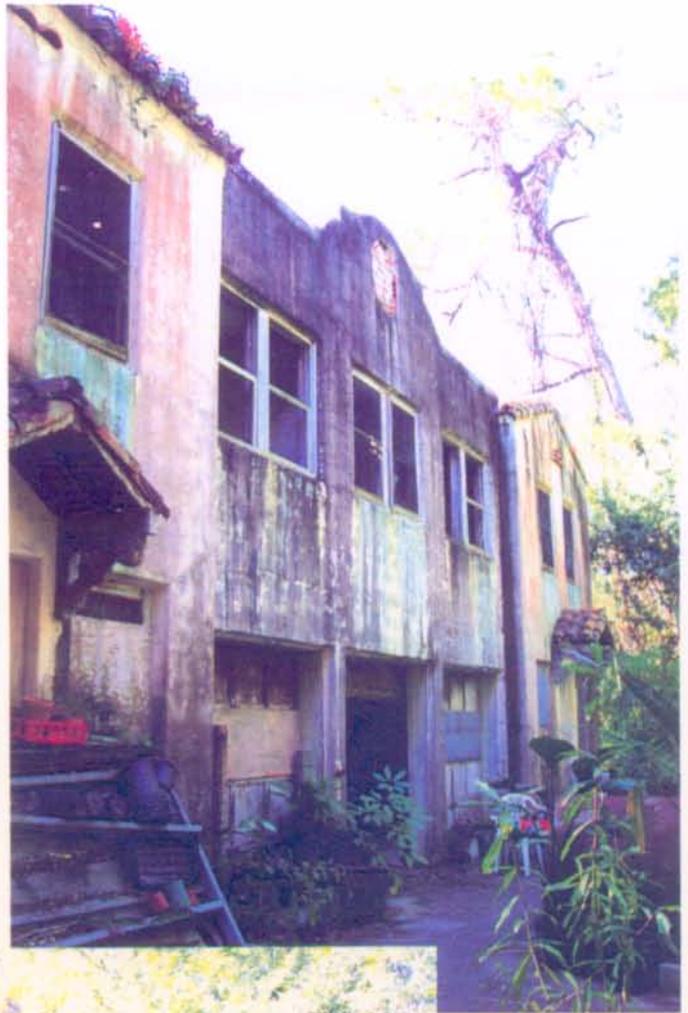
Photograph 1: NORTH ELEVATION
SHOWING GENERAL CONDITION OF
BUILDING NOTE STAINED STUCCO WALL
FINISH AND DETERIORATED WINDOWS.

The entire exterior of the structure is clad with Portland cement stucco, which was painted shortly after construction. The stucco is in fair condition and is soiled and stained with mildew and algae growth. Very careful cleaning procedures using chemical cleaners will need to be undertaken to remove the mildew and algae. Testing in small areas will be necessary to determine the least invasive materials and methods. After cleaning the walls will need to be repaired to remove the minor areas of damage and deterioration. As a final restoration procedure the walls will be painted.

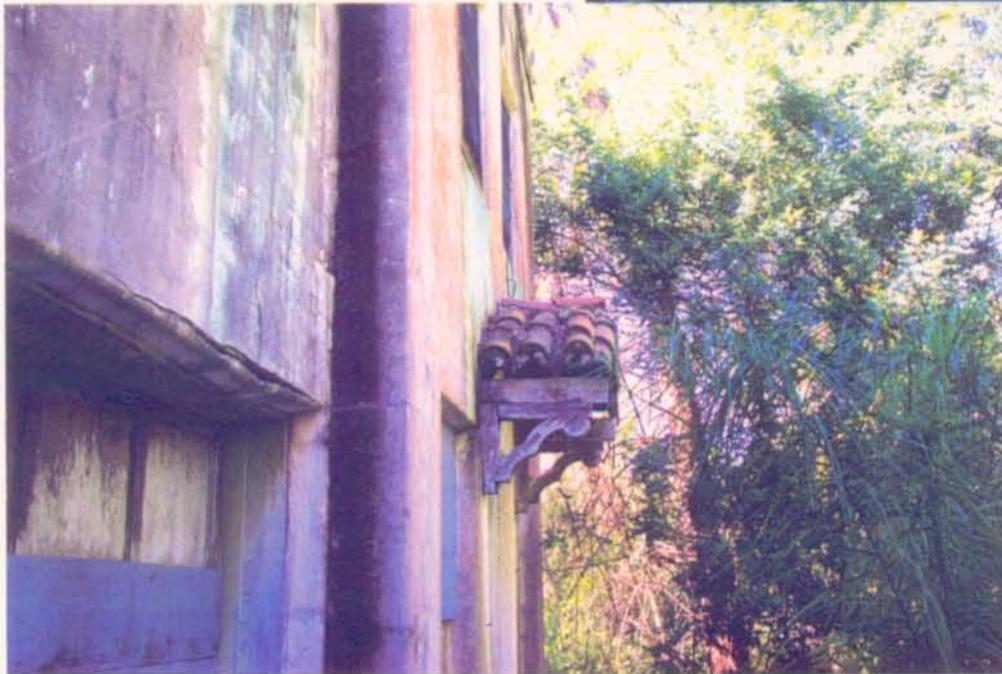
Photograph 2: DETAIL OF PARTIAL NORTH ELEVATION SHOWING HOOD
OVER ENTRY DOOR WITH TILE ROOF.

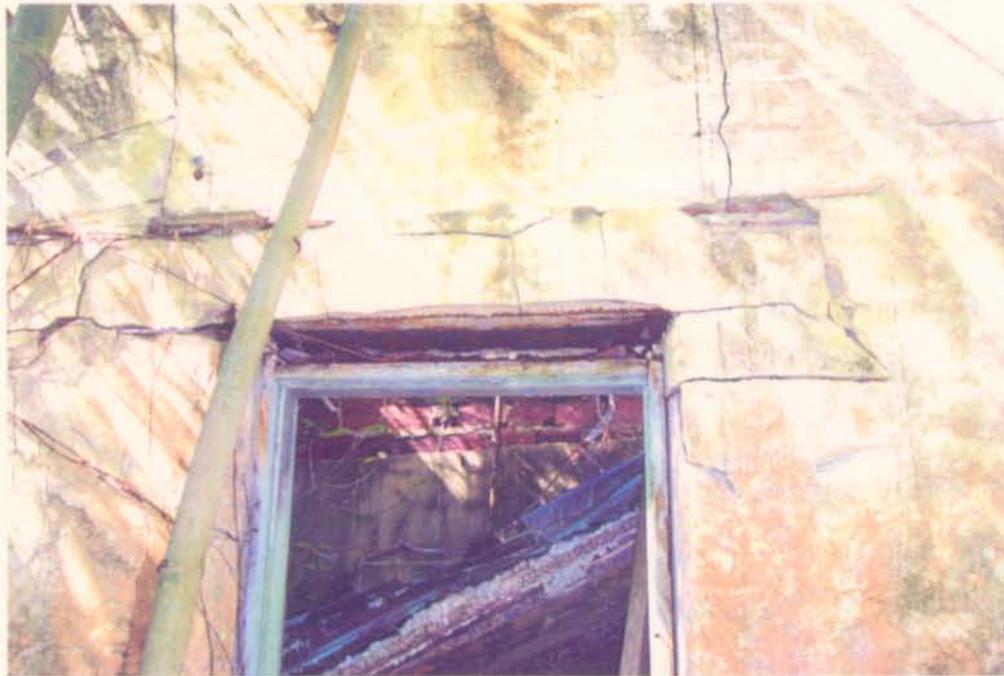
Photograph 4: DETAIL OF PARTIAL EAST ELEVATION WITH DOOR TO LAUNDRY SHOWING DETERIORATED STUCCO AND METAL LINTEL OVER DOOR.

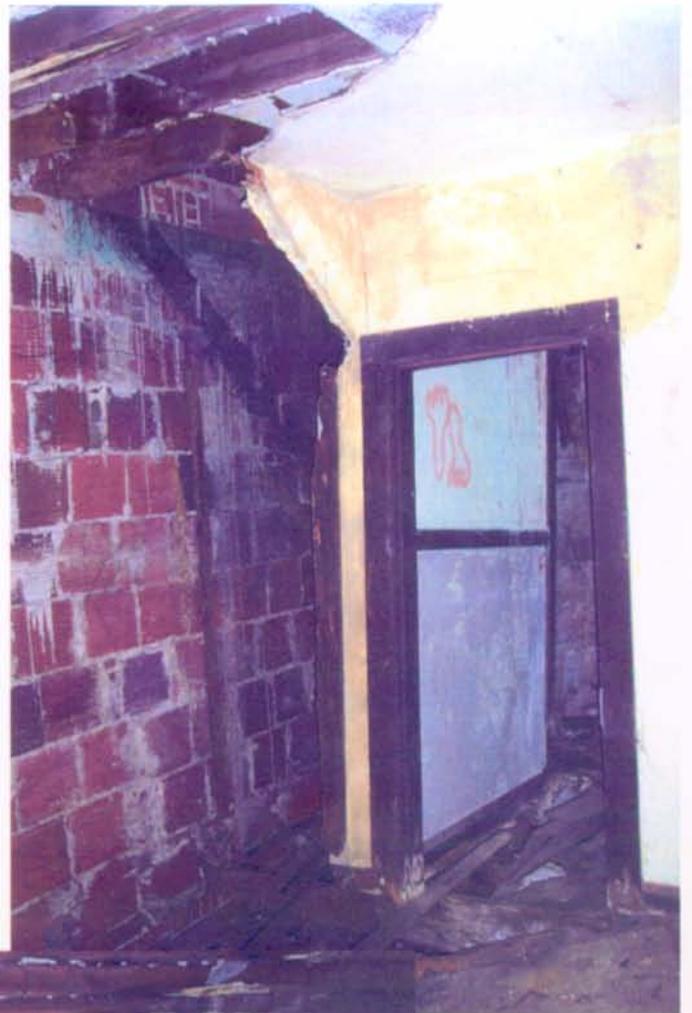
Photograph 7: DETAIL OF INTERIOR FIRST FLOOR SHOWING DOOR TO KITCHEN, DOOR TO CLOSET UNDER STAIR AND GENERAL DETERIORATED CONDITION.

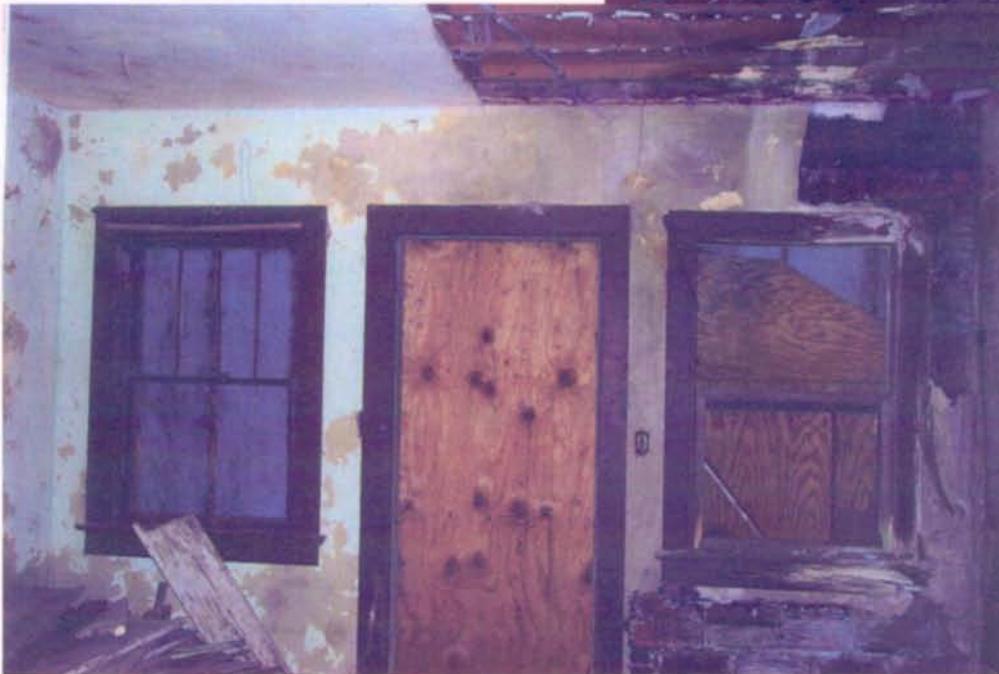
Photograph 8: INTERIOR ELEVATION OF NORTH WALL OF FIRST FLOOR LIVING ROOM.

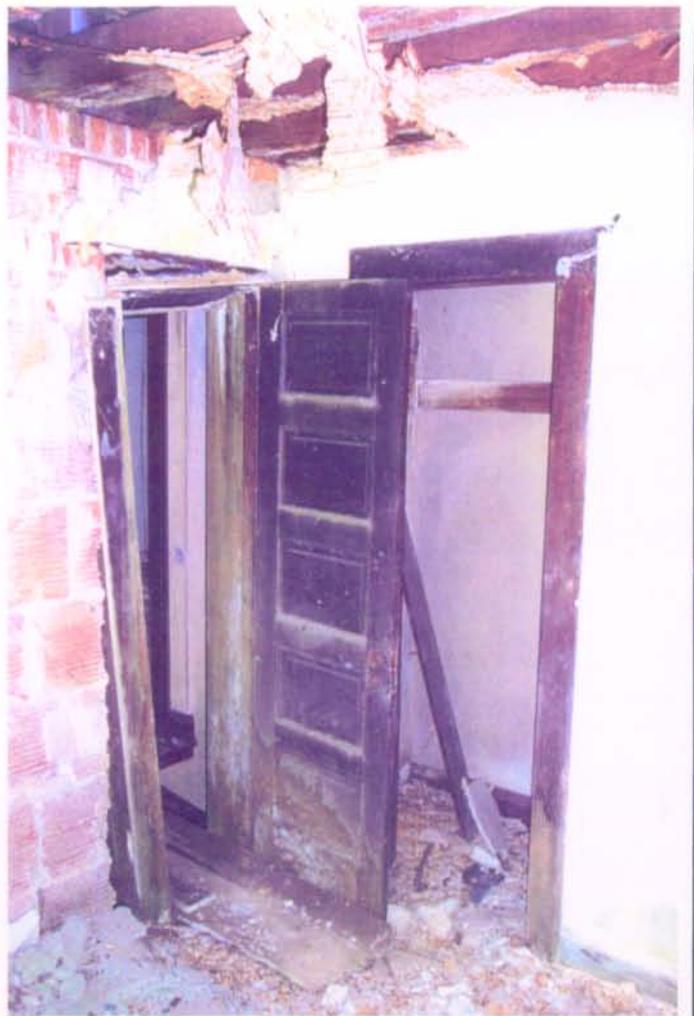
Photograph 11: INTERIOR ELEVATION OF DOOR AND CLOSET ON SECOND FLOOR SHOWING DETERIORATED CONDITION.

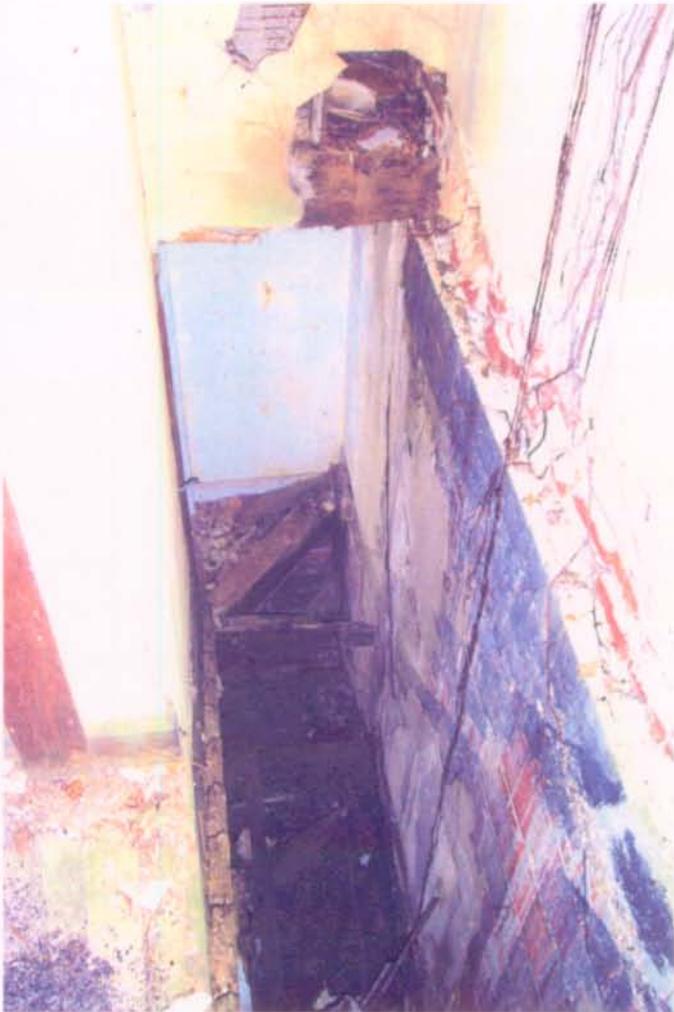
Photograph 12: VIEW FROM SECOND FLOOR LOOKING DOWN INTO STAIR WELL WITH MISSING STAIR.

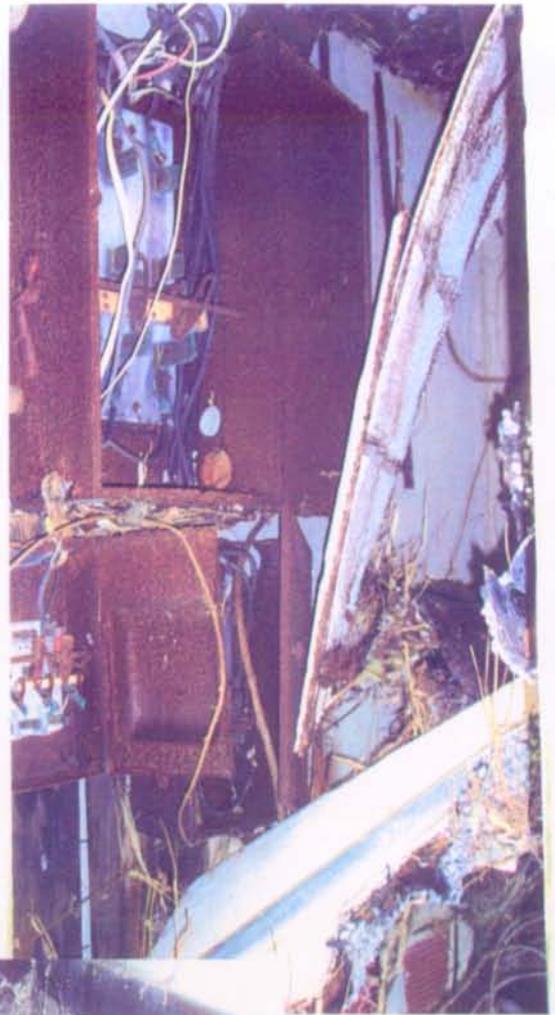
Photograph 13: INTERIOR DETAIL OF ELECTRICAL ROOM SHOWING ELECTRICAL PANELS IN DETERIORATED CONDITION.

The entire electrical system for the building from the service entry to the fixtures and devices are in poor condition and must be replaced in their entirety. It is recommended that a new underground service entry be brought to the building, to the same location as the original point of entry. A meter would be mounted on the building, west wall of the laundry room. Immediately inside the building in the laundry room would be a panel from which electricity would be distributed to all areas of the building. The electrical supply to each room would be upgraded from the original one receptacle in each room to three receptacles or as required by code. The lights for each room would match the original with a fixture in the center of each room ceiling and supplemental lighting would be provided by free standing task lights. Power would be provided to miscellaneous fixtures such as the laundry and the kitchen units.

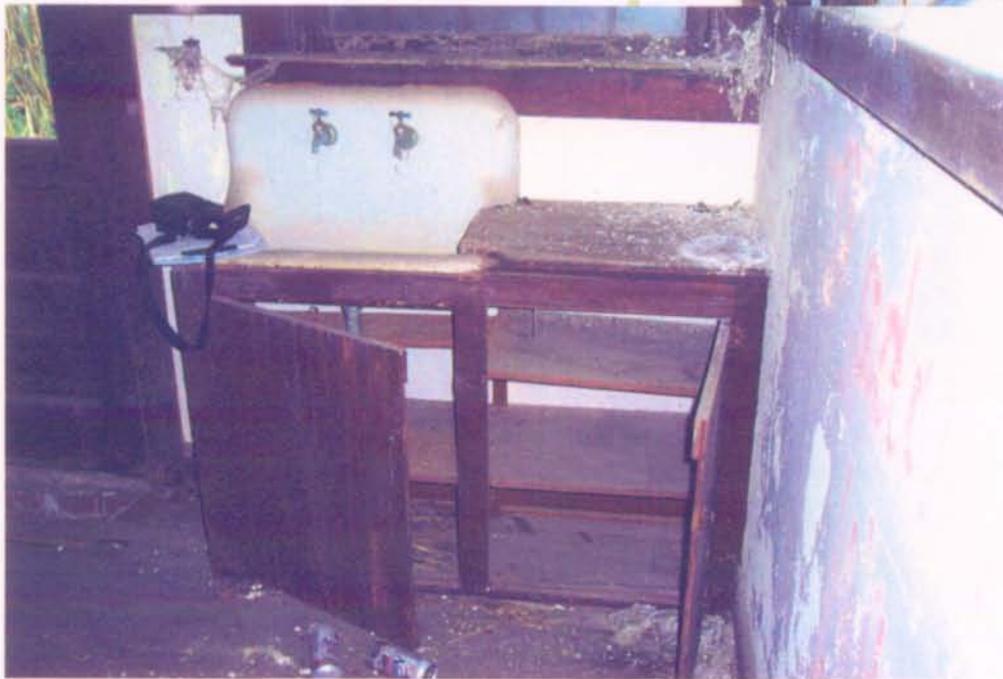
Photograph 14: DETAIL OF ORIGINAL SINK AND BASE CABINET IN WEST UNIT KITCHEN.

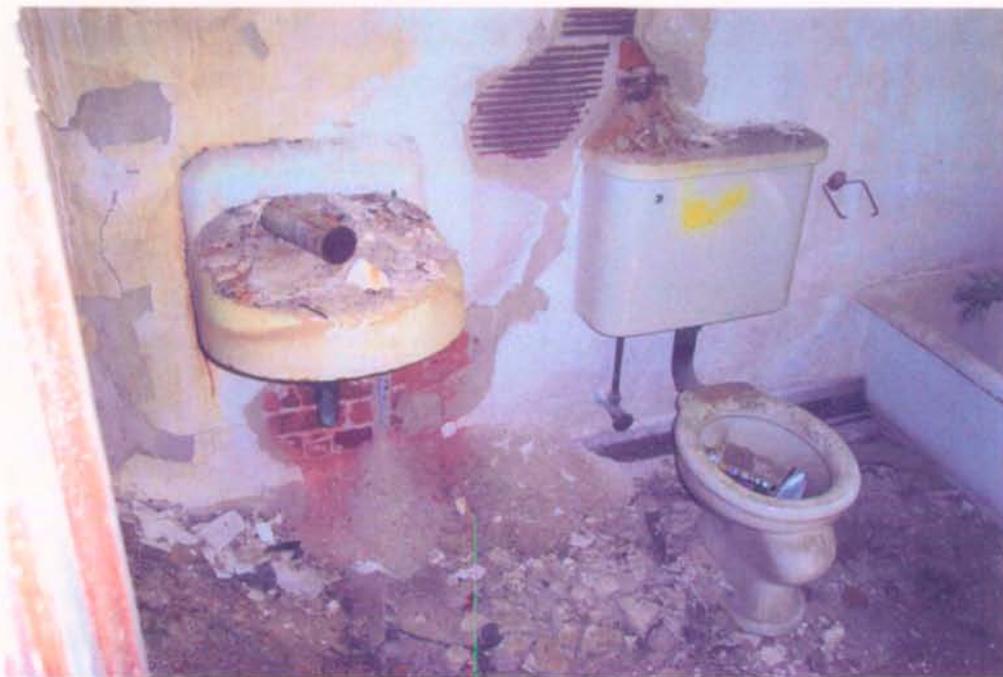
Photograph 18: DETAIL OF BATHROOM SHOWING FIXTURES AND GENERAL DETERIORATION.
