MEMS reliability in shock environments

Danelle M. Tanner, Jeremy A. Walraven, Karen Helgesen, Lloyd W. Irwin,
Fredrick Brown, Norman F. Smith, and Nathan Masters

Sandia National Laboratories, P.O. Box 5800, MS 1081, Albuquerque, NM 87185-1081
<http://www.mems.sandia.gov>
email: tannerdm@sandia.gov

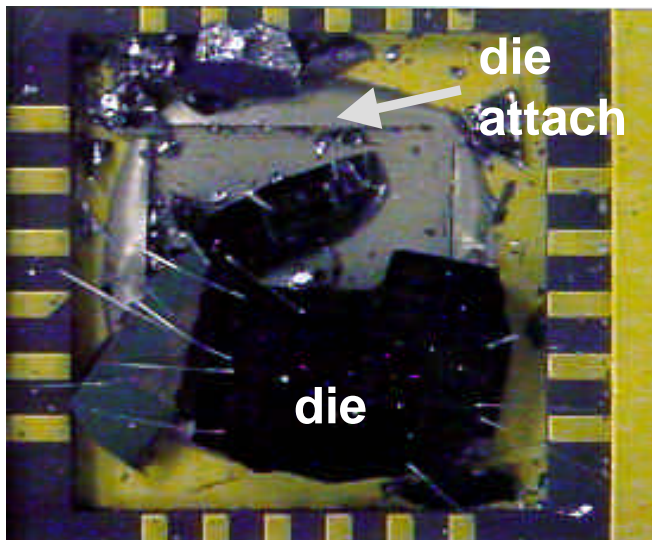
Figure 9. The interior of the package subjected to 10,000g from top impact shows the broken die and the imprint of the die in the die attach.

The two failures at 10,000g were on the same die subjected to top impact. The die actually broke away from the package and slammed into the metal lid. The broken die and package interior is shown in Figure 9. Note the imprint of the die in the die attach material. Each die was treated with a coupling agent to prevent stiction after the release. The failure occurred because the coupling agent weakened the adhesive strength at the die-package interface. This die attach failure was observed in only one package out of three subjected to top impact. Removal of the coupling agent from the back of the die before packaging should eliminate this problem.

The coupling agent used to prevent stiction in the release may also pose a reliability concern in packaging these dice. The coupling agent weakened the bond between the die and the package. These failures can be reduced by removing the coupling agent from the backside of the die prior to packaging.

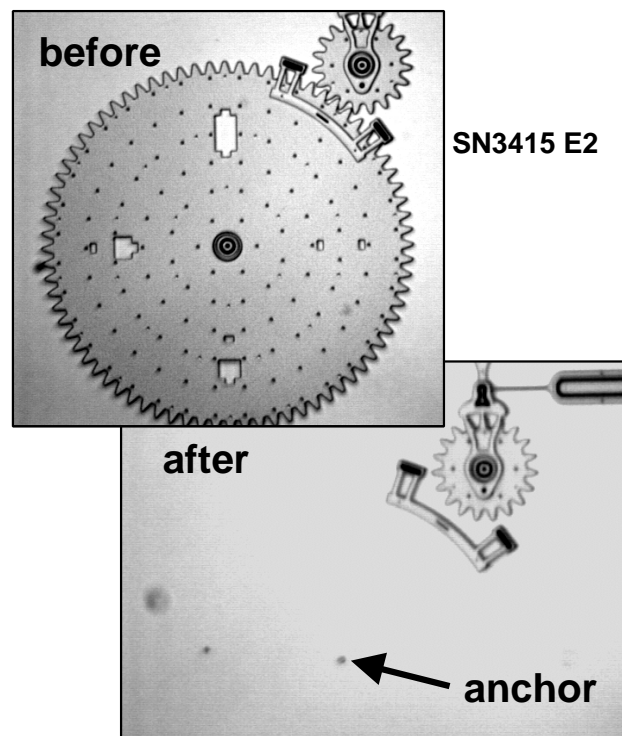
Following shock testing at 20,000g, 13 out of 19 microengines were functioning, but we began to observe structural damage. Three large gears (320- μ m diameter) broke away from the substrate as shown in Figure 10 due to a bottom impact. The microengines still

Figure 10. A bottom impact of 20,000g broke the anchor of the large gear. The microengine still functioned in this case.

functioned after test, but this would have been a system failure if the large gear were necessary. A simple design change to make the anchor for the large gear larger and thus stronger would prevent the loss of the gear. The anchor diameter is now 14 μm , which is the same as the drive gear.

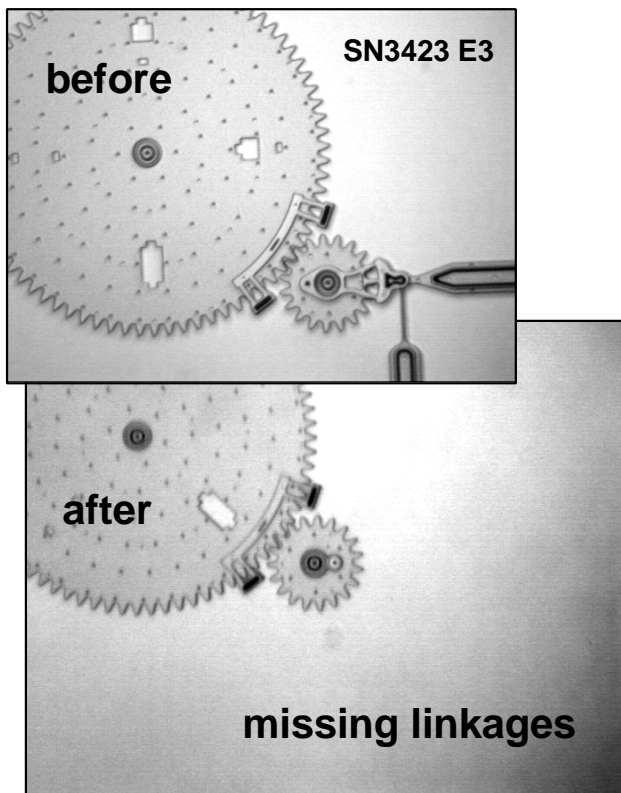
Figure 11. The linkage arms on one of the microengines broke with a 20,000g top impact.

One set of linkages was lost (Figure 11) in a top impact producing a failed microengine. Here the shock was strong enough to fracture both the pin joints and the flexures between the linkage arms. The flexures are only 2 μm wide and 40 μm long and allow bending of the linkage arms to move the gear. Illustrated in Figure 12 are the pin joint and flexure respectively. A small piece of debris is located near the pin joint. It is unknown at this time if both regions failed simultaneously, if the pin joint fractured as a result of fracturing of the flexures, or vice versa. It can be stated that this level of shock is capable of breaking the thinner, more fragile regions of the microengine.

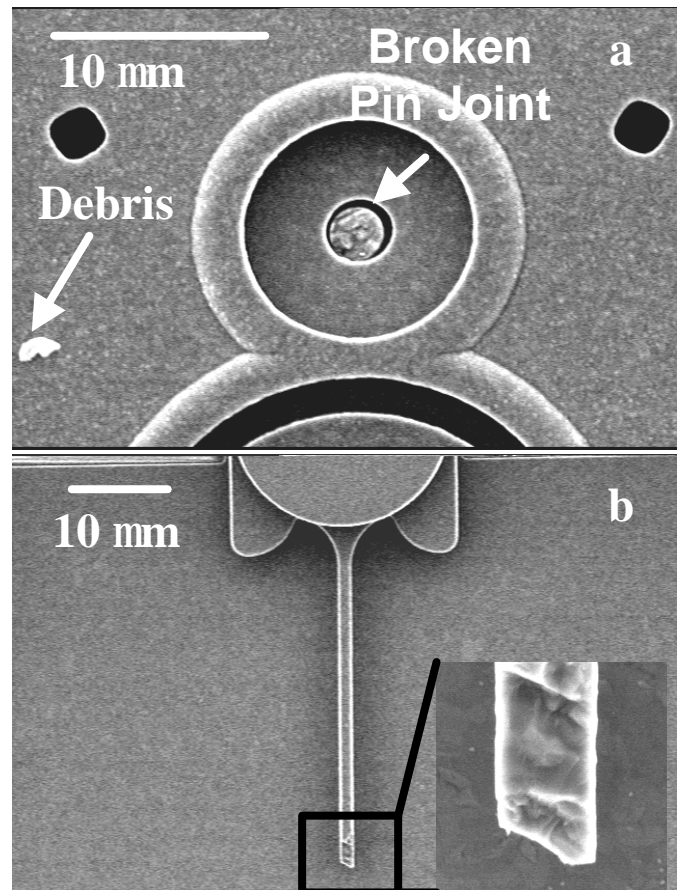
Figure 12. The broken pin joint (a) and fractured flexure (b) resulting from 20,000g top impact shock are shown.

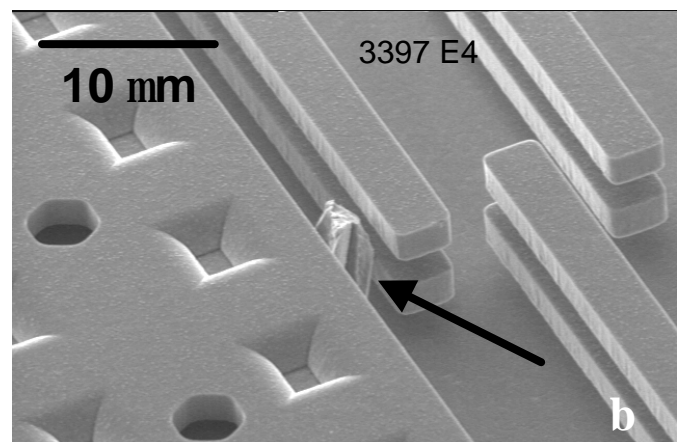
One of the microengines at 20,000g subjected to top impact failed due to debris shorting out an actuator to the ground plane. Removal of the debris by careful probing eliminated the short. Removal of this debris permitted the microengine to function, indicating that it was the source of the short.

Figure 13. Particle contamination was found within the actuator region of the microengine subjected to a 20,000g top impact. Note the contact between the particle, stationary comb fingers, and the shuttle resulting in electrical short of the drive signal to the ground plane.

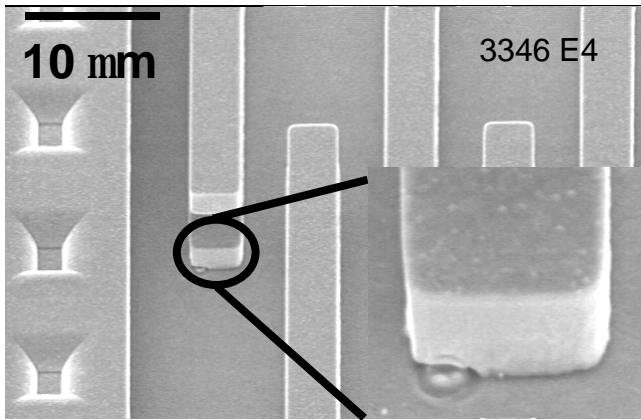
The second shorting phenomena observed in this experiment, is a comb finger contacting the ground plane. This led to a direct short of this actuator. Electrical probing revealed the presence of the short, and visual inspection using the SEM revealed the bottom comb finger adhered to the ground plane as illustrated in Figure 14.

Figure 14. This stationary comb finger was observed stuck down to the ground plane after a top shock impact at 20,000g. Note the contact at the tip of the comb finger and the ground plane in the expanded image.

Could the shock have bent and adhered the fingers? If we examine a single lower comb finger with a length of 48 μm , width of 4 μm , and thickness of 2.5 μm , we can calculate a mass of 1.1 ng. The force from a 20,000g shock could be 0.22 μN . Now, we use an equation similar to equation. (3) except it is for a uniform load on a beam,

where w is the load or F/L . A deflection of 2 μm where the tip of the finger would touch to ground plane requires a force of 117 μN . The force from the shock is almost three orders of magnitude below the force needed to bend the finger implying that the shock impact was not the cause of the short.

Additionally, after observing this short at 20,000g, we tested our controls that were kept in a benign nitrogen environment during the shock tests. Four out of nine microengine controls had failed, by exhibiting rocking behavior. Electrical probing revealed shorting of the operational voltages to the ground plane. SEM examination of the controls revealed the same signature of one or more fingers adhered to the ground plane. This result suggests that this failure mechanism was not induced by shock.

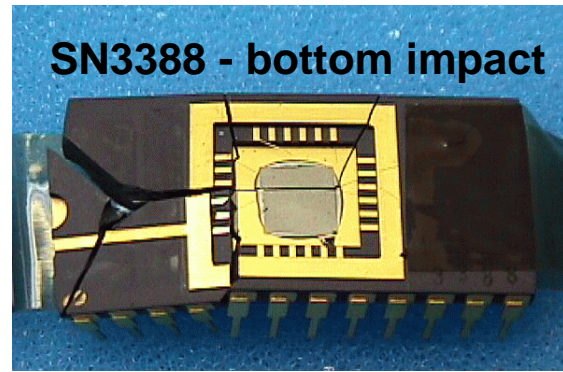
The extreme level of 40,000g shattered all four of the ceramic packages. An example of package fracture after bottom impact is shown in Figure 15. The mounting method in the fixture may have contributed to the fracture. All 8 microengines stressed in a top impact were destroyed due to die attach failure. Surprisingly, two dice survived (one from bottom impact and one from side impact) and were lifted from the fractured packages. One is shown in Figure 16 where the bond wires are visible along the edge of the die. After careful removal of the bond wires, two microengines actually functioned, one from each die. There was a large amount of debris on the surfaces of each die (Figure 17), partly from the cracked packages.

Figure 15. The 40,000g impact from the bottom fractured the package. The die was removed and tested.

A more global concern for MEMS reliability at these shock levels resides in the package. As shown in Figure 15, the limiting factor in overall functionality will reside in the survival of the package itself. Utilizing plastic or non-ceramic packages may reduce or prevent these failures from occurring.

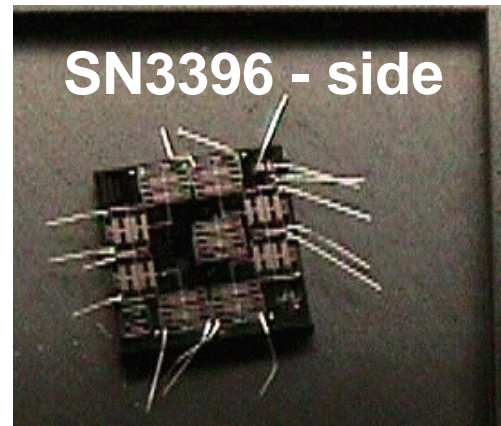
Figure 16. This die was removed from a fractured package subjected to 40,000g-shock impact.

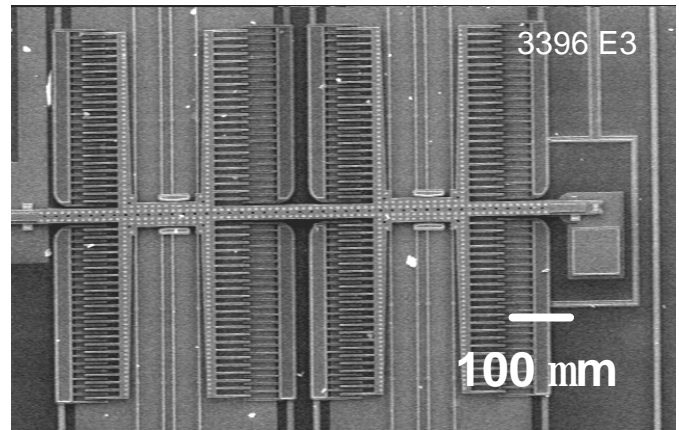
Figure 17. The particle contamination shown in this SEM image was characteristic to both dice that survived the 40,000g impact. Specifically, this is the y-axis actuator from a side impact.

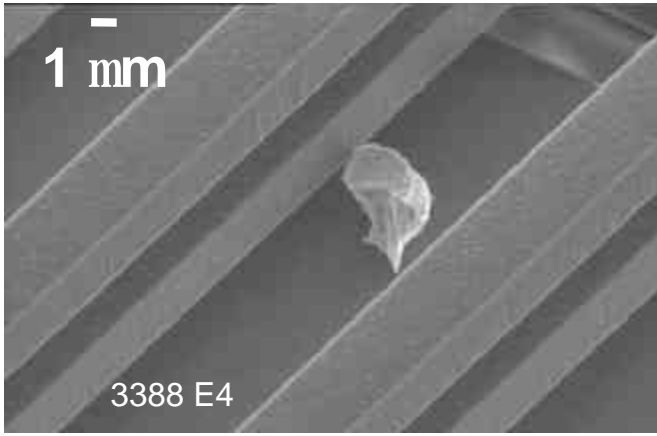
Characterization of the two microengines that failed as rockers revealed shorts between the operational voltage and the ground plane. One of the microengine failed due to debris contamination. The particle was located between the comb fingers and is illustrated

Figure 18. This particle was the short between the stationary comb finger and the ground plane. The shock impact was from the bottom at a 40,000g level.

in Figure 18. The other rocking microengine had a stuck comb finger on the ground plane due to a bottom comb finger, similar to the electrical shorts found at 20,000g.

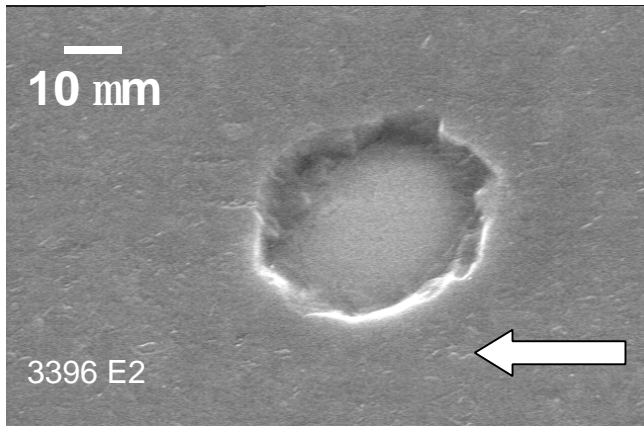
Figure 19. This crater resulted from a load gear anchor being ripped out of the polysilicon ground plane by a side shock impact of 40,000g. The arrow indicates the shock direction.

The one microengine that functioned had its load gear ripped out of the ground plane. As illustrated in Figure 19, the crater left by the missing load-gear hub is charging up in the SEM. The surrounding ground plane is polysilicon and grounded through the bond wire. For this area to charge, the silicon nitride underneath the ground plane would have to be exposed. This would indicate the hub delaminated from the silicon nitride, but fractured around the perimeter of the hub.

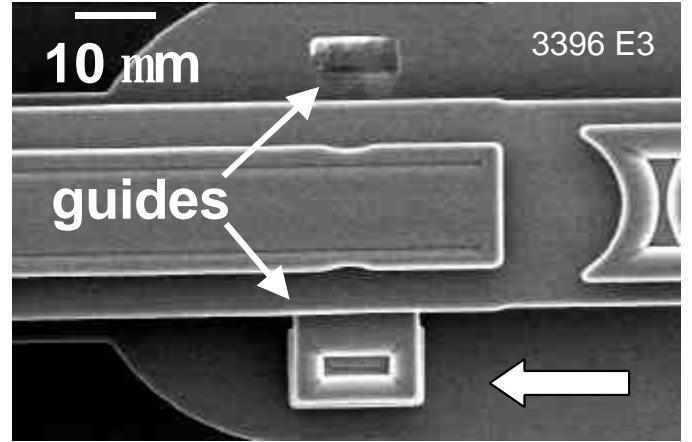
One microengine failed with a broken drive gear hub also had a broken rear guide as shown in Figure 20. Of particular interest in this microengine was the observation that the shuttles along both x and y actuators are on top of the guides. We suspect that the combination of an unanchored drive gear and the lack of a guide removed some of the constraint and the shuttle could move within the x and y plane (plane of the microengine). The residual ringing in the shock

Figure 20. The 40,000g-shock impact broke one of the rear guides of this X-axis shuttle. The shuttle now rides on top of the remaining guide.

wave may have caused motion or vibration of the linkage arms, leading to the shuttles landing on top of the guides.

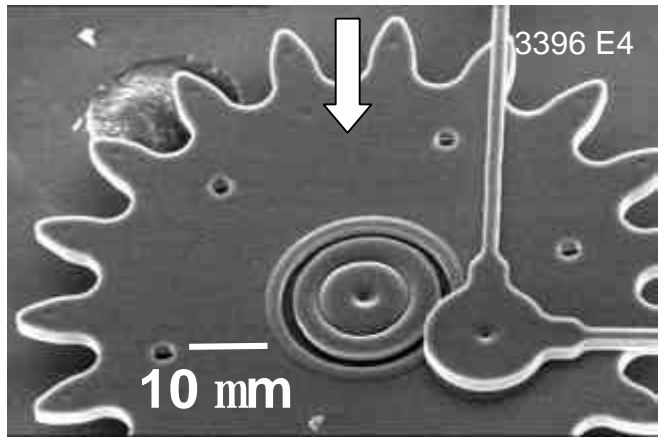
Figure 21. The drive gear anchor was broken by a side impact shock of 40,000g. The arrow indicates the direction of the impact.

The second microengine that failed due to a broken drive gear anchor (the actuators still worked) is shown in Figure 21. Note that the fracture did not expose the silicon nitride layer in this case. In this microengine, the shuttle also worked its way out of the guides, but only on the y actuator.
