HISTORY OF OPHTHALMOLOGY

The Lagerlunda Collision and the Introduction of Color Vision Testing

Abstract. In histories of vision testing, the origins of occupational screening for color blindness are often traced to a fatal railroad accident that occurred in Sweden on the night of 14–15 November 1875. The scene of the accident was the estate of Baron Lagerfelt in Östergötland, but the critical events were played out at Linköping (the normal passing place for the northbound and southbound expresses) and at Bankeberg (a small station to which the passing place was reassigned at a few minutes' notice). First to arrive at Bankeberg, the northbound express slowed almost to a halt, but then inexplicably accelerated forwards towards the Lagerlunda estate, despite a sequence of signals from the stationmaster, Uno Björkelund, and a lineman, Oskar Johansson. Soon after the accident, the ophthalmologist Frithiof Holmgren suggested that the engineer of the northbound express, Andersson, or his oiler, Larsson, had been color blind. Neither survived to be tested. Using the records of the subsequent trial and other archival materials, we have re-examined the role of color blindness in the Lagerl

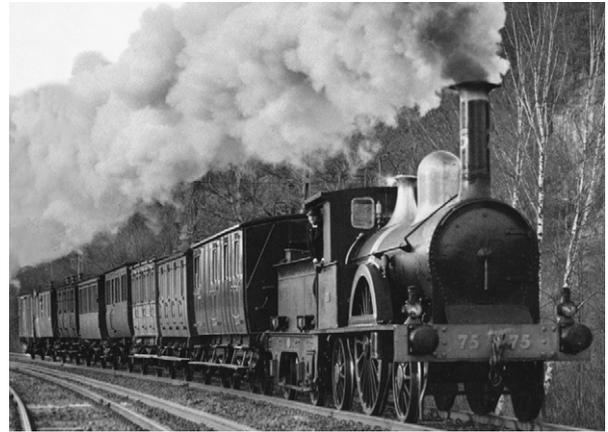
Fig. 2. A surviving example of a locomotive supplied to the Swedish State Railroad by Beyer & Peacock of Manchester in 1866. This locomotive (“Göta”) has the Beyer & Peacock serial number 627/1866 and was supplied in the same batch as the “Svea” (No. 629/1866), which was heading the up express from Malmö to Stockholm on the night of 14–15 November 1875. The “Göta” is here drawing 19th-century rolling stock. Note that the locomotive is significantly narrower than the cars and thus the engineer does not have a clear view back along the track.

Both trains were drawn by powerful 2-2-2 engines supplied by Beyer and Peacock of Manchester, England^{25,32} (Fig. 2), but braking and communication systems had not advanced in consort with locomotive design. Continuous braking systems—such as the Westinghouse vacuum system—had begun to be introduced in the United States after the disaster at Revere in August 1871¹¹ and were being actively advocated by railway inspecting officers in Britain,^{34,40,47} but had not yet been adopted in Sweden. Instead, to stop his train, the

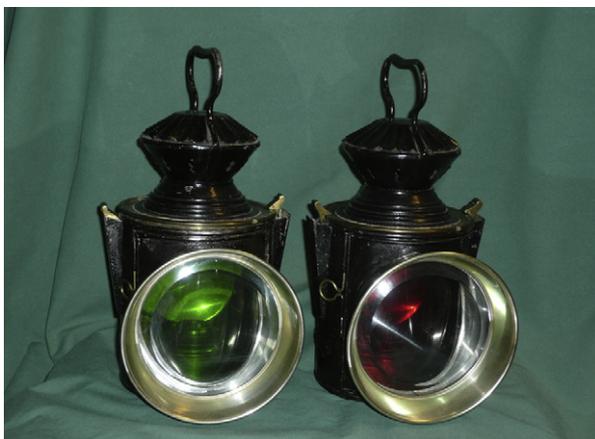
Fig. 3. Examples of railroad signal lamps from the period. By means of the handle at the top, an inner sleeve could be rotated to display red, green or clear glass. The light source was a wick, mounted above an oil reservoir and backed by a curved reflector.

Typical oil lamps used for signaling are shown in Fig. 3. The regulation hand signals in use at night in 1875 on the Swedish State Railroad were as follows:^{6,50,62}

Thirdly, however, the most striking evidence is physical—for the lanterns that Holmgren prepared for his demonstration still exist. They are those shown in Fig. 3 and in Fig. 9A. They survive in the *Medicinhistoriska museet Uppsala*, an extensive collection of medical apparatus that is housed in a former hospital in the forest outside the city of Uppsala. The lanterns carry a dusty label stating that they were those used by Holmgren in his demonstration to Troilius. They are in good condition and do not appear to have seen railroad service. One lantern has three red glasses, the other, two green glasses and one yellow-green.

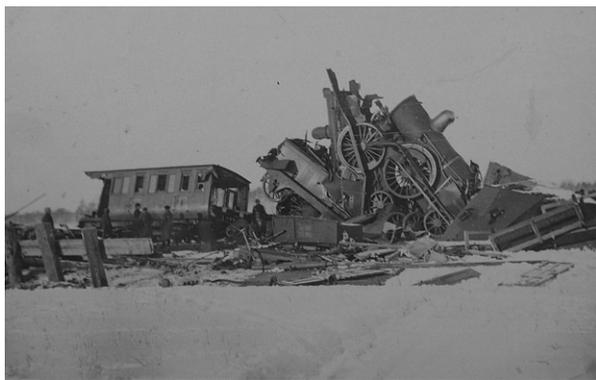
Fig. 5. A photograph of the wrecked trains. This photograph appears to have been taken from south of the track, so that the locomotive of the No. 2, the *Svea*, is to the left.

One factor was the distinguished passenger list, another, the spectacular appearance of the wrecked locomotives. Photographs of the scene after the accident show the two locomotives mounted against each other (Fig. 5). The image that contributed
