RESEARCH REPORT 1405-1

STATE-OF-THE-ART REPORT ABOUT
DURABILITY OF POST-TENSIONED BRIDGE
SUBSTRUCTURES

OCTOBER 1999

*DURABILITY DESIGN OF POST-TENSIONED
BRIDGE SUBSTRUCTURE ELEMENTS*

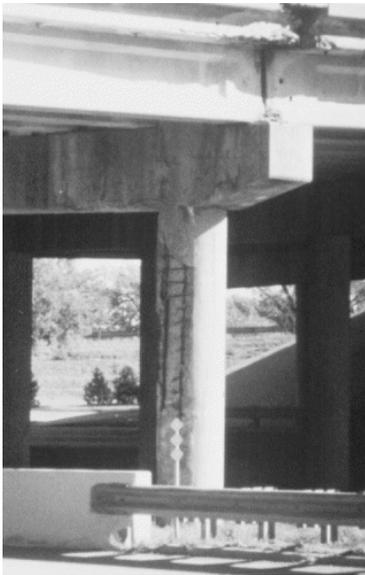
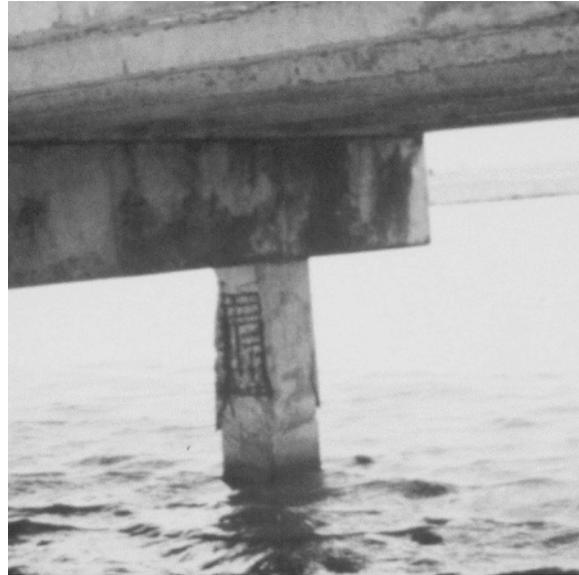
Figure 1.1 - Typical Corrosion Damage in Texas Bridge Substructures

(a) Deicing Chemical Exposure
“Attack from Above”

(b) Coastal Saltwater Exposure
“Attack from Below”

Durability is the ability of a structure to withstand various forms of attack from the environment. For bridge substructures, the most common concerns are corrosion of steel reinforcement, sulfate attack, freeze-thaw damage, and alkali-aggregate reactions. The last three are forms of attack on the concrete itself. Much research has been devoted to these subjects, and, for the most part, these problems have been solved for new structures. The aspect of most concern for post-tensioned substructures is reinforcement corrosion. The potential for corrosion of steel reinforcement in bridges is high in some areas of Texas. In the northern regions, bridges may be subjected to deicing chemicals leading to the severe corrosion damage shown in Figure 1.1(a). Along the Gulf Coast, the hot, humid saltwater environment can also produce severe corrosion damage, as shown in Figure 1.1(b).

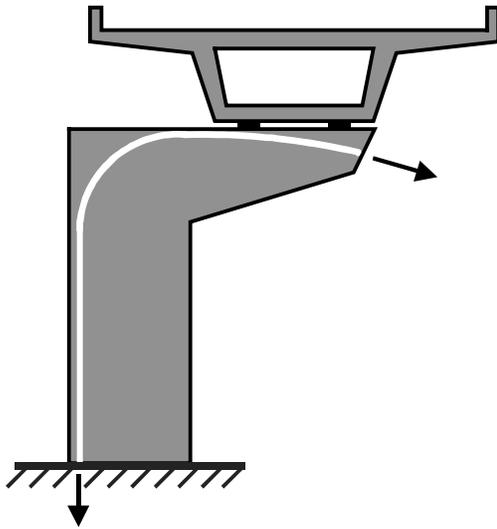
(a) Cantilever Substructure

Post-tensioning provides continuous reinforcement from the cantilever to the foundation. Deflection control and crack control are improved. Heavy reinforcement congestion in the joint region of the column is reduced.

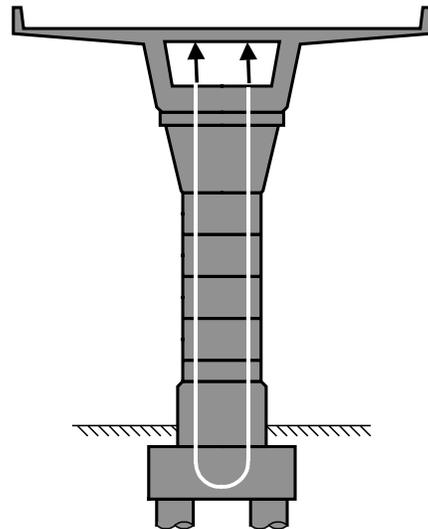
(b) Precast Segmental Hollow Pier

Post-tensioning provides continuous reinforcement in the substructure. Temporary post-tensioning is used during construction for structural integrity.

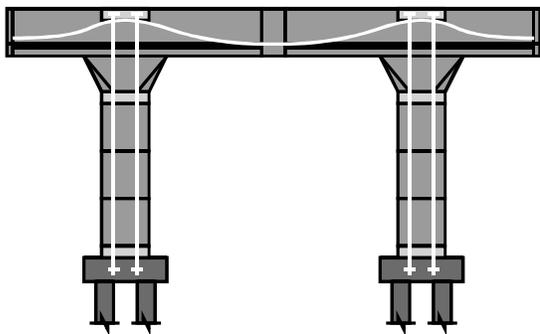
(c) Precast Frame Bent

Post-tensioning provides continuity of reinforcement and structural integrity for this entirely precast substructure. Construction proceeds rapidly, minimizing traffic interruption.

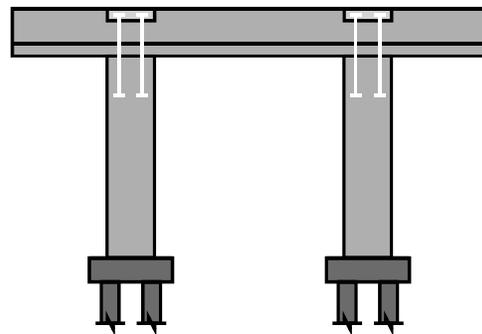
(d) Precast Bent Cap Post-Tensioned to Cast-in-Place Columns

Post-tensioning provides continuity between precast and cast-in-place components. Erection is rapid, minimizing traffic interruption.

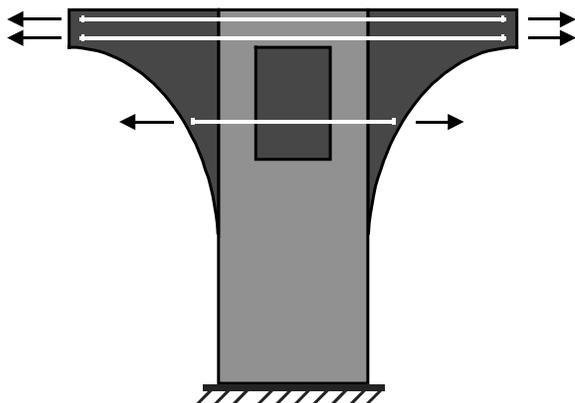
(e) Widening of Existing Substructure

Cantilever overhangs are added to allow widening of the bridge. Post-tensioning is used to provide continuous reinforcement and to improve shear transfer between the overhangs and existing substructure.

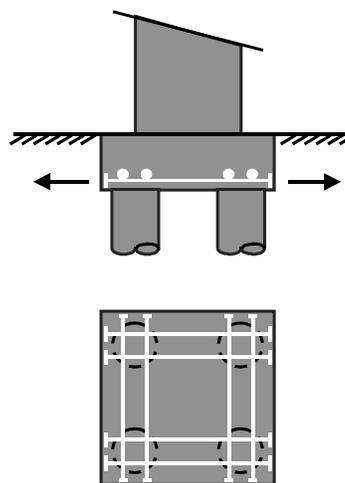
(f) Pile Cap

Post-tensioning is used to reduce the necessary size of the pile cap and the required steel area. The concentrated application of the post-tensioning anchorage forces is well suited to strut and tie methods of design for this element.

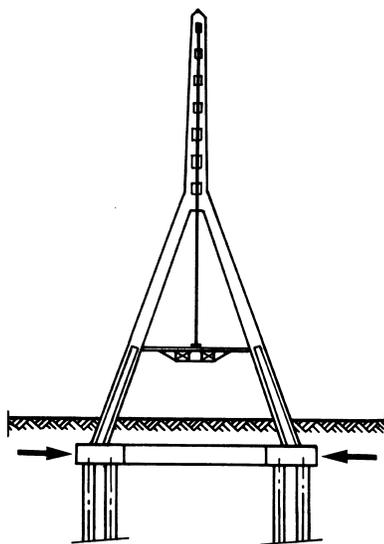
(g) Tie Beam²

High strength prestressing steel used for post-tensioning provides the necessary reinforcement for the large tension forces in the tie beam.

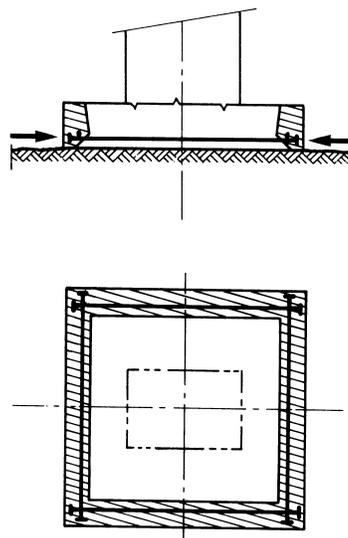
(h) Strengthening of Existing Footing²

Post-tensioning improves force transfer between existing and added concrete.

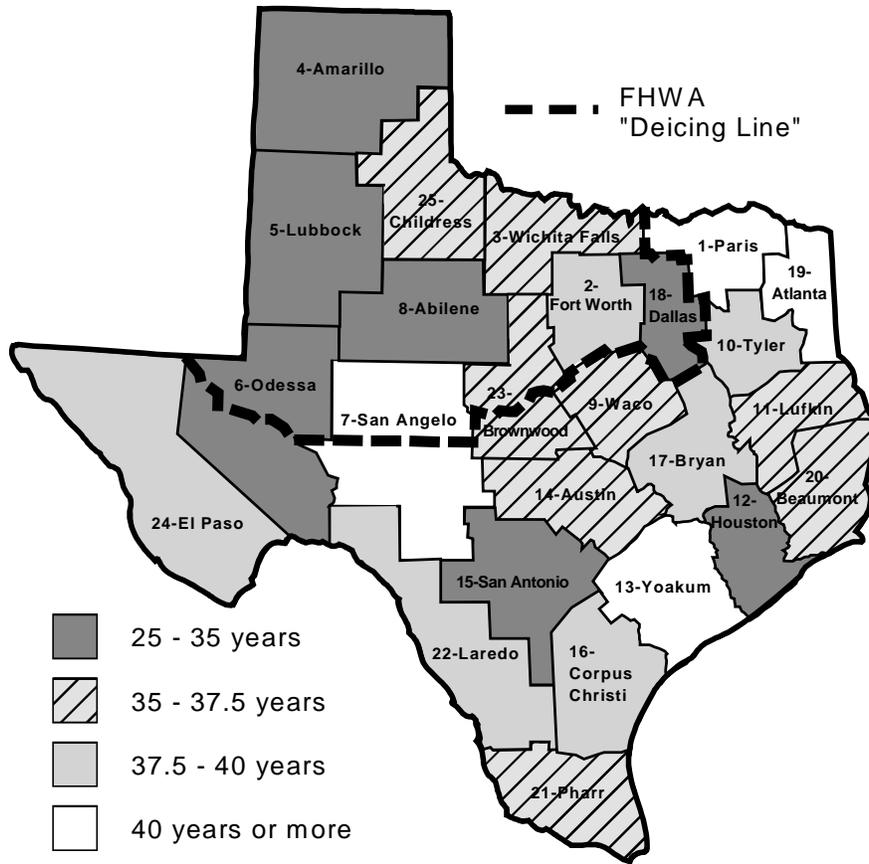
Figure 2.3 - The State of Texas, by District Depicting Mean Age of Deficient Bridge Structures

The mean age of bridges with deficient substructures is shown graphically in Figure 2.3. Figure 2.3 illustrates distinct regions and shows clear trends. The San Angelo district may be the exception as far as mean age. It is interesting to note the low median age of the bridges in the Texas Panhandle. Lubbock District has a mean age of 27.7 years and the Amarillo District is 30.6 years old. Currently, TxDOT is designing bridges for an expected service life of 75 years.¹⁴ The FHWA deicing line is significant from the standpoint of dividing the geographic regions. There are 10 districts above the deicing line. Of those ten districts, eight have a mean age of less than 37.5 years or half of the required design service life.

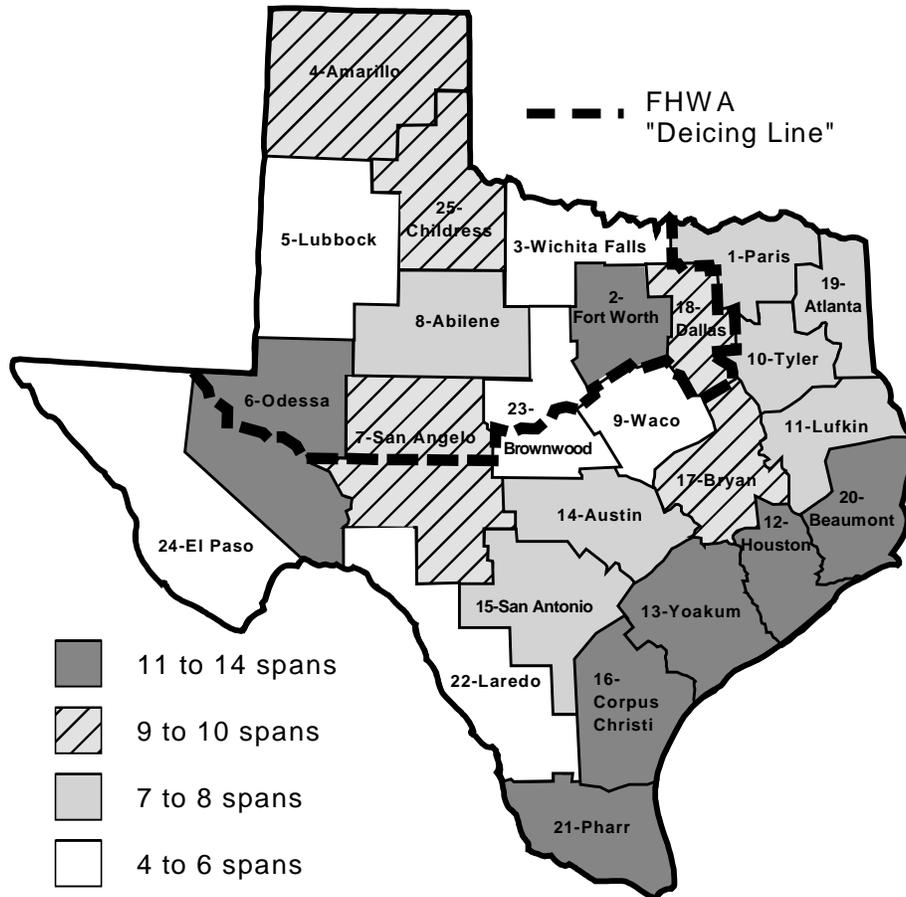
Figure 2.4 - Average Number of Spans/Bridge

Figure 2.4 illustrates the average number of spans for bridges with a substructure rating of 5 or below. The Texas coast has several bridges with a significant number of spans due to the large number of saltwater bays and the inter-coastal waterway. This high number of spans, which adversely affects the replacement cost, illustrates the severity of the substructure durability problem in Texas.

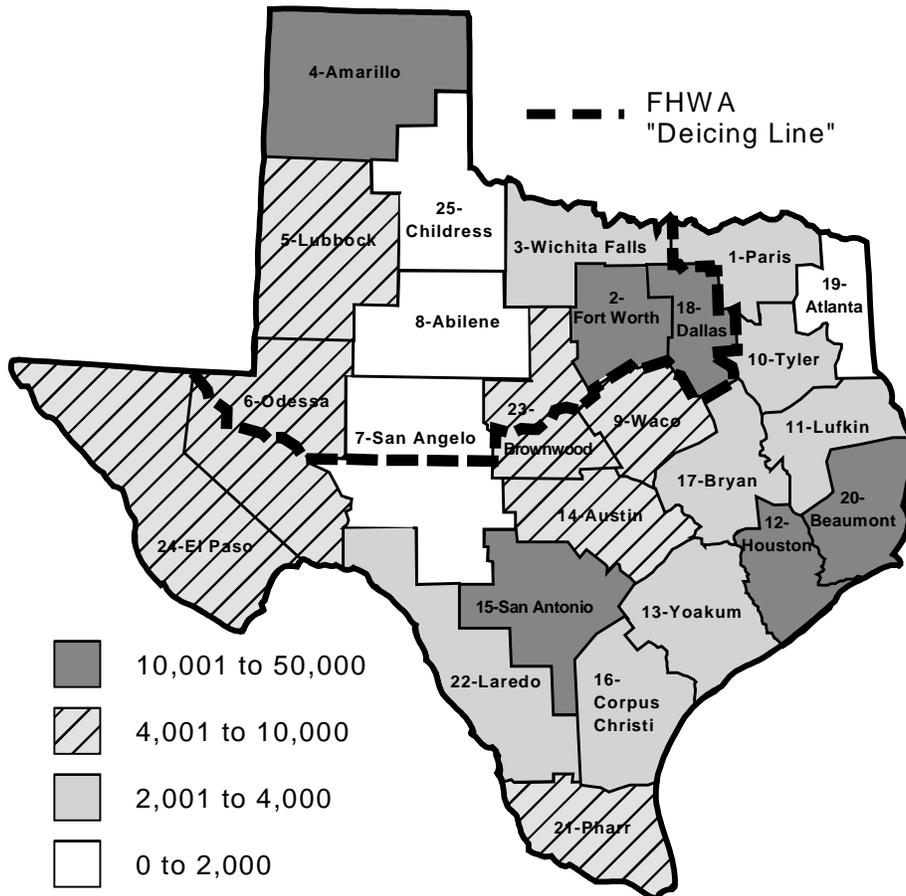
Figure 2.5 - Average ADT Counts by District

To further illustrate the magnitude of the problem, consider the value of a highway by the number of vehicles that a particular highway or structure serves per day. This daily average of vehicles is referred to as "average daily traffic" or ADT. Significant traffic volume increases the replacement cost of a structure when the cost of traffic disruption is considered. Average daily traffic volumes for bridges with a substructure rating of 5 or below are listed in Table 2.4. This information is presented graphically in Figure 2.5. This figure illustrates the cost and complexity of bridge replacement along the Texas coast in terms of traffic concerns. In each of the coastal districts the average ADT exceeds 2000 vehicles per day. In three of the five coastal districts the ADT exceeds 4000 vehicles per day. The Houston district has the most difficult conditions for bridge replacement due to three significant statistics:

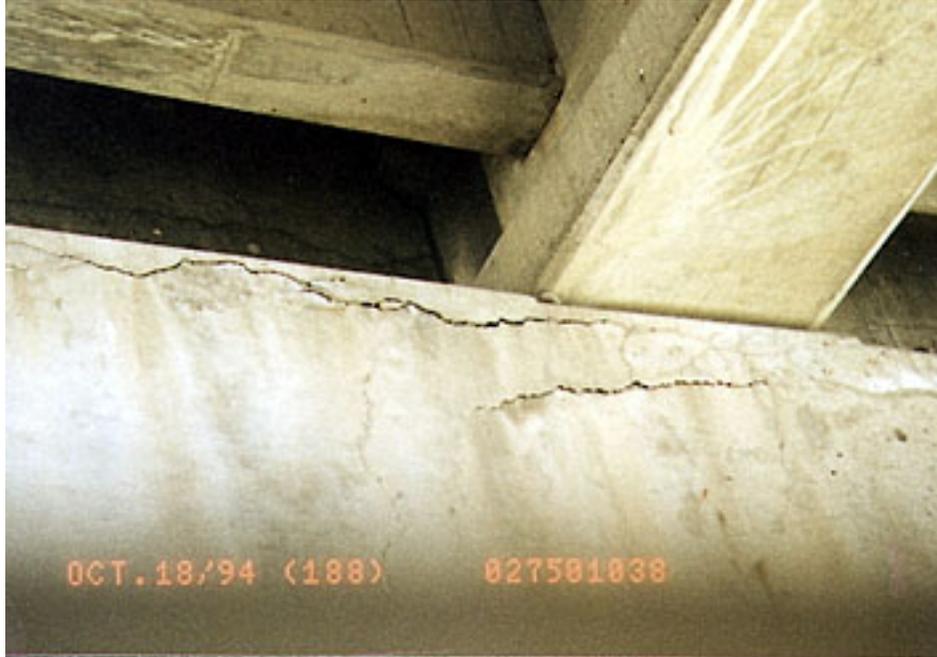
Figure 2.6 - Top and Side Splitting around Upper Reinforcement in Bent Cap (Amarillo)

The trends in the Amarillo district, which is representative of the western region, are significant. The portion of the substructure that is impacted the most is the area directly under an open joint. This area is exposed to chloride-laden moisture and is prone to several freeze thaw cycles over the course of a single winter. Generally, the top and sides of the cap will exhibit cracking and splitting along the top reinforcement, clearly indicative of corrosion. This form of damage is shown in Figure 2.6 for a bridge constructed in 1984. This photograph shows a bent cap with cracking parallel to the main reinforcement. The leaching of calcium carbonate above the bent cap on the bottom of the slab is indicative of a construction joint.

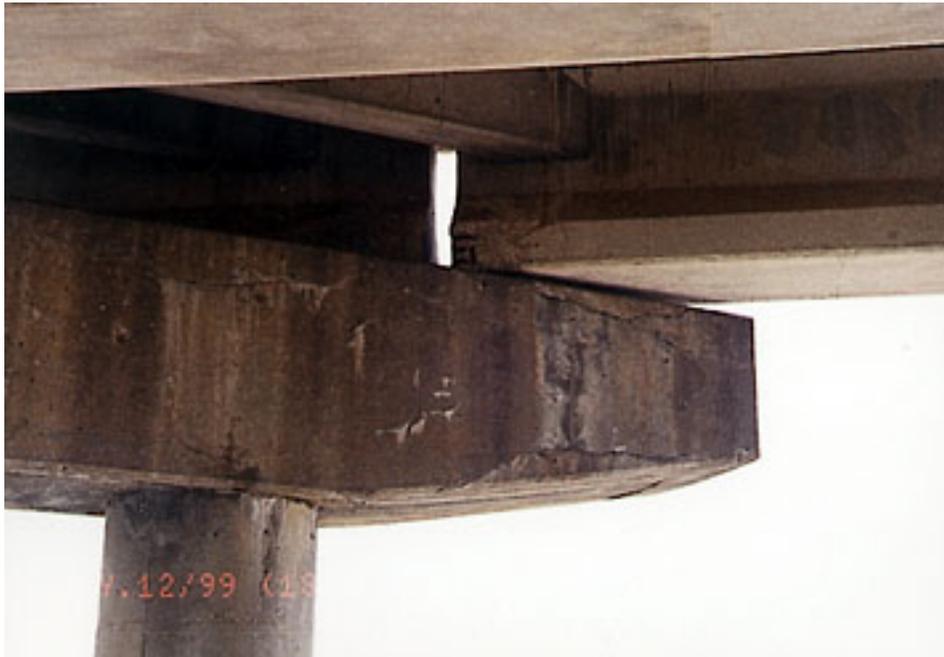
Figure 2.7 - Severe Deterioration of an Amarillo Bent Cap

As the structure begins to age, chlorides migrate to the lower portion of the cap and the entire cap becomes cracked and in need of replacement. Figure 2.7 shows a structure where the corrosion has become more pronounced. This structure was built in 1962, and was 34 years old at the time of the photo. Note the significant amount of damage from the chloride penetration in this structure and the resulting corrosion.

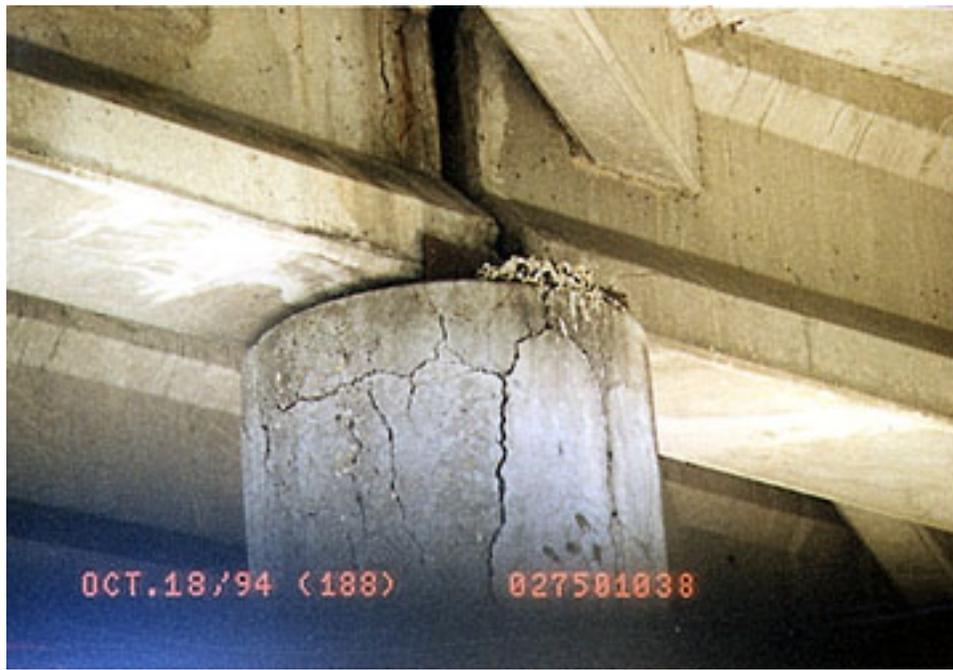
Figure 2.8 - Single Column Directly under a Construction Joint in Amarillo.

Figure 2.8 illustrates the corrosive attack of single columns directly supporting a beam and under an open joint.

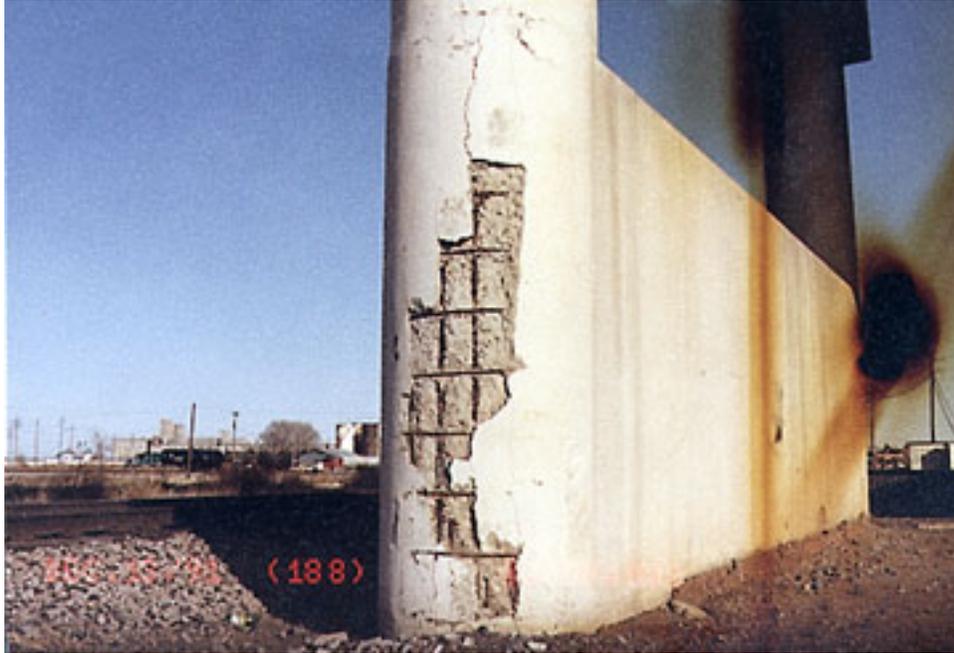
Figure 2.9 - Deterioration of Columns Due to Salt Laden Snow Piled against the Column

The adverse affects of snow accumulations pushed onto the bridge columns can be seen in Figure 2.9. The field studies in Amarillo offered significant insight to the transportation of chloride ions into the structural member. The structure shown in Figure 2.9 supports two overpass spans on Interstate 40. Interstate 40 has a high volume of traffic with an ADT count of 1850 cars per day. Table 2.9 illustrates the chloride samples taken from this substructure by a concrete powder test performed by TxDOT.

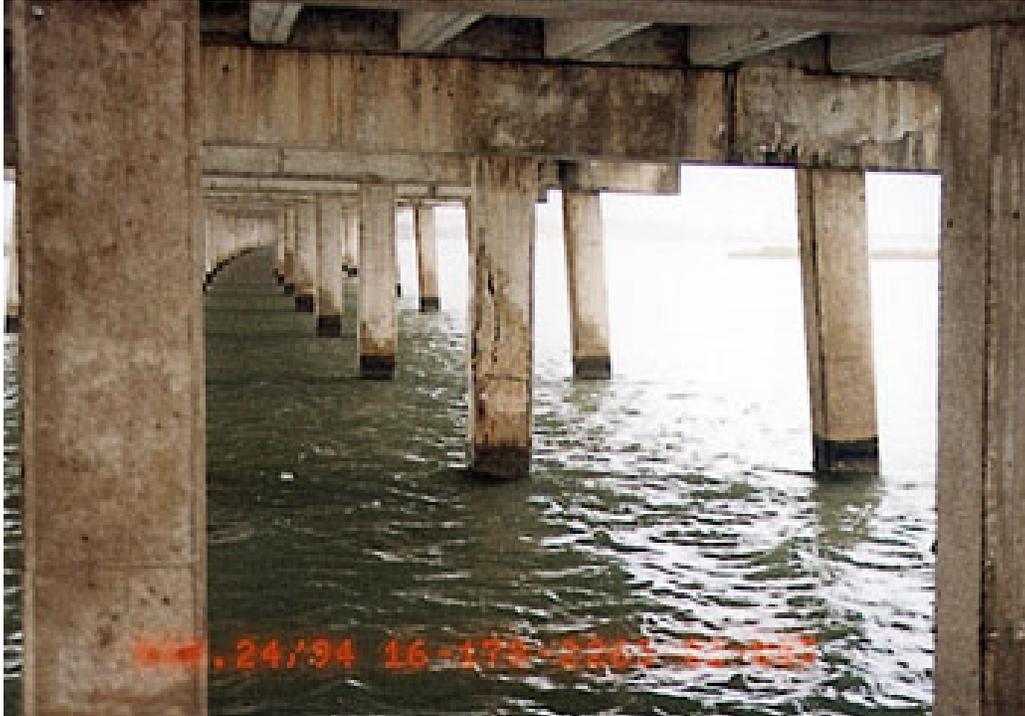
Figure 2.10 - Horizontal Splitting of the Upper and Lower Reinforcement in a Typical Bent Cap

The durability problems are similar in nature to the Amarillo District. The source of chlorides is primarily from wave action and ocean spray onto the bent caps. The horizontal splitting of the upper and lower reinforcement is evident in Figure 2.10.

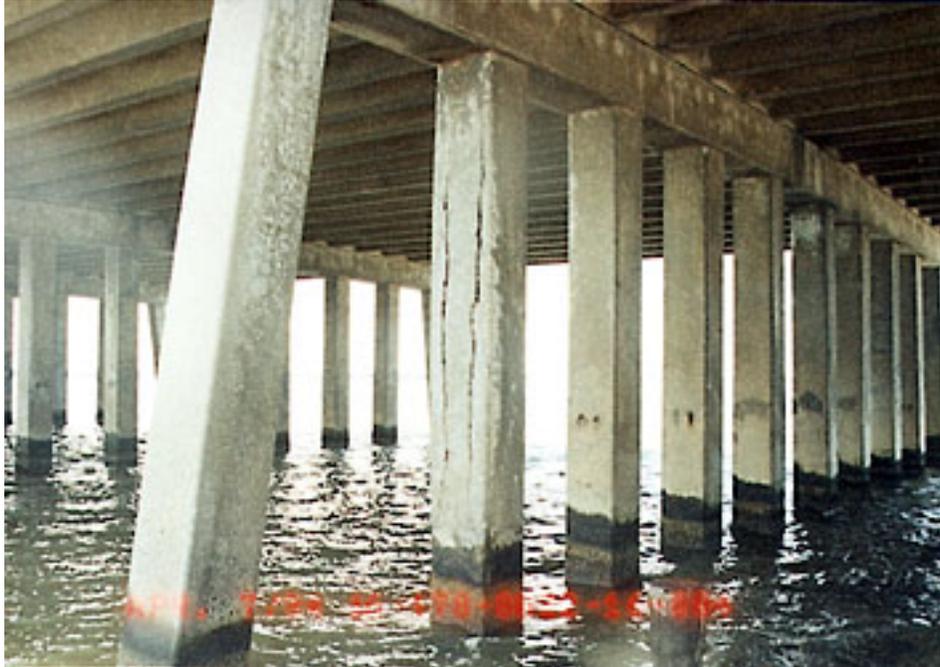
Figure 2.11 - Face Splitting of a Bridge Column in Corpus Christi

The coastal substructures suffer from column and piling durability problems as well. The columns have the same type of attack as the columns in the West Texas region, displaying similar forms of deterioration although the exposure conditions and source of chlorides are different. The columns typically exhibit concrete splitting in the longitudinal direction, as illustrated in Figure 2.11. The most severe corrosion damage in the coastal bridge substructures occurs above the water line where a fresh supply of oxygen is readily available. A question has been raised as to how much of the chloride penetration comes from tidal action and spray versus how much results from capillary rise in the pore structure of the concrete. Misra and Uomoto have documented the question of capillary rise in the pore structure of the concrete.¹⁶ Misra and Uotomo state that "...in this case by capillary action, plays a vital role in the transport of chlorides within the concrete." This capillary action is a significant aspect considered in this research project in the development of the long-term column corrosion tests (see Report 1405-3).

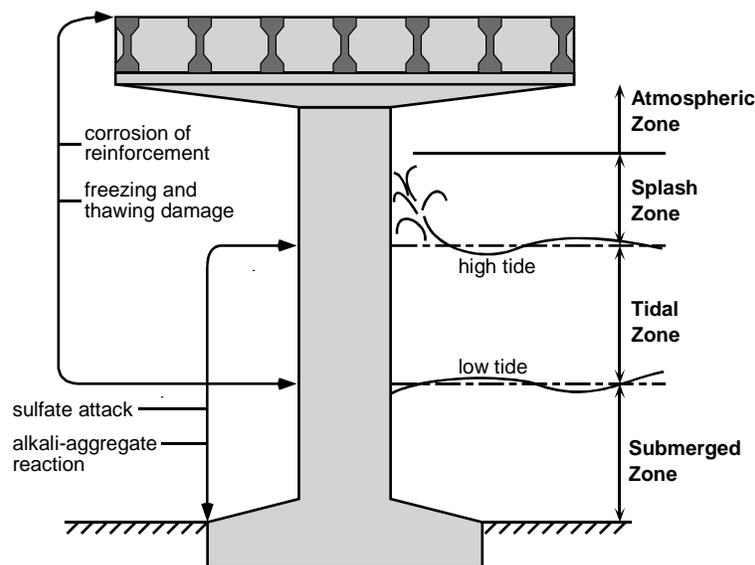
Figure 3.1 – Substructure Exposure Zones and Forms of Deterioration in Coastal Seawater Exposures

Coastal exposures are one of the most severe environments for concrete structures. This danger is particularly true for structural components located directly in the seawater, as in the case of bridge substructures. Seawater contains dissolved salts that affect the durability of concrete. The most prevalent salts in order of quantity are sodium, magnesium and potassium chlorides and magnesium, calcium and potassium sulfates.¹⁷ These salts provide sources of chlorides and sulfates, which can lead to corrosion of reinforcement and sulfate attack on concrete. To a lesser extent, these salts also provide a source of alkalis which may lead to expansive alkali-aggregate reactions if reactive aggregates are present. There are four main exposure zones for a structure in a coastal exposure. Each zone and the associated forms of attack are described below and shown in Figure 3.1.

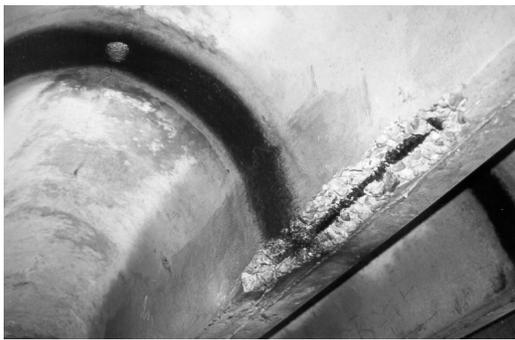
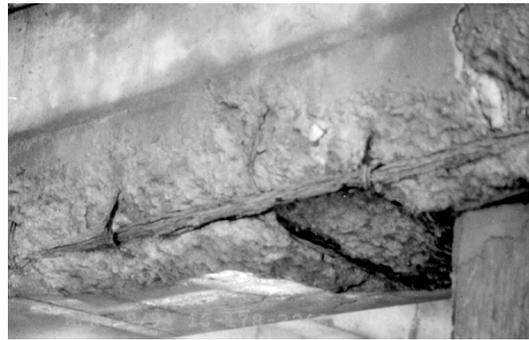
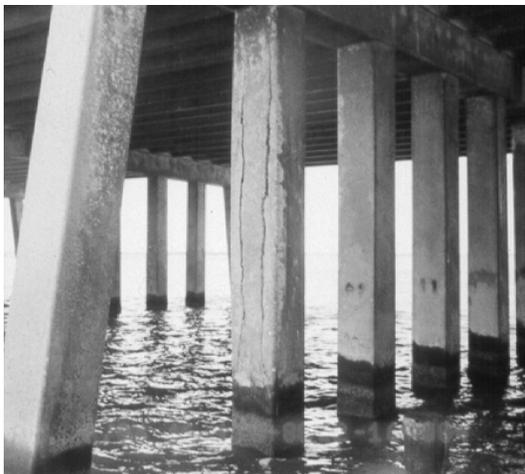
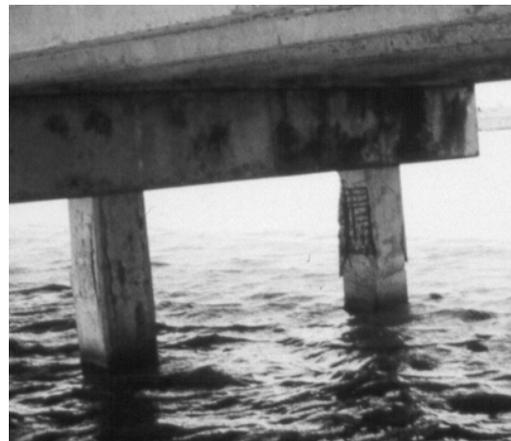
Figure 3.2 – Coastal Exposure Corrosion Damage in Bridges

(a) Atmospheric Zone - Girder

(b) Atmospheric Zone - Bent Cap

(c) Splash Zone - Column

(d) Splash Zone - Column

Corrosion of steel reinforcement requires oxygen and thus generally occurs only in zones which experience some amount of drying. Also, corrosion rates are highest when humidity is in the 90-95% range.¹⁷ The greatest risk of corrosion occurs in the splash and atmospheric zones for these reasons. Corrosion in the tidal zone is normally limited due to the shorter drying periods and slower rate of oxygen diffusion through saturated concrete. The submerged zone of concrete has a low risk of corrosion due to lack of oxygen. Several examples of typical corrosion damage in coastal exposures are shown in Figure 3.2. These photos are all of Texas bridges located along the Gulf of Mexico. Photo (a) shows the underside of a pan-joist bridge. Holes had been cored through the deck to improve drainage. These holes allowed salt-laden moisture to drain onto the joists where insufficient concrete cover was provided and corrosion damage occurred at the base of the joists. Photos (c) and (d) show typical corrosion of columns or trestle piles. In (c), large vertical cracks have developed along the line of the longitudinal reinforcement. In (d), severe corrosion has caused complete spalling of the cover concrete, exposing the longitudinal and transverse reinforcement. The corrosion damage occurs above the high tide line within the splash zone of the structure. Moisture and chlorides have entered the concrete from spray or splashing, or possibly through capillary rise.

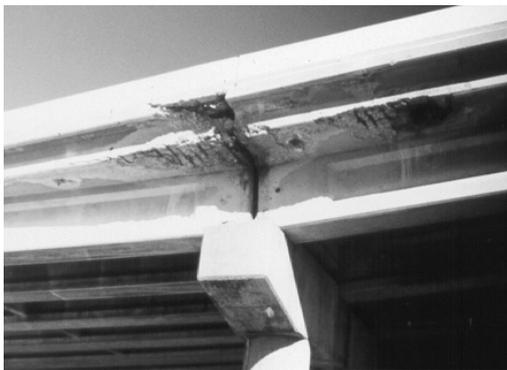
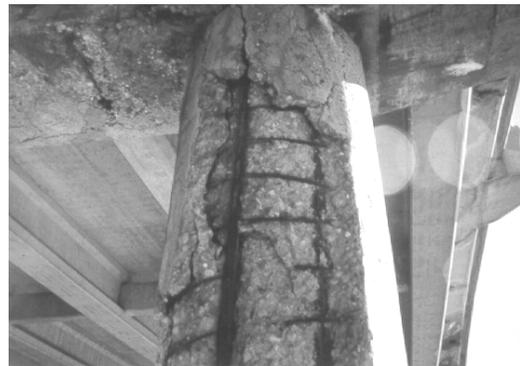
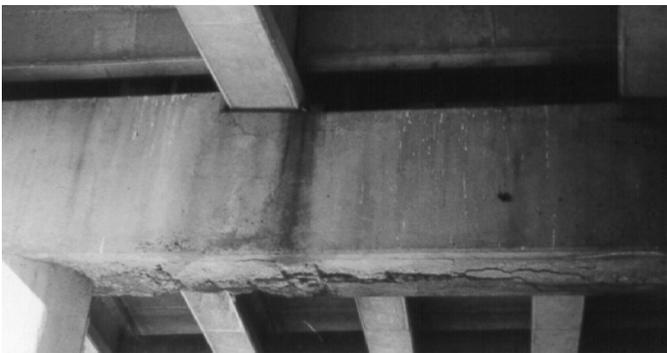
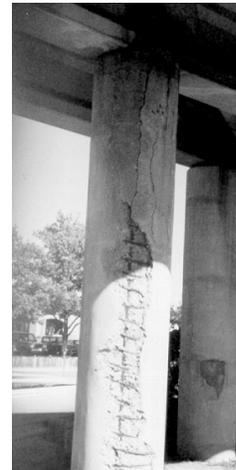
(a) Corrosion at Leaking Deck Joint

(b) Column Corrosion

(c) Bent Cap Corrosion

(d) Column Corrosion

Although deicing chemicals would not normally be applied directly to substructure components, moisture and chlorides may come into contact with the substructure through leaking joints in the bridge deck, inadequate drainage or from splashing due to traffic movement. Corrosion of steel reinforcement from this type of exposure can be severe due to its localized nature and often very high concentration of chlorides as discussed in more detail in Section 5.1. Photos of substructure corrosion resulting from drainage of deicing chemicals are shown in Figure 3.3. Typical damage locations include columns and the underside of bent caps located near leaking deck joints. Very severe corrosion damage results due to the localized nature of the attack.

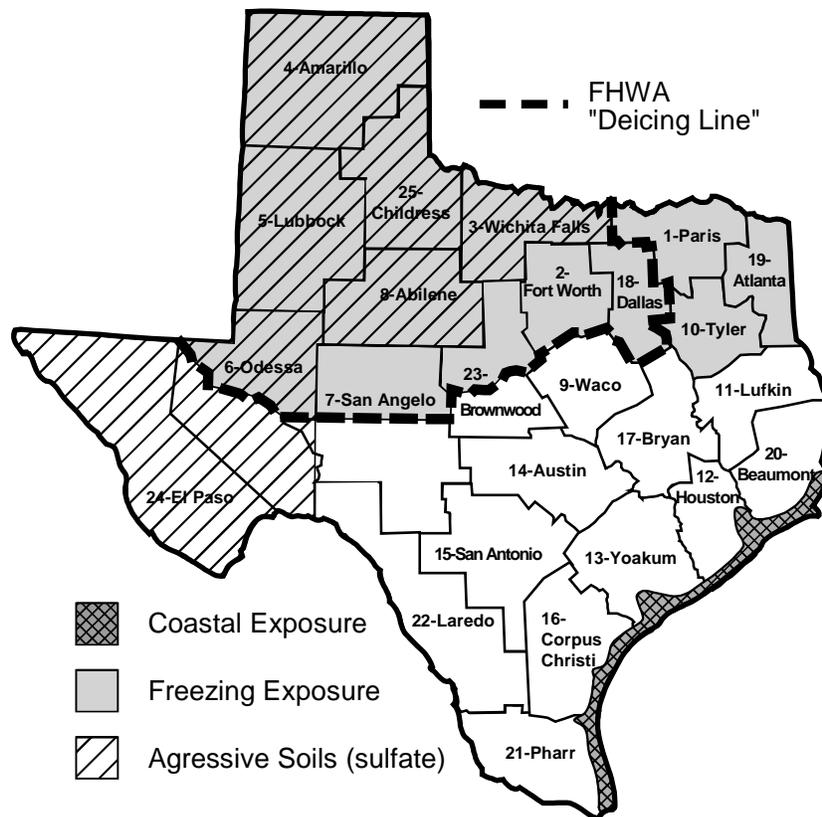
Figure 3.4 - Substructure Exposure Conditions for the State of Texas

The northwestern regions of the state have an increased probability of sulfate attack due to aggressive soils. The risk of sulfate attack in these regions is highest where moisture content of the soil is highest, such as bodies of water, rivers, or areas where drainage around the structure is poor.

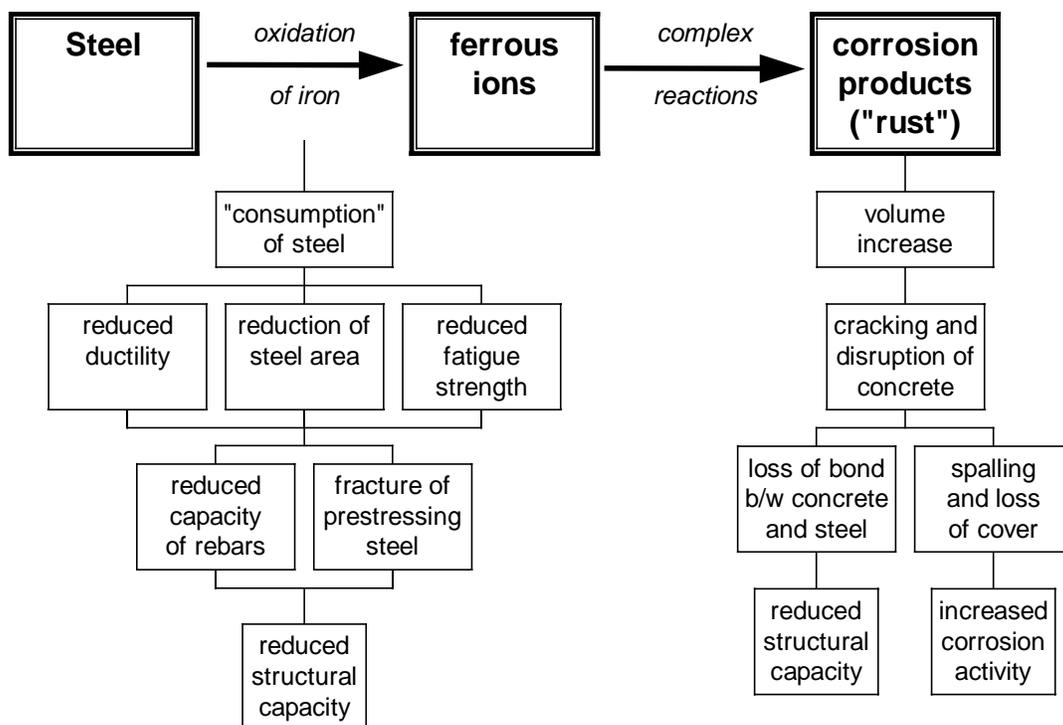
Figure 4.1 - Deterioration Mechanism for Corrosion of Steel in Concrete

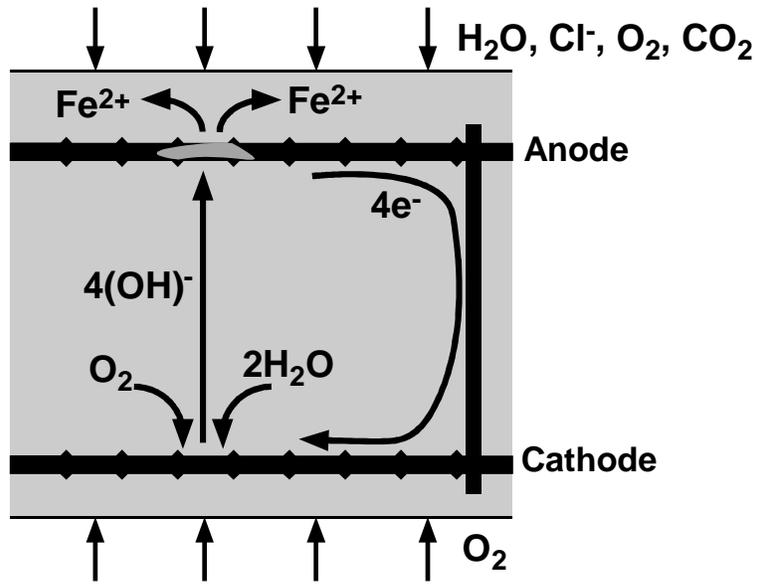
Figure 4.2 - Idealized Macrocell Corrosion

The corrosion cell may exist as a macrocell or a microcell. The corrosion microcell consists of very small anodes and cathodes separated by a distance of as small as a micron. The corrosion macrocell consists of anodic and cathodic regions separated by a finite distance of millimeters or meters. The macrocell may develop on a single bar, or it may occur between different layers of steel or different areas of the structure. A common example of a corrosion macrocell is a bridge deck where the top layer of steel acts as the anode and the bottom layer as the cathode, as shown in Figure 4.2. The top layer is closer to the source of moisture and chlorides, and therefore becomes depassivated before the bottom layer. Oxygen is readily available near the bottom layer to facilitate the cathodic reaction. Electrical continuity between the layers is provided by stirrups or other reinforcement or ties. Another form of macrocell corrosion can occur at crack locations.²⁰ The anodic reaction occurs in the vicinity of the crack, while the cathodic reaction takes place on the same bar within the distance between cracks, as shown in Figure 4.3. The steel near the crack becomes depassivated due to chloride or carbon dioxide penetration at the crack. This form of corrosion cell can lead to very high corrosion rates and pitting corrosion due to the large cathode area in comparison to anode area. In most situations of corrosion in concrete structures, a combination of microcell and macrocell corrosion occurs.²²

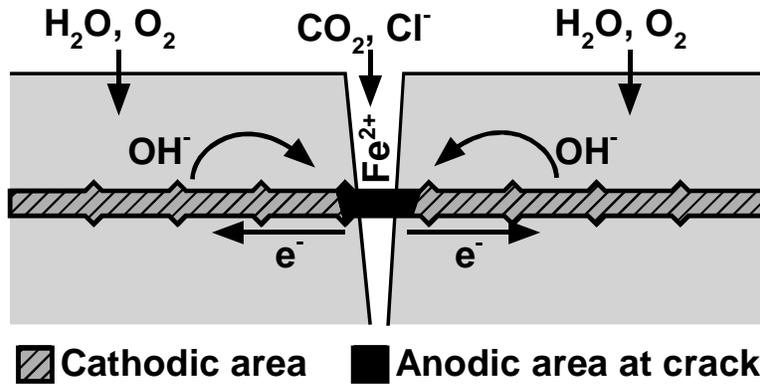
Figure 4.3 - Macrocell Corrosion at a Crack

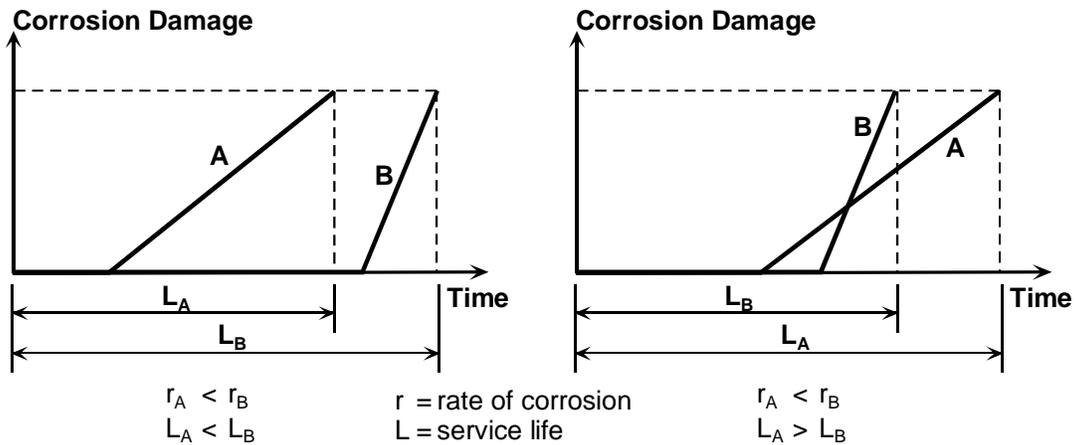
Figure 4.5 - Effect of Time to Corrosion and Corrosion Rate on Service Life (adapted from Ref. 28)

This simple model can be used to illustrate the effects of time to corrosion initiation and corrosion rate on the service life of the structure. Two different situations are illustrated in Figure 4.5. In the first situation, structure A has a lower corrosion rate, but its service life is shorter since corrosion initiation occurred earlier than structure B. In the second situation, structure B has a shorter service life although the corrosion rates are the same as the first situation. Thus, it is important to consider both the time to corrosion and corrosion rate, as a single parameter is not sufficient to determine the service life of the structure.

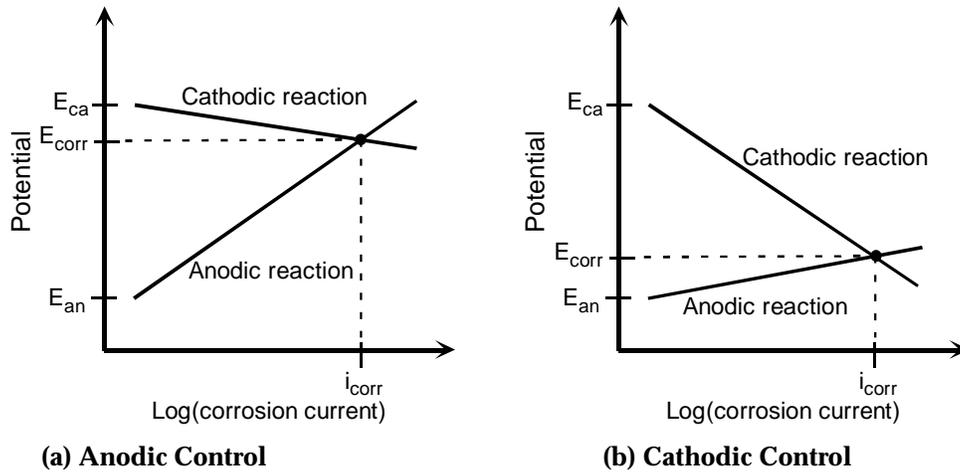
example would be the passive film on steel that limits oxidation of iron, slowing the anodic reaction as is illustrated in Figure 4.6(a). If the cathodic reaction is slower than the anodic reaction, the process is said to be cathodically controlled as shown in Figure 4.6(b).

Figure 4.6 – Electrochemical Processes Under Activation Polarization²⁷

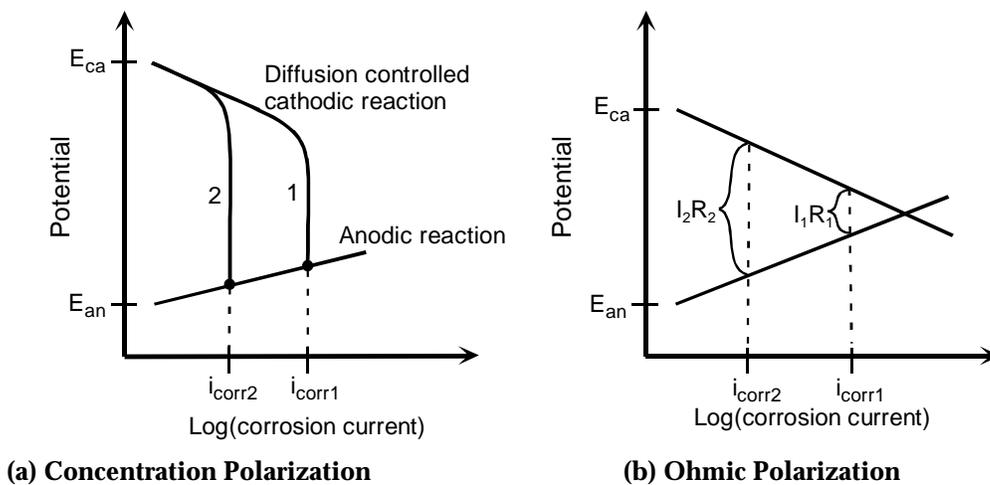
The most common corrosion rate controlling mechanisms in concrete structures are concentration polarization and ohmic polarization. Concentration polarization occurs when the conditions change in the electrolyte near the anode or cathode, slowing the reaction rate. An example of concentration polarization in concrete is depletion of oxygen near the cathode, as illustrated in Figure 4.7(a). This condition is referred to as cathodic diffusion control. The slope of the polarized cathodic reaction curve approaches infinity, resulting in very negative half-cell potentials but low corrosion rates. The oxygen diffusion rate for case 2 is lower than case 1 in Figure 4.7(a). Ohmic polarization occurs when the resistivity of the concrete is high. The electromotive force (potential) available for corrosion is reduced by the resistance of the concrete, sometimes referred to as the “IR effect” or “IR drop.” As a result, the corrosion rate is limited as shown in Figure 4.7(b). The corrosion rate decreases as the IR drop increases, as indicated in the figure.

Figure 4.7 – Common Polarization Effects in Concrete Structures²⁷

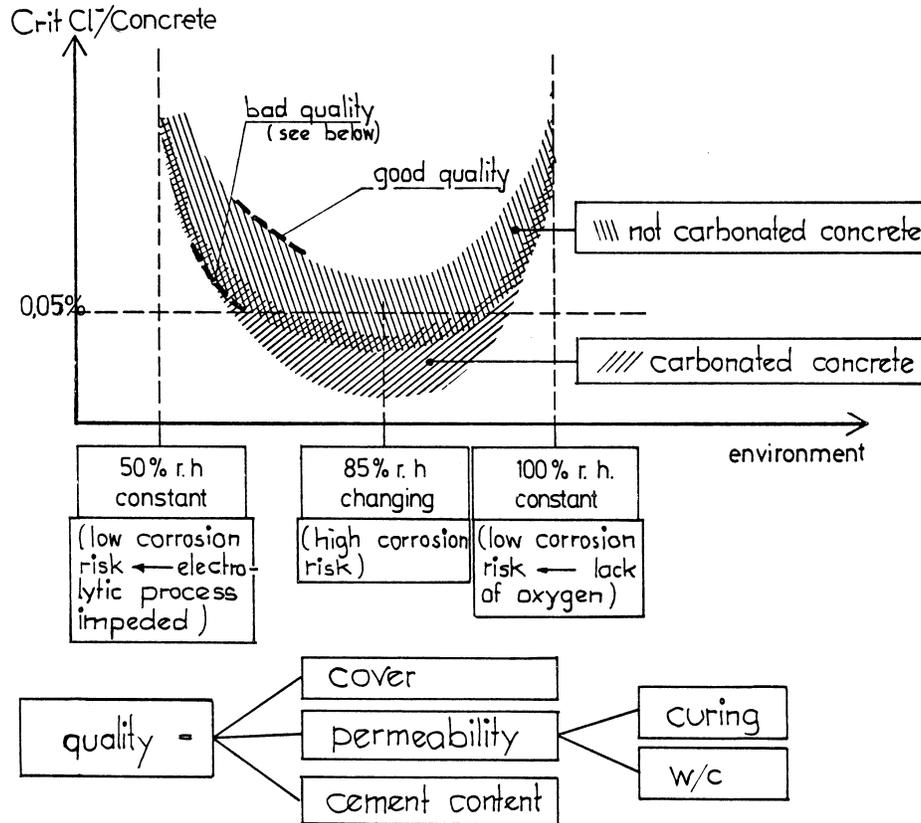
Figure 4.8 - CEB Critical Chloride Ion Content for Corrosion¹⁷

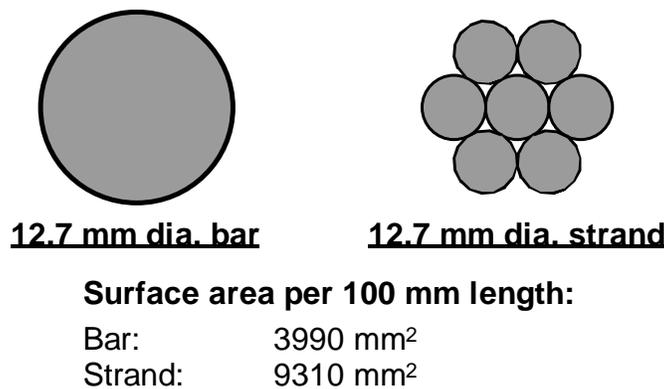
Figure 4.9 - Surface Area of Bars and Strands

Prestressing steels are generally believed to be more susceptible to corrosion than mild steel reinforcement for several reasons. In the case of 7-wire prestressing strands, the surface area to volume ratio is larger than for the equivalent diameter bar, as illustrated in Figure 4.9. This larger ratio means that more surface area is available for corrosion, and the cross-sectional area of the strand may be reduced at a faster rate. The configuration of the 7-wire prestressing strand also makes the strand more susceptible to crevice corrosion. Crevice corrosion is a type of severe corrosion occurring in small spaces or crevices, such as the interstices between wires. The geometric constraints of the crevice enhance the formation of chloride ion concentration cells. Once corrosion has initiated, it progresses similar to pitting corrosion. Due to the geometry of the crevice, Fe^{2+} ions cannot disperse easily, and chloride ions are drawn into the crevice by the positive charge accumulation. The process becomes autocatalytic as the presence of chloride ions leads to formation of hydrochloric acid (HCl) and higher corrosion rates ensue.

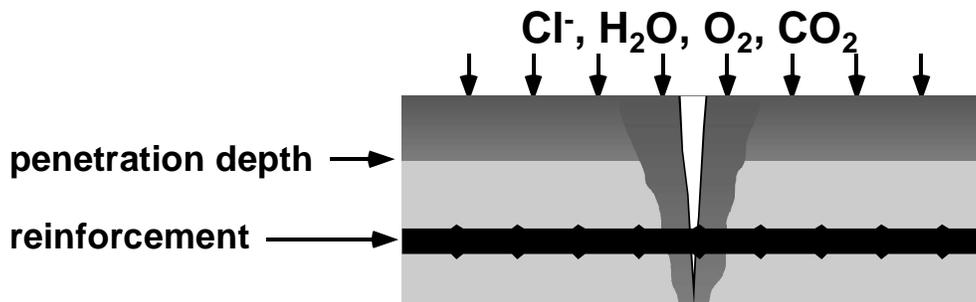
Figure 4.10 – Point of View 1: Increased Penetration of Moisture and Chlorides at Crack Location Accelerates the Onset and Severity of Corrosion

The two points of view are illustrated in Figure 4.10 and Figure 4.11. Both points of view indicate that the presence of cracks will accelerate the onset of corrosion. The first point of view suggests that the accelerated onset of corrosion will lead to more corrosion damage in a shorter period, and thus reduce the service life of the structure. The second point of view suggests that the corrosion rate in uncracked concrete will reach the corrosion rate at the crack locations after some duration. This point of view implies that the length of time between corrosion initiation at a crack, t_i , and corrosion initiation in uncracked concrete, t_{cr} , is not significant. This latter point of view means that the two curves in Figure 4.11 are close together when the entire service life is considered, and thus the early onset of corrosion at cracks has little effect on the service life in comparison to the case where the concrete was entirely uncracked.

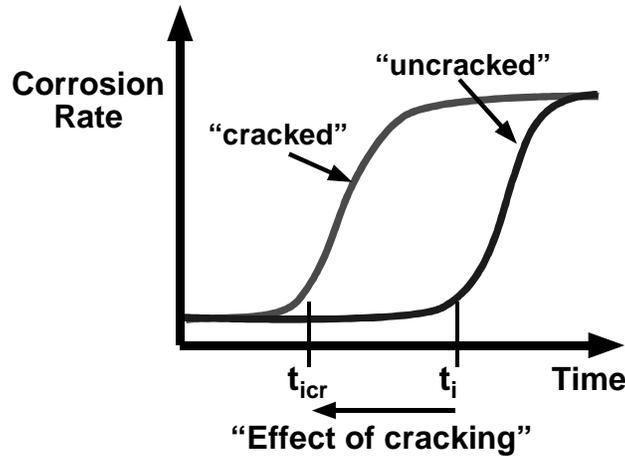
Figure 4.11 – Point of View 2: Cracking Accelerates Onset of Corrosion, But Over Time Corrosion is Similar in Cracked and Uncracked Concrete

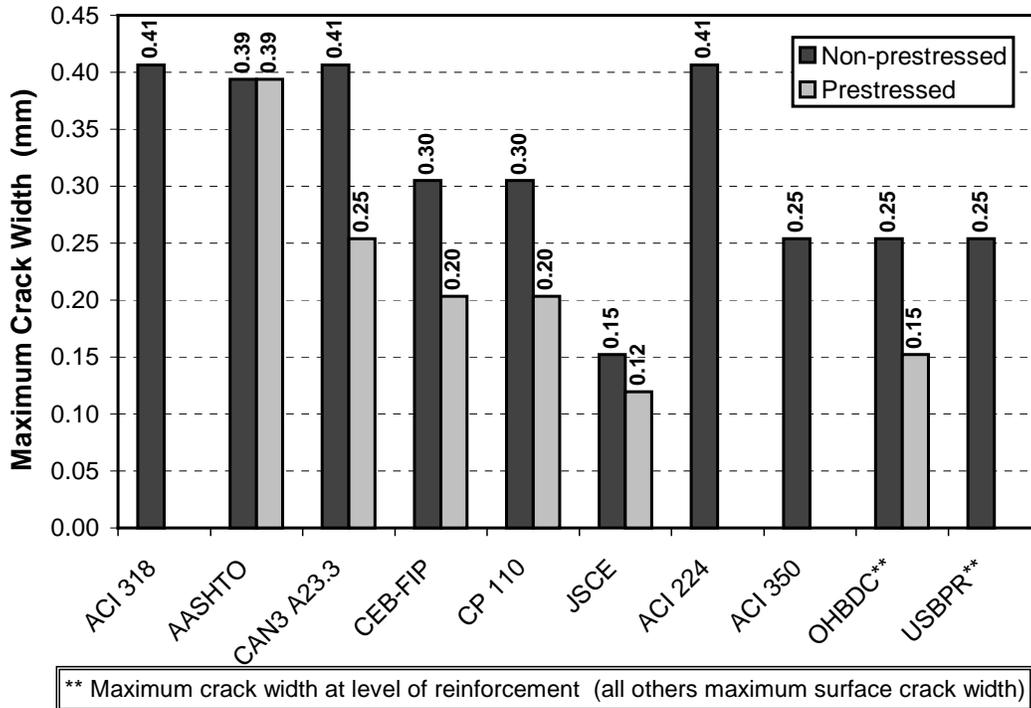
Figure 4.12 - Comparison of Allowable Crack Widths: Mild Exposure

For comparison purposes, the maximum allowable crack widths specified or implied by the reviewed design codes and technical committees are presented in Figure 4.12 and Figure 4.13 for the most mild and most severe environment specified by each document. In some cases, intermediate environmental conditions were also specified but have not been shown here. The majority of the crack widths presented in the figure are specified as surface crack widths, with the exception of the Ontario Highway Bridge Design Code (OHBDC)^{A.6} and the U.S. Bureau of Public Roads (USBPR)^{A.19} which use maximum allowable crack widths at the level of the reinforcement. These values will be less than crack widths at the concrete surface.

For reinforced concrete elements, the range of recommended allowable crack widths is fairly consistent. The highest value of 0.41 mm (0.016 in.) (surface crack width), recommended by ACI 318-95^{A.2} and ACI 224R-90^{A.16} for mild environments, is intended for interior exposures or dry air and thus represents a condition not likely to be encountered in bridge applications. The most strict requirements for allowable crack widths in reinforced concrete members are provided by the JSCE standards for concrete structures^{A.11} and ACI 224R-90.^{A.16} The JSCE surface crack width requirements are specified in terms of the amount of concrete cover. Because larger cover is required by the JSCE for severe exposures, the allowable surface crack width is larger than for mild conditions. The severe environments defined by both the JSCE standard and ACI 224R-90 are for marine structures, and thus would reasonably represent the most severe exposure conditions to be encountered for bridge structures.

report a critical crack width, the range of compiled results was 0.1 mm to 0.5 mm (0.004 in. to 0.020 in.), as shown in the two tables. It is surmised that the broad range of critical crack widths could be attributed to the nature of cracking in reinforced concrete and the wide variation in test methods employed by the various researchers. However, it is interesting to note that the compiled range of critical crack widths is approximately equal to the range of allowable crack widths recommended by the various code bodies and technical committees reported in Section A.1 and shown in Figure 4.12 and Figure 4.13.
