RESEARCH REPORT 1405-1

STATE-OF-THE-ART REPORT ABOUT
DURABILITY OF POST-TENSIONED BRIDGE
SUBSTRUCTURES

OCTOBER 1999

*DURABILITY DESIGN OF POST-TENSIONED
BRIDGE SUBSTRUCTURE ELEMENTS*

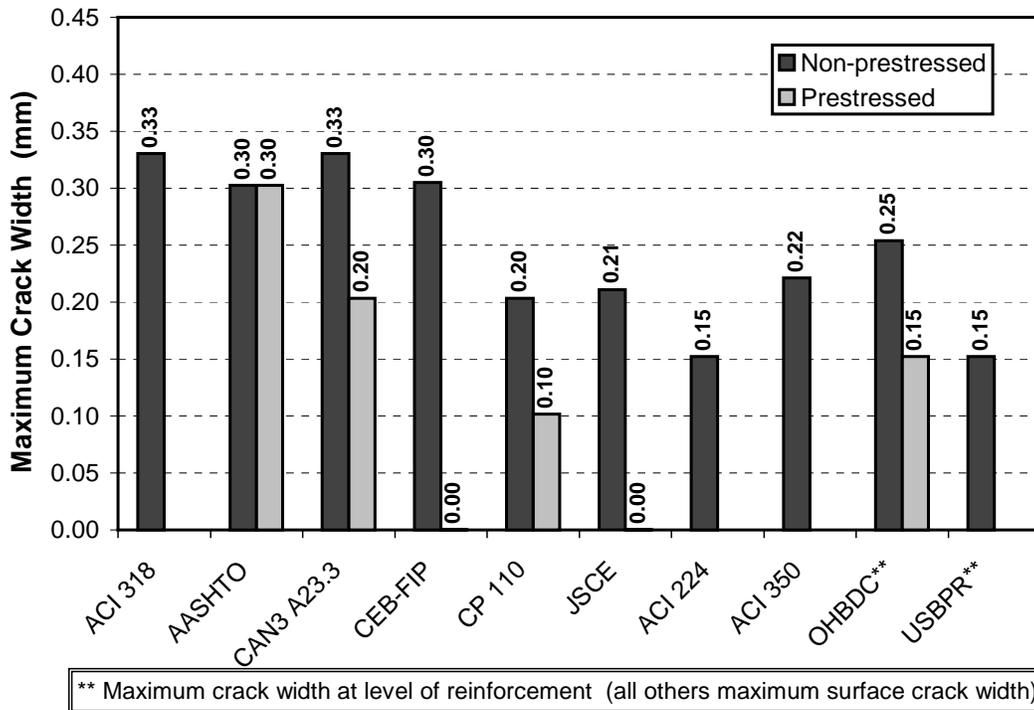
Figure 4.13 - Comparison of Allowable Crack Widths: Severe Exposure

For comparison purposes, the maximum allowable crack widths specified or implied by the reviewed design codes and technical committees are presented in Figure 4.12 and Figure 4.13 for the most mild and most severe environment specified by each document. In some cases, intermediate environmental conditions were also specified but have not been shown here. The majority of the crack widths presented in the figure are specified as surface crack widths, with the exception of the Ontario Highway Bridge Design Code (OHBDC)^{A.6} and the U.S. Bureau of Public Roads (USBPR)^{A.19} which use maximum allowable crack widths at the level of the reinforcement. These values will be less than crack widths at the concrete surface.

The recommended allowable crack widths for prestressed concrete elements are, in general, more strict than for nonprestressed elements with the exception of the *AASHTO LRFD Specifications*^{A.3} where they are equal. In several cases, the commentary sections accompanying the recommendations indicated that stricter crack width requirements were necessary for prestressed concrete elements due to the higher susceptibility of prestressing steels to more severe forms of corrosion such as pitting and stress corrosion, and the increased uncertainty in computing crack widths for prestressed members. The most strict requirements are again specified by the JSCE standard.^{A.11} For severe corrosive environments such as marine exposures subjected to tides and splashing, no cracks are allowed by the JSCE. A similar requirement is specified by the CEB-FIP Model Code^{A.8} for severe environments. However, the CEB-FIP Model Code allows this requirement to be relaxed to a surface crack width of 0.2 mm (0.008 in.) for post-tensioned members if positive protection methods are employed. Recommended protection methods include epoxy coating of the strands or use of an impermeable duct.

report a critical crack width, the range of compiled results was 0.1 mm to 0.5 mm (0.004 in. to 0.020 in.), as shown in the two tables. It is surmised that the broad range of critical crack widths could be attributed to the nature of cracking in reinforced concrete and the wide variation in test methods employed by the various researchers. However, it is interesting to note that the compiled range of critical crack widths is approximately equal to the range of allowable crack widths recommended by the various code bodies and technical committees reported in Section A.1 and shown in Figure 4.12 and Figure 4.13.

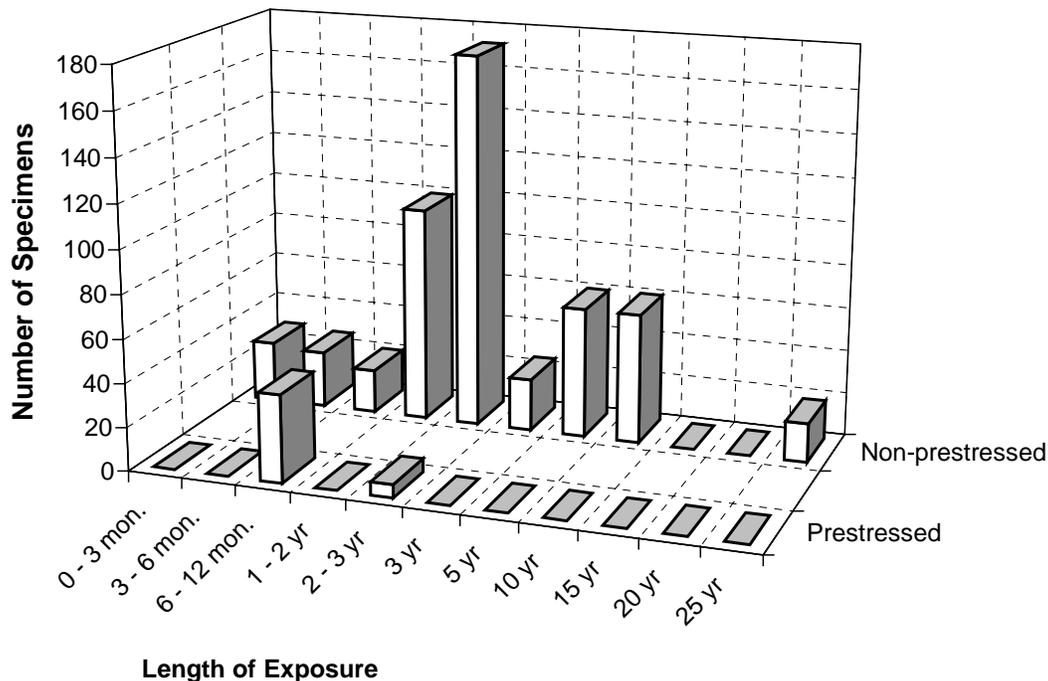
Figure 4.14 - Summary of Corrosion Studies Considering Crack Width

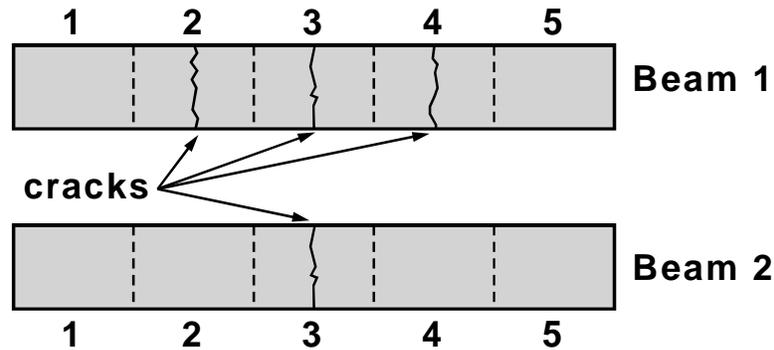
Figure 4.15 - Beams for Effect of Cracking Illustration

In order to fully assess the effect of cracking, both the local and global effects of cracking on corrosion should be considered. This approach is also suited to the two definitions of unacceptable damage. The effect of cracking can be illustrated by subdividing the structure to consider local and global effects, and by using the two stages of corrosion concept. For example, consider the two concrete beams shown in Figure 4.15. The beams have been subdivided into five sections for consideration. It is assumed that the details and loading are such that Beam 1 has three cracks, while Beam 2 has one crack. Based on the literature review described in the preceding sections, the simplifying assumption that crack width has little effect on the time to corrosion and corrosion rate is made. The length of time to corrosion is assumed to be $L_{i,cr}$ and $L_{i,uncr}$ for cracked and uncracked concrete, respectively, with $L_{i,uncr}$ greater than $L_{i,cr}$. The corrosion rates after initiation are assumed to be R_{cr} and R_{uncr} , with R_{cr} higher than R_{uncr} . It is assumed the corrosion rate is constant over time.

The preceding discussion is a very simplified look at the effect of cracking on corrosion, yet it addresses important factors that have frequently been overlooked in the past. Many assumptions have been made for the two specific cases shown in Figure 4.15. Many other situations and the effect of other variables could be considered/illustrated in the same manner. The intention of this discussion is not to draw conclusions on corrosion rates, times to corrosion and the effect of cracking. Rather, the purpose of this exercise is to illustrate that the effect of cracking could be important for some situations, and general conclusions stating that the effect of cracking on corrosion is significant or is not significant should not be made since many factors are involved.

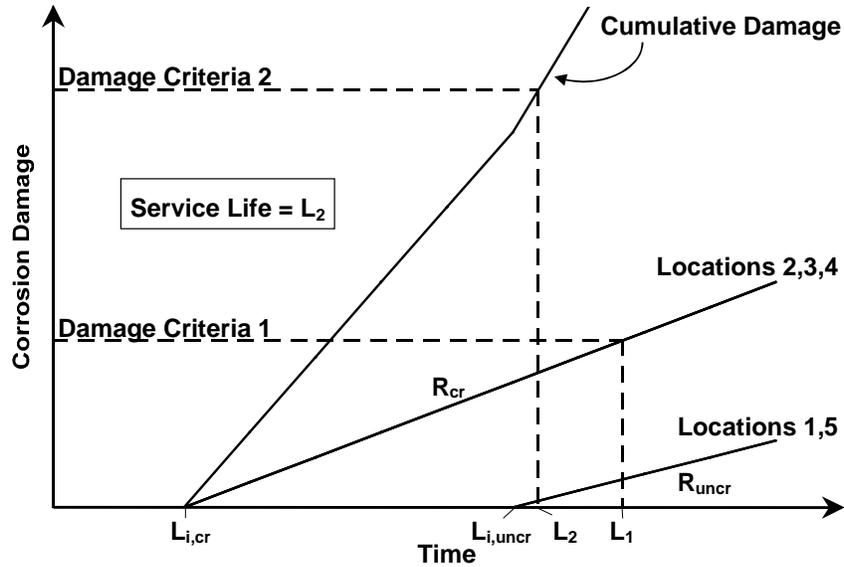
Figure 4.16 - Corrosion Damage Plot for Beam 1

A plot of corrosion damage over time is made for each of the five subdivisions on the beams, as shown in Figure 4.16 and Figure 4.17. For Beam 1, the curves for Locations 1 and 5 are the same, and indicate corrosion in uncracked concrete. The curves for Locations 2, 3 and 4 are identical, and represent corrosion in cracked concrete. For Beam 2, Locations 1, 2, 4, and 5 are uncracked, and Location 3 is cracked. Arbitrary units have been used in the plots, and both figures are plotted to the same scale. The total corrosion damage in a beam is assessed as the cumulative plot of the five curves for each beam. The limit of unacceptable damage is defined in two ways:

1. **Criteria 1:** The corrosion at a given location in the member exceeds a critical value (i.e., loss of section controls).
2. **Criteria 2:** The cumulative corrosion damage for the member/structure exceeds a critical value (i.e., disruption of concrete controls).

Several observations can be made from the plots for Beam 1 and Beam 2:

- Using prestressing to limit the number of cracks and increase crack spacing could increase the service life. It may also change the corrosion damage criteria from overall disruption of concrete to localized loss of reinforcement section.
- If the concrete quality is improved in terms of lowered permeability and increased resistivity, or if the cover thickness is increased, it would be logical to assume the time to corrosion initiation in uncracked concrete ($L_{i,uncr}$) could be increased significantly, and the corrosion rate (R_{uncr}) would be decreased. Looking at Figure 4.16, it is clear that this combined effect could increase the service life of the structure. However, in the case of limited cracking in Beam 2 (Figure 4.17), these improvements would not increase the service life since it is limited by a localized loss of section at the crack locations.

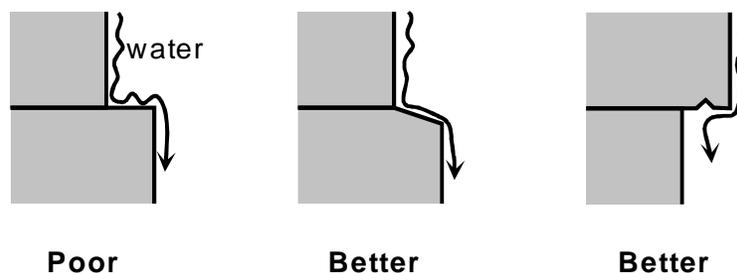
Figure 5.1 - Avoiding Horizontal Surfaces (adapted from Ref. 17)

Drainage is always considered in bridge superstructure design, and it should also be considered for the substructure components. Adequate superstructure drainage must be provided and must ensure chloride-laden water does not come in contact with the substructure. If drains are provided, they must be located such that they can readily be inspected, maintained and repaired. Horizontal surfaces in the substructure should be avoided by sloping wherever possible, as shown in Figure 5.1. Typical examples would include the top surface of bent caps and pile caps, and flanges of girders and inverted T-beams. Drainage and ventilation are important for box girders and hollow columns. Although the interior of these elements are not intended to be exposed to moisture, water accumulation can occur and lead to corrosion damage.

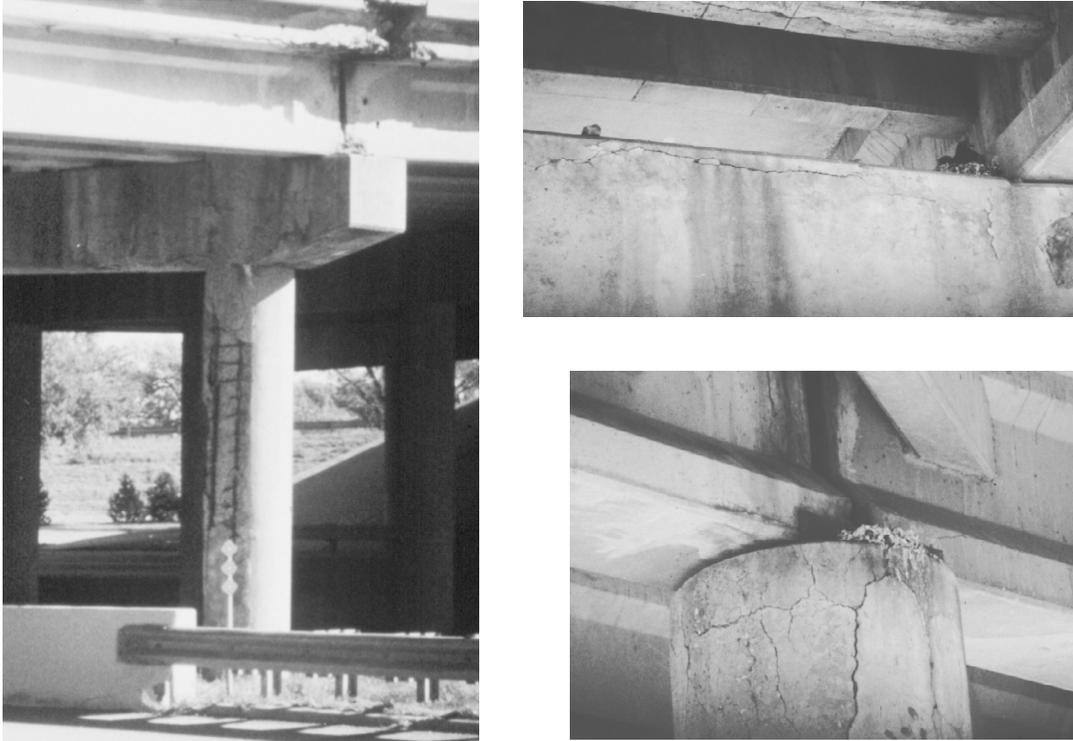
Figure 5.2 – Severe Substructure Corrosion Damage Due to Defective Expansion Joint

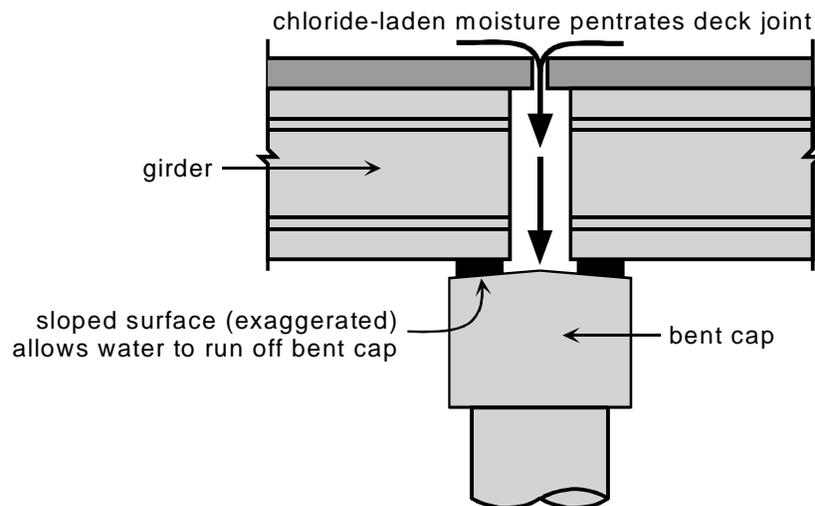
Figure 5.3 - Sloped Bent Cap to Promote Run-Off (adapted from Ref. 17)

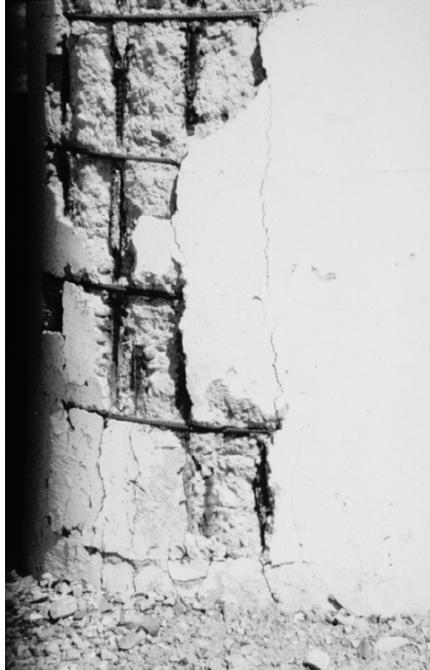
Figure 5.4 - Column Corrosion Resulting from Splashing Adjacent to Roadway

Substructure components adjacent to roadways where deicing chemicals are used can be prone to corrosion damage due to splashing. Figure 5.4 shows a close-up of the bases of a column located very close to traffic. Splashing of chloride-laden moisture has caused extensive corrosion damage. Increasing the distance between the roadway and substructure may increase initial construction costs, but may reduce long-term costs by avoiding this type of corrosion damage.

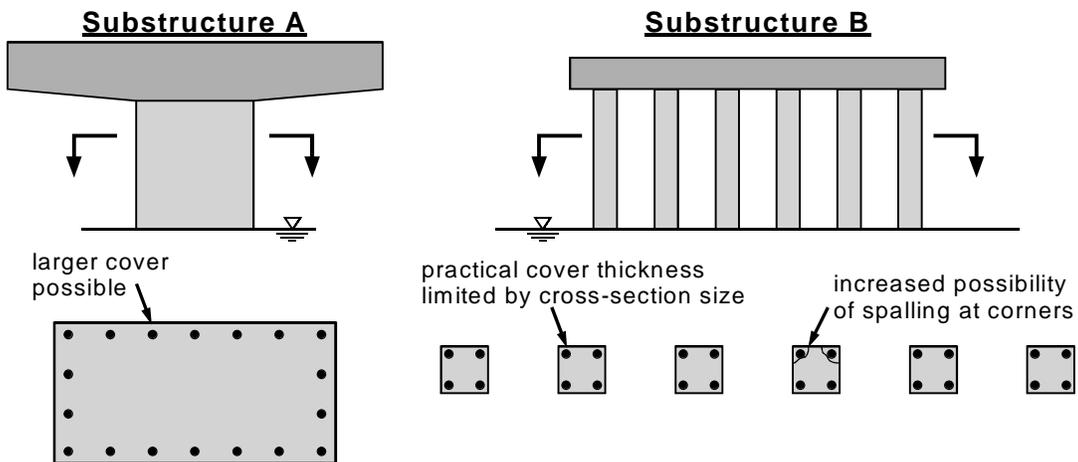
Figure 5.5 - Geometry Effects on Durability for Alternate Substructure Designs

Other aspects of the structural geometry can influence durability. For example, consider the two substructures shown in Figure 5.5. Assuming the substructures are located in a marine saltwater environment, the single column/pier substructure (A) offers a more durable alternative than the multi-column or trestle pile substructure (B). The surface area to volume ratio is decreased in the large single column. In addition, increased concrete cover is more easily accommodated and the potential for spalling is reduced.

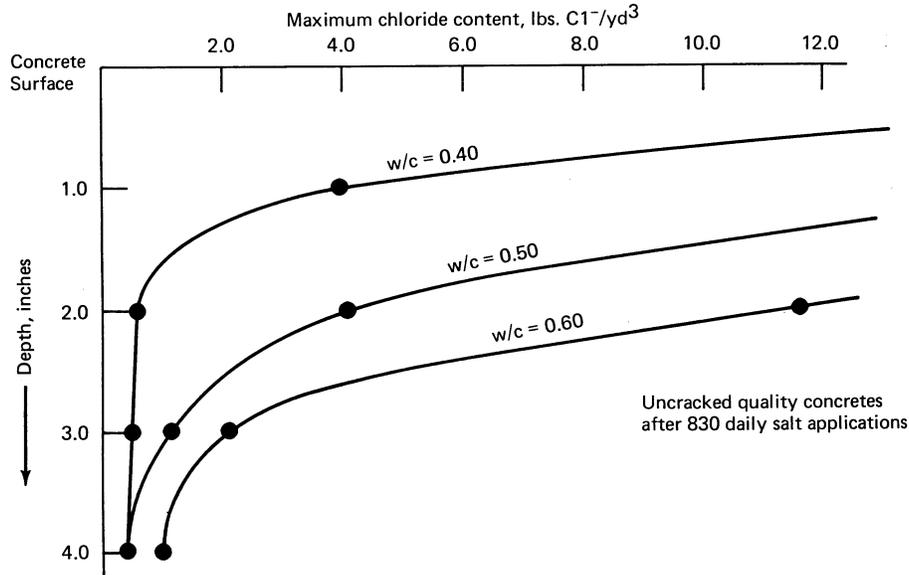
Figure 5.6 - Effect of Water-Cement Ratio on Chloride Ion Penetration⁵⁷

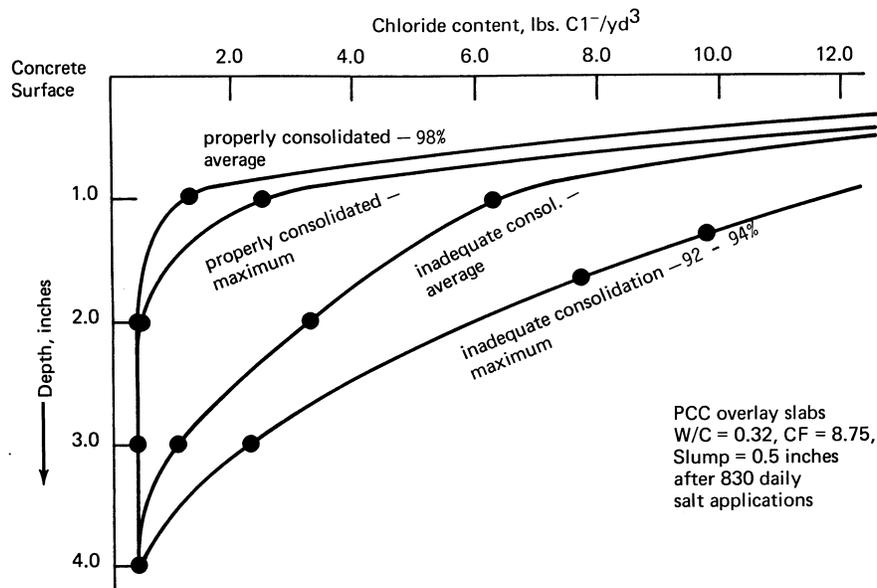
Figure 5.7 – Effect of Consolidation on Chloride Ion Penetration⁵⁷

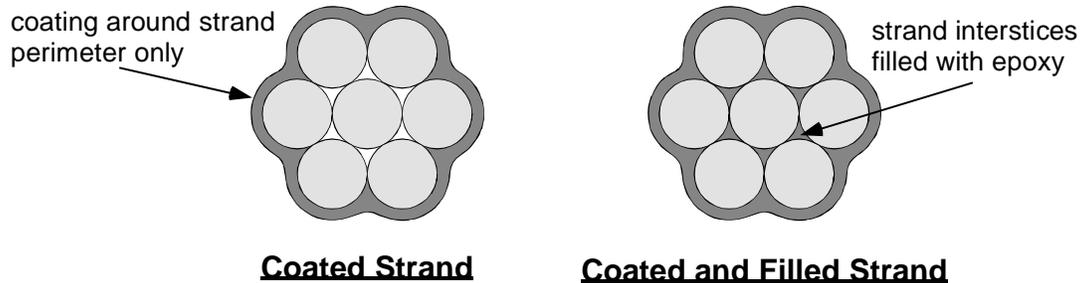
Figure 5.8 - Epoxy Coated Strand Types

Epoxy-coated strand is available in two configurations: coated, and coated and filled. The two configurations are shown in Figure 5.8. In the coated configuration, a thick epoxy coating is provided around the exterior circumference of the seven-wire strand. In the coated and filled version, the interstices between the individual wires are filled with epoxy in addition to the external coating. By filling the interstices with epoxy, migration of moisture and chlorides along the strand interstices is prevented. Both configurations of epoxy-coated strand are available either with a smooth surface or with grit particles embedded on the surface to improve bond transfer characteristics. The smooth surface epoxy-coated strand is intended for use in applications where bond is not critical, such as unbonded post-tensioning systems, external post-tensioning systems and stay cables. When used in unbonded systems, the strand must still be encased in a duct as the smooth epoxy coating is not a replacement for the sheathing used in monostrand post-tensioning systems. The grit impregnated epoxy-coated strand is

intended for use in bonded post-tensioning systems and in pretensioned applications. Epoxy-coated strand is available in conventional sizes of 10 to 16 mm (3/8 in. to 0.6 in.) diameter at Grade 1860 (270 ksi). Details of installation and stressing procedures are provided in a PCI report on the use of epoxy-coated strand.⁷⁸

Epoxy-coated strand is manufactured to meet the requirements of ASTM A882-92, "Standard Specification for Epoxy-coated Seven-Wire Prestressing Steel Strand"⁷⁹ and ASTM A416, "Standard Specification for Seven-Wire Prestressing Steel Strand."⁷⁴ The physical properties of the epoxy coating used for prestressing strand are significantly different from those used to coat mild steel reinforcement. The epoxy coating developed for prestressing strand is very tough and ductile with good bond to the steel to withstand the elongation during stressing. The coating is also durable and abrasion resistant to minimize damage during handling, placement and stressing. The design final coating thickness for the strand is usually 0.76 mm (0.03 in.),⁸⁰ although the thickness can range from 0.63 to 1.14 mm (0.025 to 0.045 in.) according to ASTM A882.⁷⁹ This strand coating thickness is considerably thicker than the coating thickness for mild steel reinforcement (0.18 to 0.30 mm (0.007 to 0.012 in.))⁸¹.

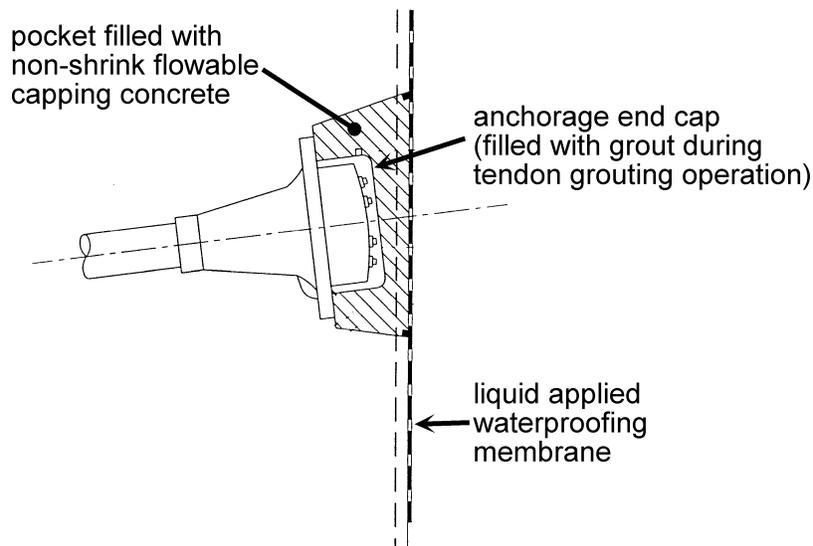
Figure 5.9 -Multi-Layer Corrosion Protection for Buried Post-Tensioning Anchorages⁹²

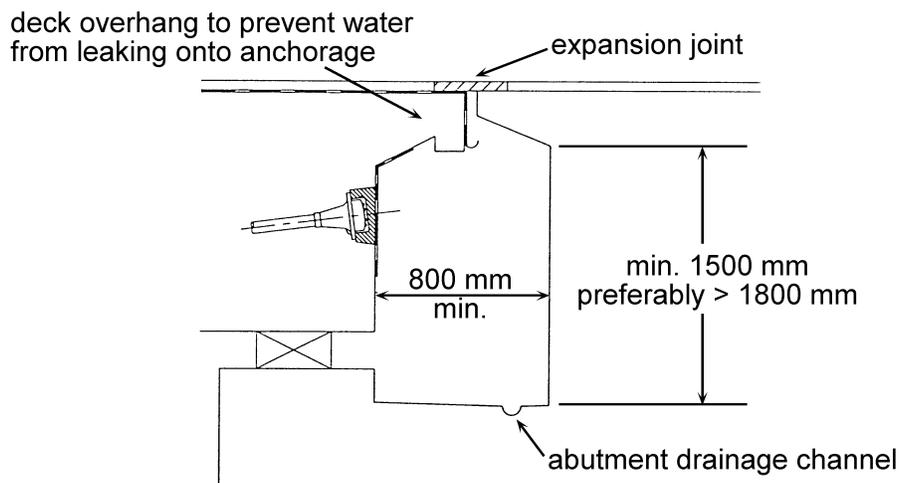
Figure 5.10 - Member End Details for Anchorage Corrosion Protection⁹²

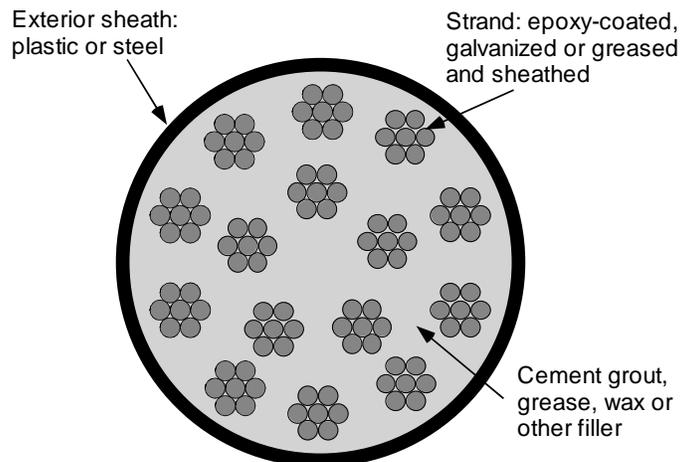
Figure 5.11 - External Post-Tensioning Tendon Corrosion Protection

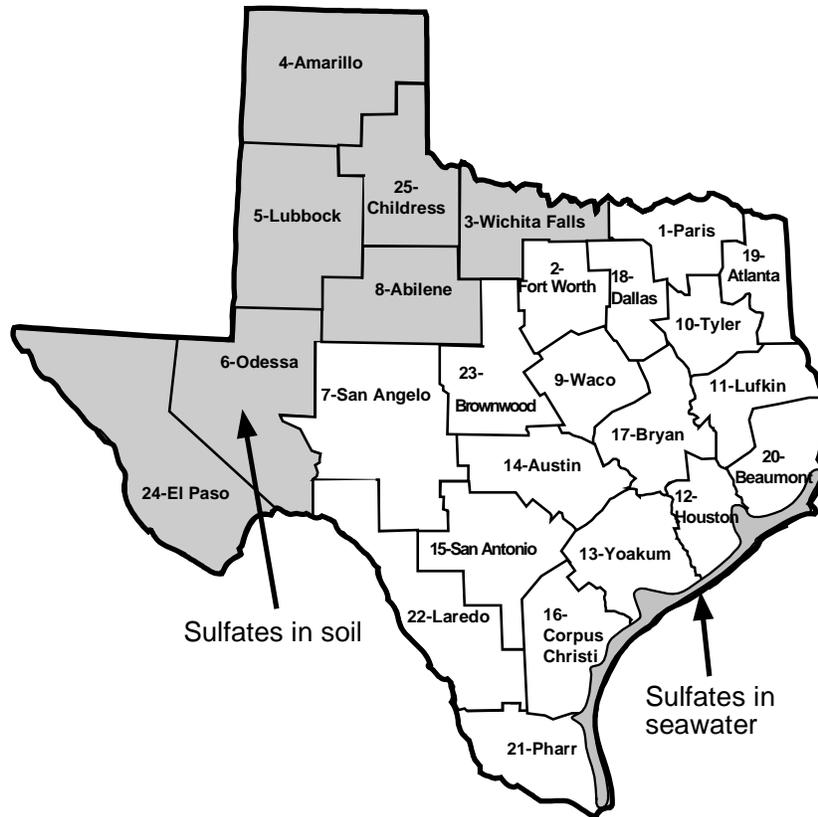
Figure 6.1 - Possible Sulfate Attack Exposure Conditions in Texas¹⁸

Sulfate attack may occur where the structure is in contact with seawater or soils containing sulfates. The TxDOT Bridge Design Guide¹⁸ contains a Texas map indicating districts where sulfate attack may occur, as shown in Figure 6.1. Sulfate attack due to sulfates in soils primarily occurs in the northwestern portion of the state. Sulfate attack due to seawater is a concern along the gulf coast. The source of this exposure map is not certain, but it was likely based on historical occurrences of sulfate attack in TxDOT structures.⁹⁸

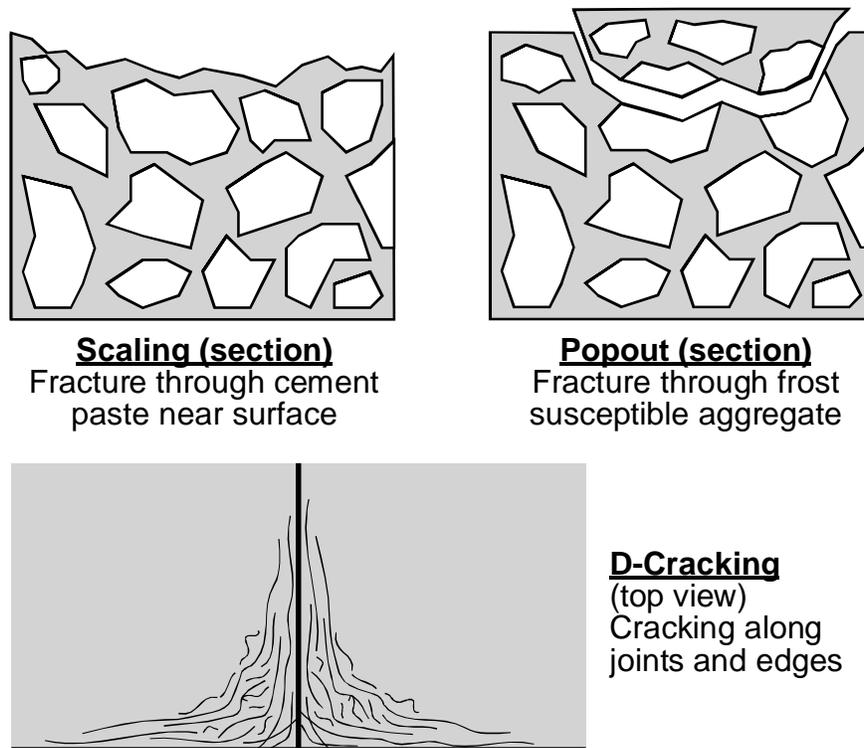
Figure 6.2 - Forms of Freezing and Thawing Damage

Freezing and thawing of moisture in concrete is a common form of physical deterioration of concrete. Damage due to freeze-thaw can occur in the form of scaling, popouts and D-cracking, as shown in Figure 6.2. Scaling refers to shallow fractures through the cement paste near the concrete surface. Scaling may occur in small patches or over large areas, and may or may not expose the coarse aggregate. Popouts refer to small pits on the concrete surface resulting from pieces of concrete "popping out." Popouts normally occur due to frost expansion of coarse aggregate near the concrete surface, and are characterized by a fracture surface through the aggregate, as shown in Figure 6.2. D-cracking consists of frost induced cracks running parallel to expansion joints and edges. The joints and edges allow greater moisture penetration, and provide less restraint for cracking. D-cracking is most common in pavements, and normally occurs due to expansion of frost susceptible aggregates. Freeze-thaw damage in structural members may also occur as general spalling along joints, corners and cracks in the member. Spalling may occur due to frost expansion of the cement paste and aggregate.

Scaling (section)
Fracture through cement
paste near surface

Popout (section)
Fracture through frost
susceptible aggregate

The freeze-thaw durability of the aggregate will have a large effect on the durability of the concrete. As described earlier and shown in Figure 6.2, freeze-thaw damage often results directly from inferior aggregates. The freeze-thaw resistances of aggregate are related to the absorption capacity, porosity, pore structure and size of the aggregate. The first three factors influence how much water may be present in the aggregate and whether the pore volume and structure can accommodate the actions of freezing. In general, larger aggregate sizes are less frost resistant than smaller sizes.⁵¹ Some types of aggregates are more prone to freeze-thaw damage, and in particular D-cracking.¹⁹ Aggregate of sedimentary origin, including limestone and dolomite, are particularly susceptible to D-cracking. Discussion on assessing the freeze-thaw resistance of aggregates is provided by ACI Committee 201.⁵¹

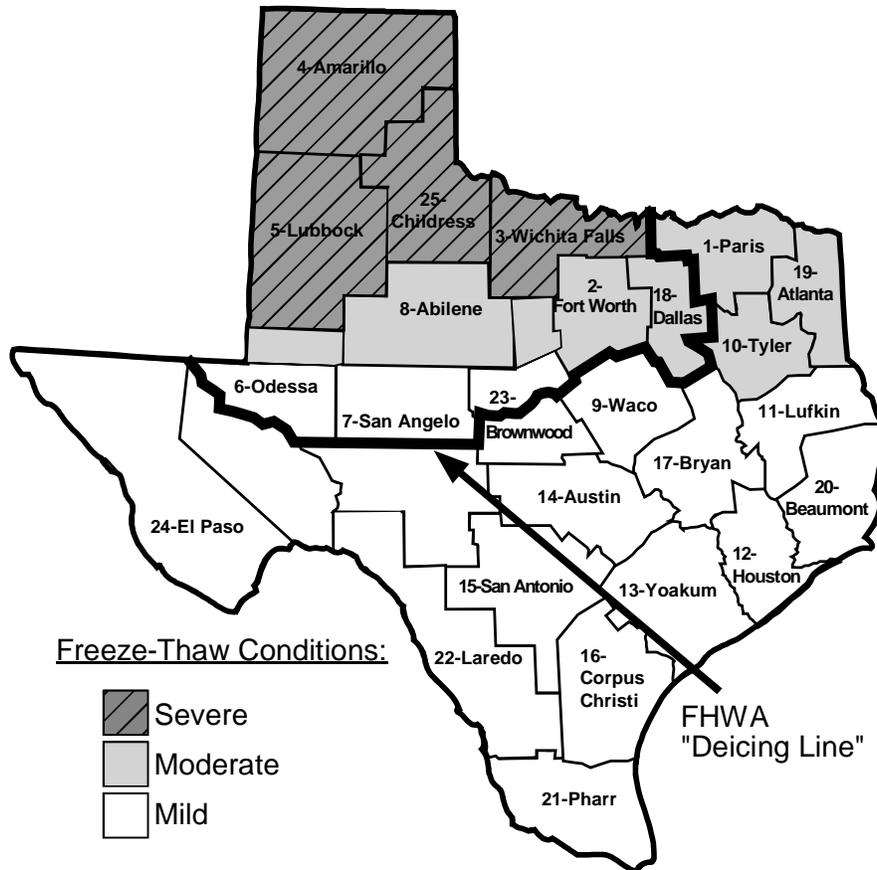
Figure 6.3 - Freeze-Thaw Exposure Conditions in Texas¹⁹

The areas where freeze-thaw deterioration of concrete structures may occur in Texas are indicated in Figure 6.3. The most severe conditions are in northern Texas where the highest number of freezing and thawing cycles occurs. Although the northeastern portion of the state has a milder climate, it has a moderate potential for freeze-thaw damage due to higher precipitation during the winter months.¹⁹

Member exposure (micro-exposure) condition ratings were assigned based on the member’s proximity to moisture and deicing chemicals, and its susceptibility to freeze-thaw damage. Member micro-exposure condition ratings are listed in Table 6.9. The various regions of the state of Texas were assigned regional exposure (macro-exposure) condition ratings to reflect the severity of the environmental conditions. These ratings were based on the combined effects of number of annual freeze-thaw cycles, precipitation during winter months and use of deicing chemicals. The macro-exposure condition ratings were shown previously in Figure 6.3. Depending on the member exposure severity and environmental exposure severity, Watkins assigned a recommended total air content for the concrete, as shown in Table 6.10. The medium and maximum total concrete air contents are a function of maximum aggregate size, as indicated in Table 6.11. The total concrete air content is provided by air entrainment with consideration for the volume of entrapped air.

Member Exposure (Table 6.9)	Environmental Exposure (Figure 6.3)		
	Mild	Moderate	Severe
Mild	None	None	None
Moderate	None	Medium Air	Maximum Air
Severe	None	Maximum Air	Maximum Air

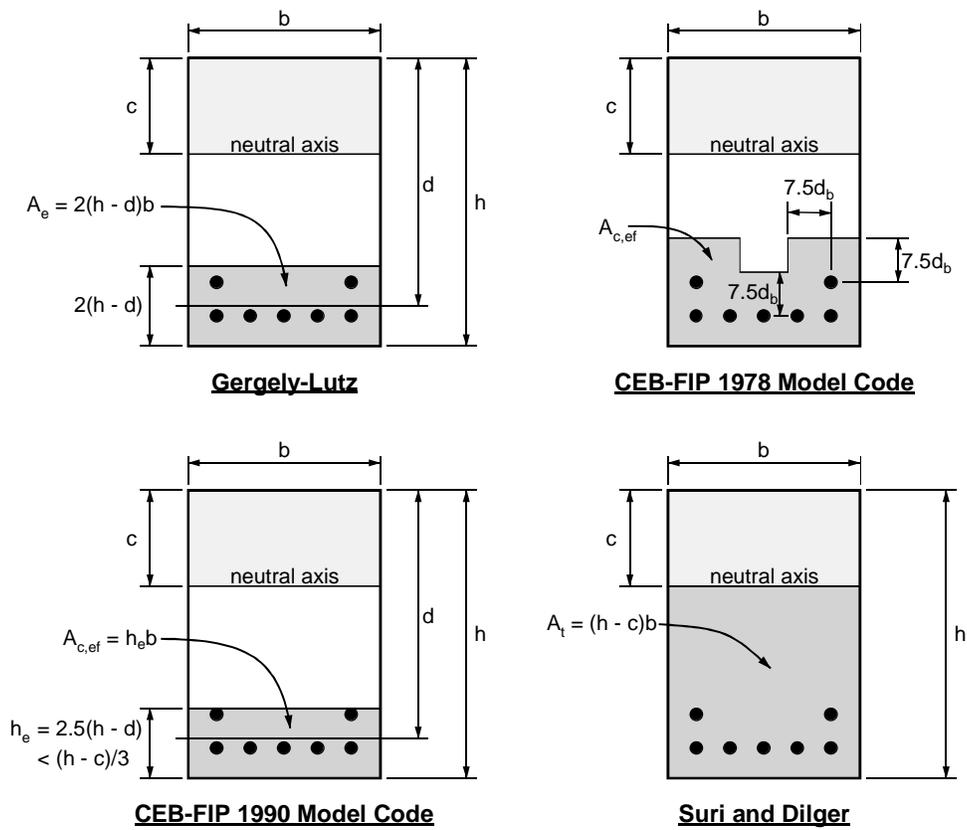
Figure 9.1 - Calculation of Effective Concrete Area in Tension for Various Models

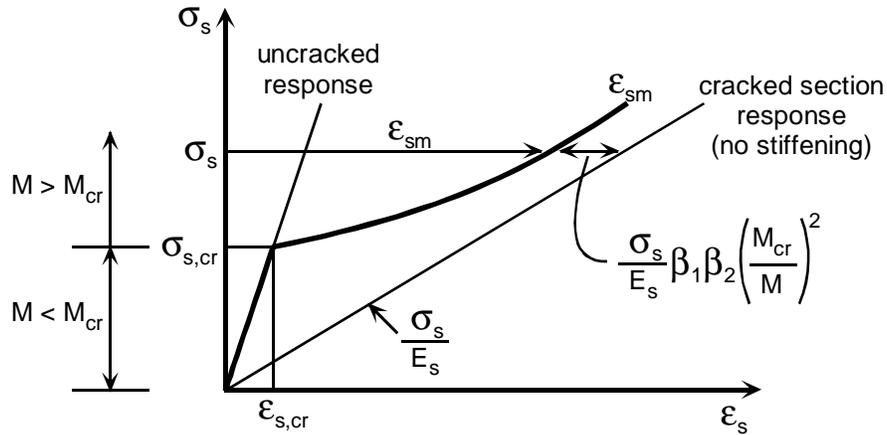
Figure 9.2 - Mean Reinforcement Strain, ϵ_{sm} , Accounting for the Contribution of Concrete in Tension (MC 78)

ε_{sm} = mean steel strain for reinforcement situated in the effective embedment section, taking into account the contribution of the concrete in tension as shown in Figure 9.2.

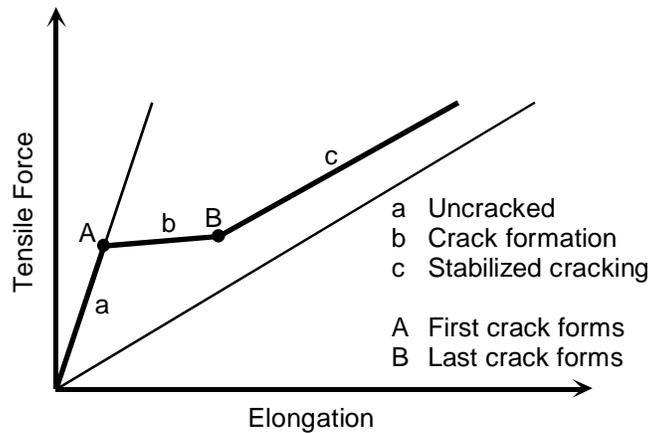
Figure 9.3 - Idealized Phases of Cracking Behavior for a Reinforced Concrete Tension Tie (adapted from Ref. 137)

The CEB-FIP 1990 Model Code (MC 90)¹³⁷ also specifically identifies cracking as a limit state in the design process. Similar to MC 78, the MC 90 crack width model is based on general principles of cracking in concrete. However, the MC 90 model defines the characteristic crack widths as a function of the length over which slip between steel and concrete occurs near a crack, and the difference between the average steel and concrete strains within the length of slip. The characteristic crack width is compared to allowable limits to satisfy the limit state. The MC 90 crack width model also allows the effect of shrinkage strains to be introduced. Another difference between MC 90 and MC 78 is that MC 90 identifies different phases of cracking to better represent observed cracking behavior and crack formation in structural concrete, as shown in Figure 9.3.

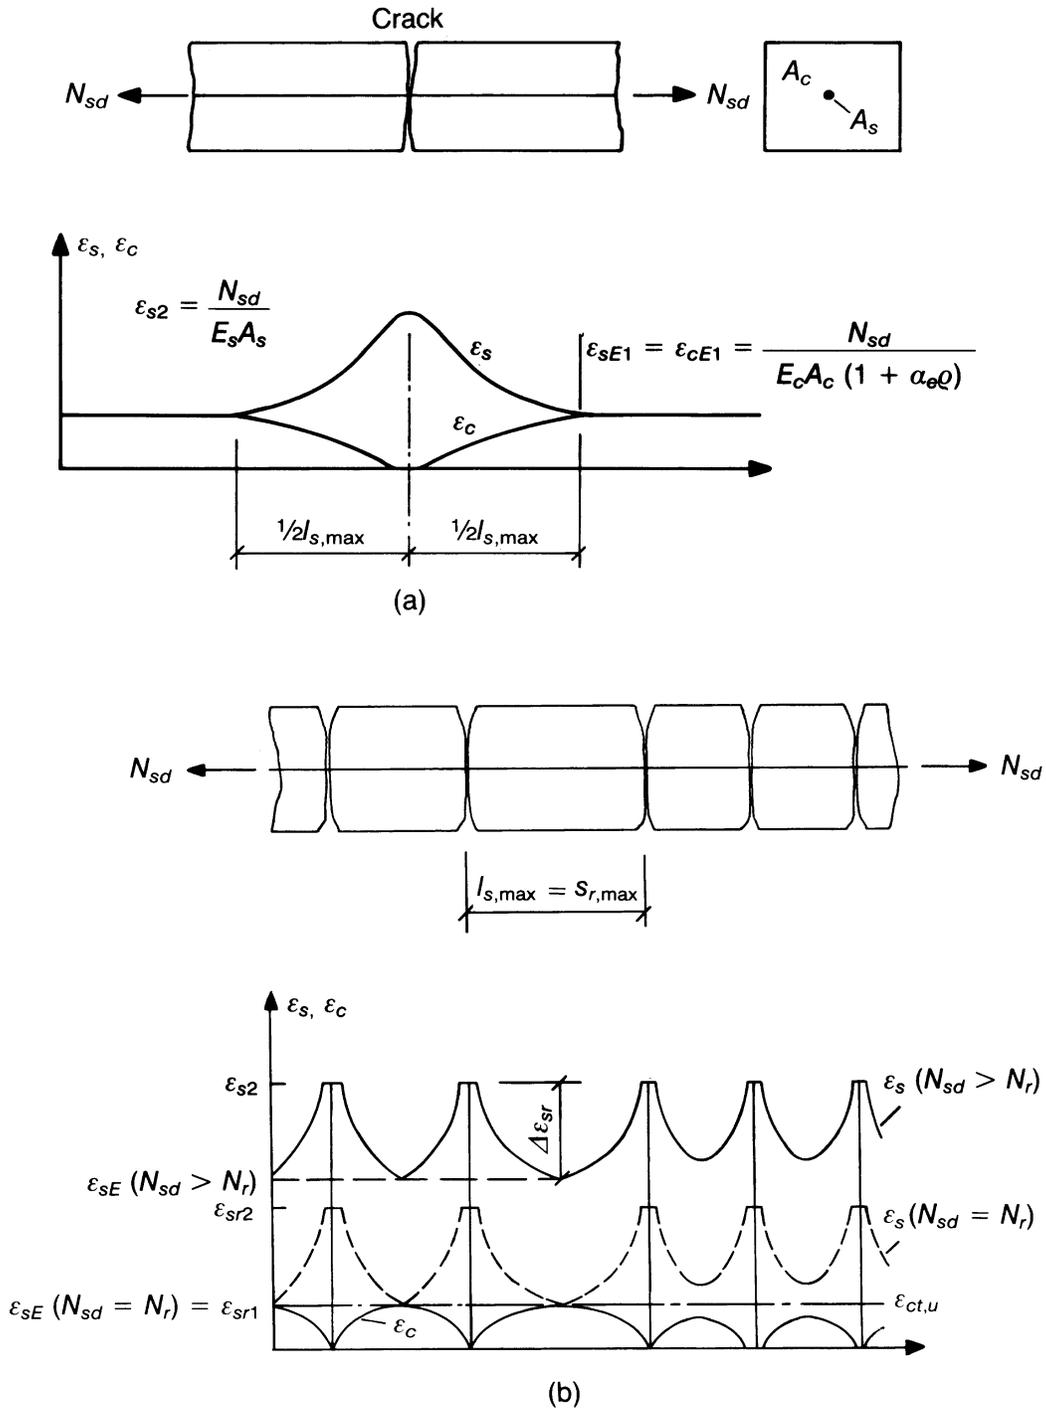
Figure 9.4 - Strains for Calculating Crack Widths Under MC 90: (a) For Single Crack Formation, (b) for Stabilized Cracking (from Ref. 137)

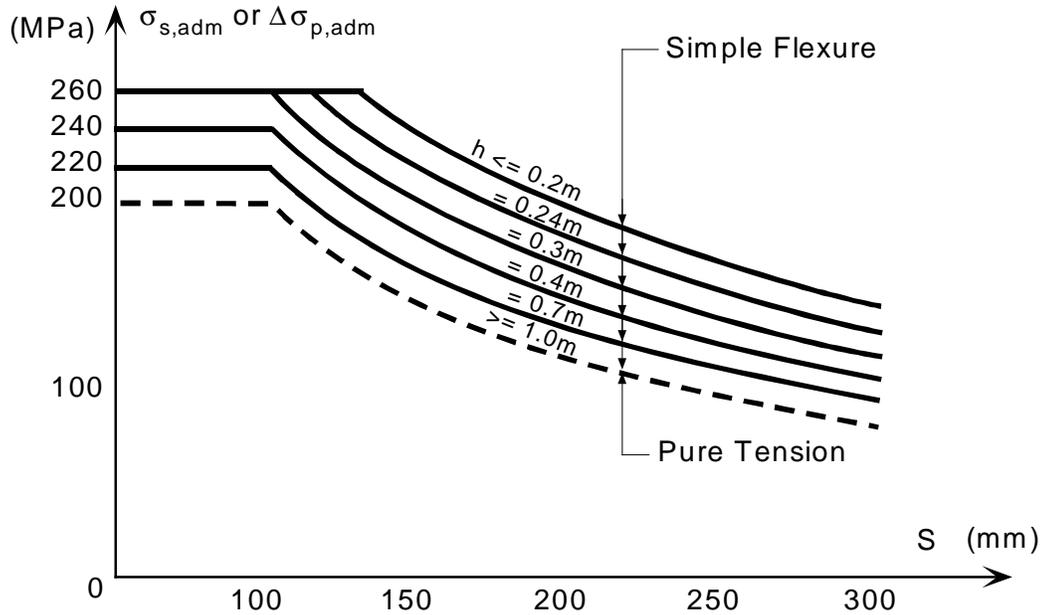
Figure A.1 -Limitation of Cracking Due to Loads (Severe Requirements): Stress in Reinforcing Steel and Increases in Stress in Prestressing Steel (SIA 162^{A.10})

For severe requirements, the minimum reinforcement required for normal conditions is to be increased by 30%. In addition, stresses in reinforcing steel and increases in stress in prestressing steel are limited according to Clause 3.33.5. Under the actions of all long term loads and one variable load, the stresses in the reinforcing steel and increases in stress in prestressing steel must not exceed the allowable stresses shown in Figure A.1.

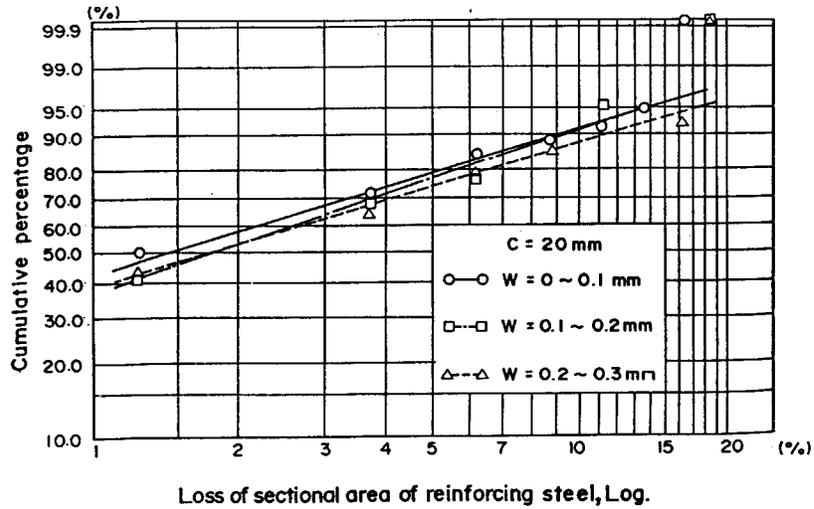
Figure A.2 - Loss of Cross-Sectional Area after 10 Years, 20 mm (0.79 in.) cover (Ohta^{A.35})

1. Crack widths did not correlate significant loss of the cross sectional area of steel for 20 mm (0.8 in.) cover after ten years (Figure A.2).
2. For 40 mm (1.6 in.) cover, there appeared to be a relationship between the amount of corrosion and crack widths (Figure A.3).
3. Corrosion was only slight for covers of 50 mm and 68 mm (2 in. and 2-2/3 in.).

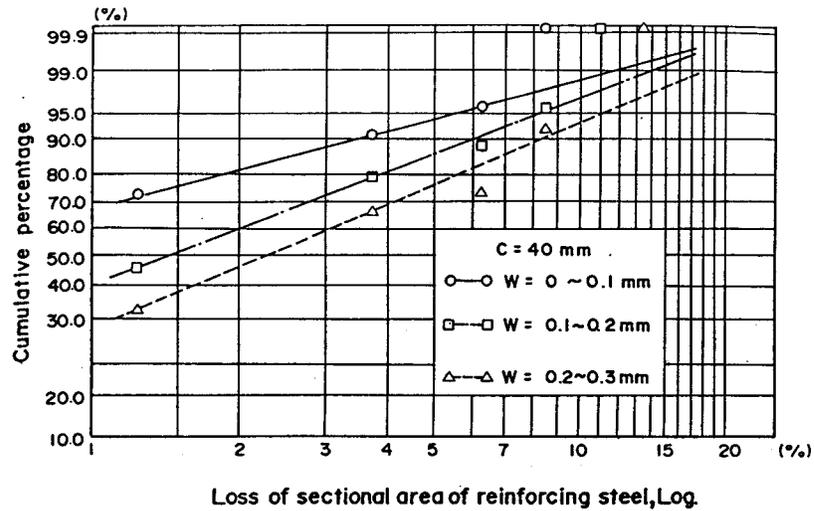
Figure A.3 - Loss of Cross-Sectional Area after 10 Years, 40 mm (1.57 in.) cover (Ohta^{A.35})

It was then concluded that the rate of progress of depassivation depends on crack width when cover is thick, and when term of exposure is short.

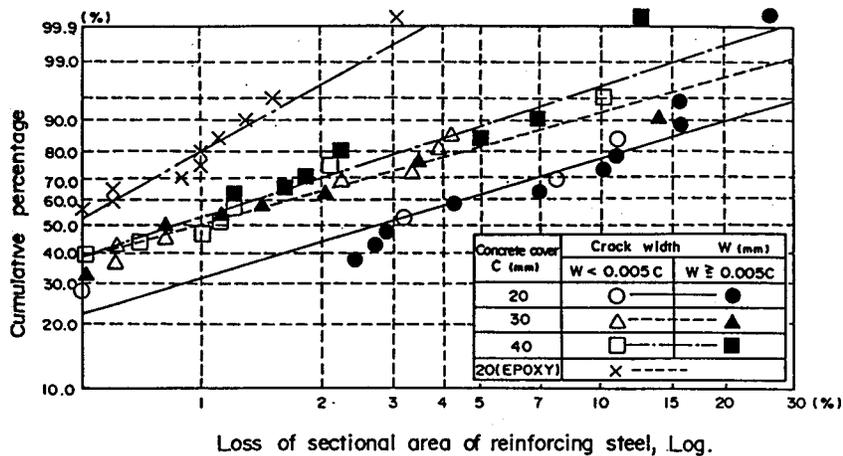
Figure A.4 - Loss of Cross-Sectional Area After 20 Years (Ohta^{A.35})

1. The effect of crack widths on corrosion disappeared for even the 40 mm (1.6 in.) cover specimens (Figure A.4).
2. Specimens with 20 mm (0.8 in.) cover were very heavily corroded, and longitudinal cracks along the reinforcement were observed

It was concluded from these tests that cover, and not crack width played the most important role in the control of corrosion of reinforcing steel in concrete.

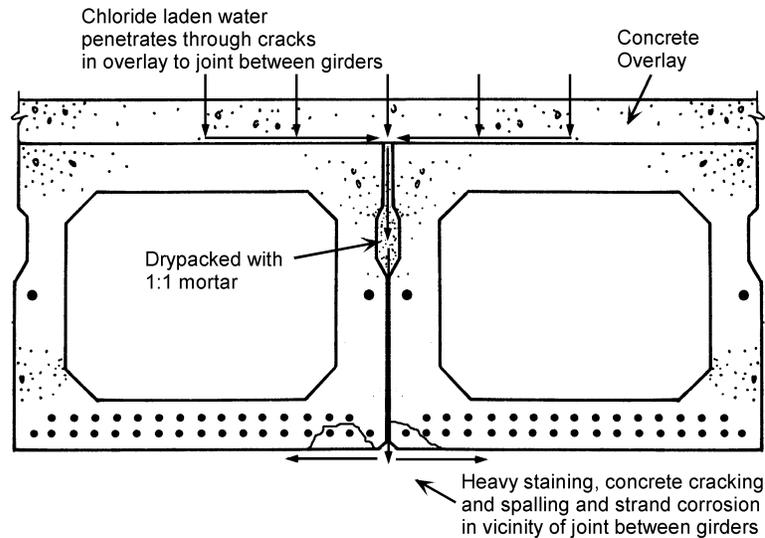
Figure B.1 - Mechanism for Moisture and Chloride Penetration Through Concrete Overlay in Precast Pretensioned Box Girders (adapted from Ref. B.4)

Novokschenov^{B.4} performed an extensive condition survey of several pretensioned and post-tensioned bridges, in both marine and de-icing salt environments. One bridge located in the Gulf of Mexico consisted of pretensioned girder approach spans and post-tensioned segmental box girder main spans. The bridge was 16 years old at the time of inspection. Corrosion damage consisting of concrete cracking caused by corrosion of the prestressing steel was found on the ends of the pretensioned girders adjacent to the expansion/contraction joint at the transition between the approach and main spans. Corrosion was attributed to chloride laden moisture from the deck leaking through the expansion/contraction joint onto the ends of the girders, producing highly localized, severe exposure conditions. Novokschenov^{B.4} also examined a precast pretensioned box girder viaduct that had been exposed to de-icing salts throughout its service life. The bridge was 29 years old at the time of inspection. Examination revealed that almost all longitudinal joints between box girders were leaking, ranging from very minor to extensive. The leakage appeared to have resulted from moisture and chlorides penetrating through cracks in the cast-in-place concrete deck overlay and progressing through the longitudinal joints between the girders, as shown in Figure B.1. In the areas of heaviest leakage, extensive staining and white deposits were visible, accompanied by corrosion of the prestressing strands and deterioration of the concrete cover. In some areas, spalling exposed the prestressing strands, leading to severe deterioration and failure of up to six of the seven wires in several strands. The specified concrete cover for this bridge was 45 mm (1.75 in.), and measured cover was up to 6 mm (0.25 in.) less than this value. Novokschenov mentioned that this type of damage was common in other, similar bridges, and concluded that is an inherent problem to this particular bridge design. A third bridge examined in this report^{B.4} consisted of precast pretensioned I-girders. Corrosion related damage consisting of concrete cracking and spalling was found in girders adjacent to longitudinal expansion joints and at the ends of most girders at transverse joints, both expansion and fixed. The path of chloride laden water at a longitudinal expansion joint and the resulting deterioration are shown in Figure B.2. In areas where the strand was exposed due to spalling, wire fractures were common. Corrosion damage at the ends of the girders was less severe at fixed joints in comparison to expansion joints, attributed to less leakage of chloride laden moisture from the bridge deck. The specified cover was 50 mm (2 in.), and measured covers were up to 6 mm (0.25 in.) less than this value.

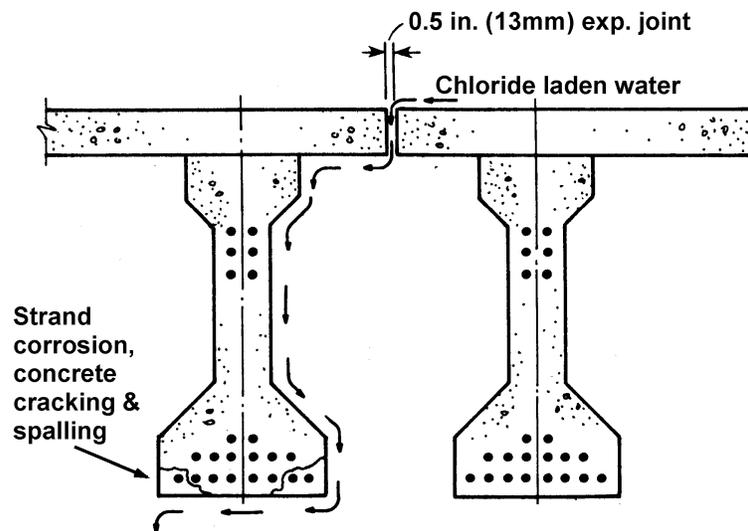
Figure B.2 - Mechanism for Moisture and Chloride Penetration at Longitudinal Expansion Joints in Precast I-Girder Bridges (adapted from Ref. B.4)

Others have performed similar condition studies of bridges with pretensioned elements.^{B.5} In general, these surveys found corrosion related deterioration in pretensioned members to be localized in specific areas of the structure, primarily at transverse joints along the bridge. The findings of condition surveys of pretensioned bridges indicate that corrosion problems in this type of structure are primarily a function of the design of the structure, rather than the pretensioned elements. Improved joint design and maintenance or minimization of joints would appear to eliminate most corrosion problems.

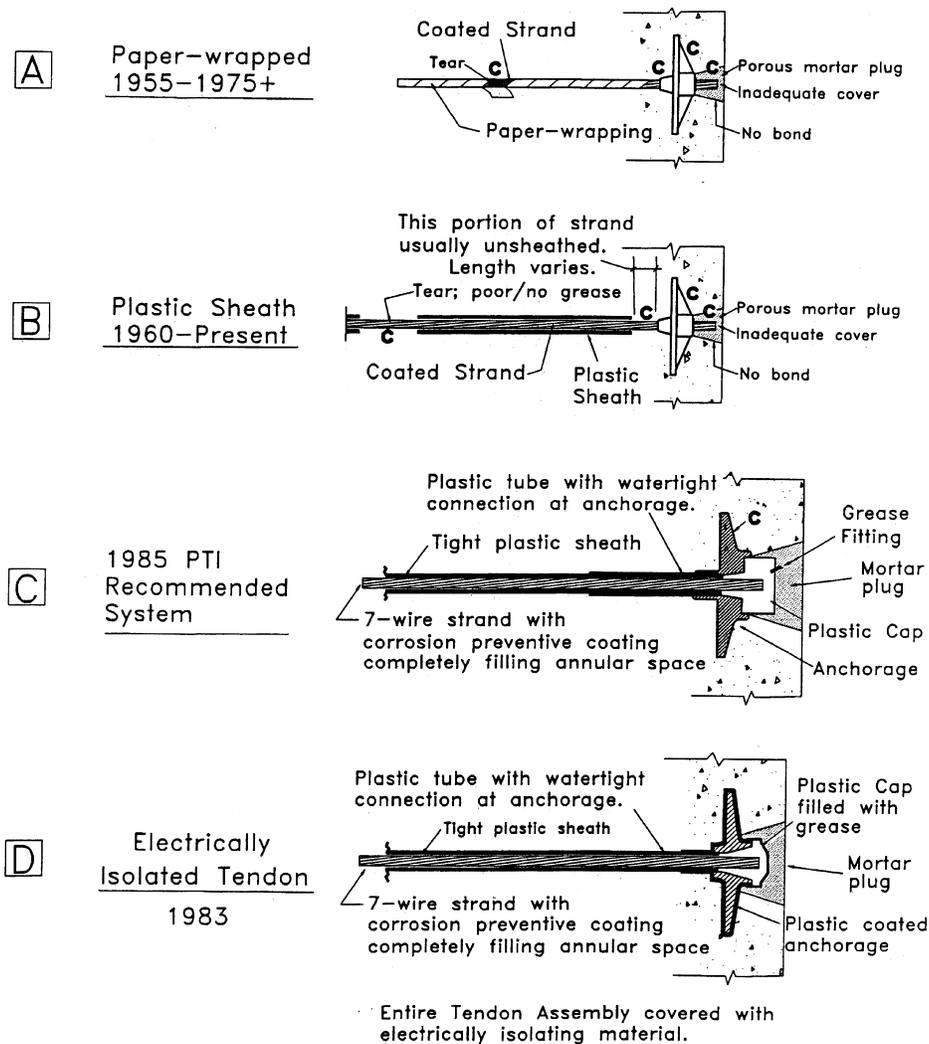
Figure B.3 - Evolution of Monostrand Systems for Post-Tensioning (Ref. B.6) (common locations for corrosion indicated by "c")

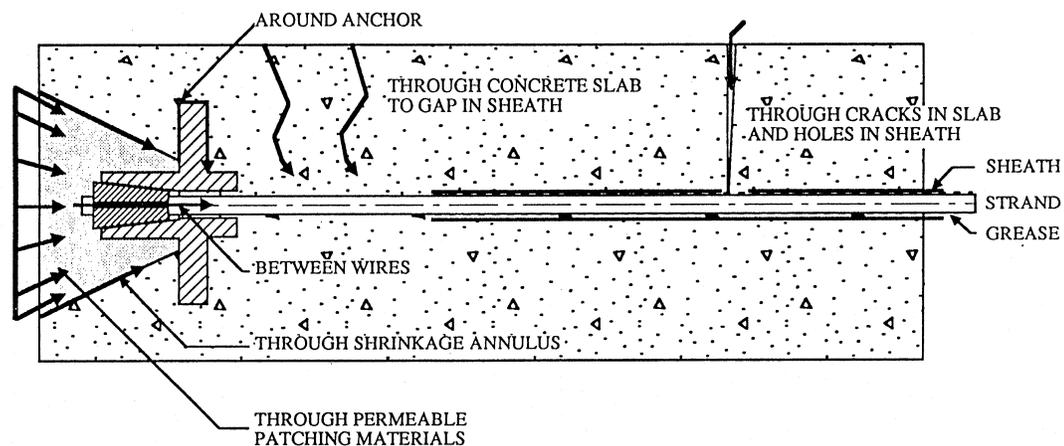
Figure B.4 - Possible Moisture and Chloride Access to Monostrand Systems (Ref. B.8)
