RESEARCH REPORT 1405-1

STATE-OF-THE-ART REPORT ABOUT
DURABILITY OF POST-TENSIONED BRIDGE
SUBSTRUCTURES

OCTOBER 1999

*DURABILITY DESIGN OF POST-TENSIONED
BRIDGE SUBSTRUCTURE ELEMENTS*

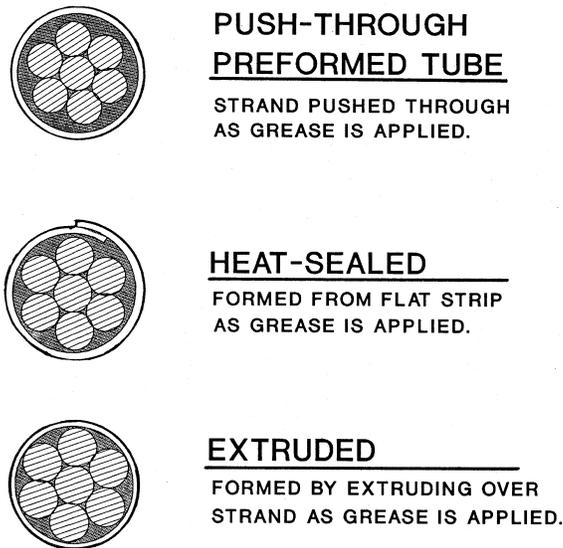
Figure B.5 - Evolution of Sheaths for Monostrand Systems (Ref. B.10)

The evolution of sheath types used in monostrand systems is shown in Figure B.5. Earlier sheath systems have shown poor long-term corrosion protection. Paper wrapping is not waterproof and is easily damaged. Peterson^{B.11} reports that paper wrapped monostrand tendons are a common corrosion problem in parking structures. Heat sealed sheaths have been found to split open over time, compromising the moisture barrier for the strand. A large number of monostrand corrosion problems have been encountered with the push-through sheath.^{B.6} Even when the sheath is intact, the annular space around the strand allows movement of moisture and chlorides. Schupack^{B.6} reported severe tendon corrosion and failures in a seven year old platform structure with push-through monostrand tendons. Water entered the sheathing at poorly protected end anchorages. Intermittent corrosion and wire failures were found throughout the structure. Tight fitting extruded sheaths should minimize this problem.
