TECHNICAL REPORT

Accident to the Airbus A380
registered F-HPJE and operated by Air France
on 30/09/2017 en route over **Greenland**

October 2017 - June 2018
Searches **Phase I & II**

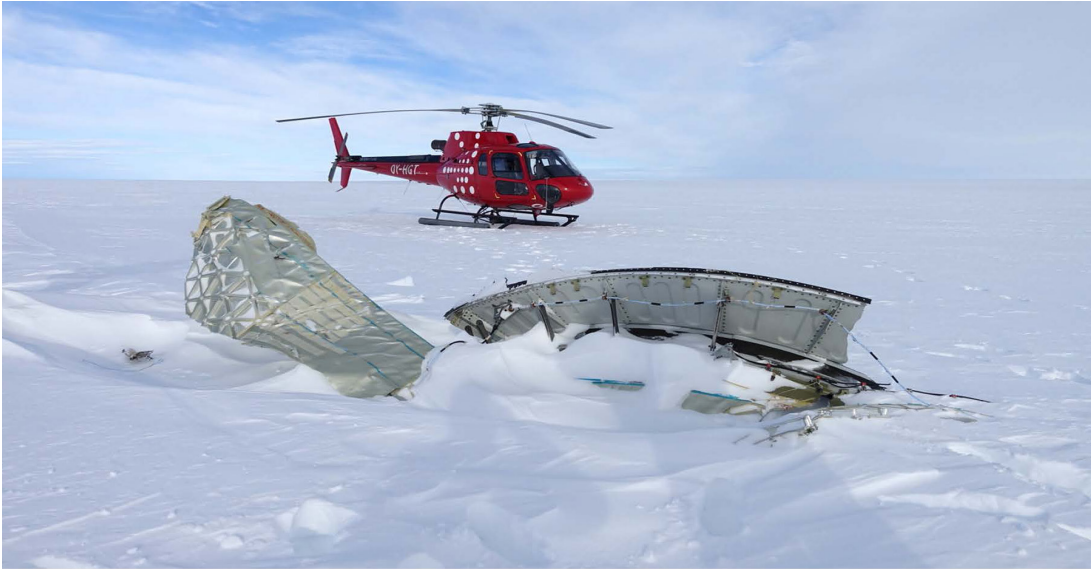
Fig. 6: bulkhead and fan containment case fragment as found on site
(picture courtesy of Air Greenland/AIB-D)

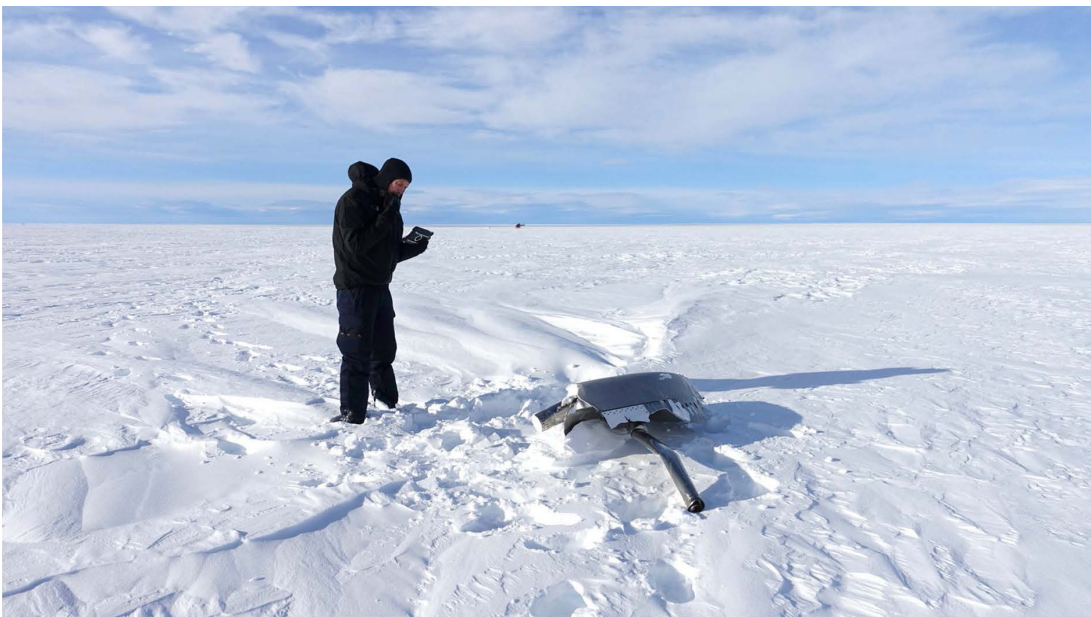
Fig. 7: part of inlet lip photographed on site by an Air Greenland staff member
(picture courtesy of Air Greenland/AIB-D)

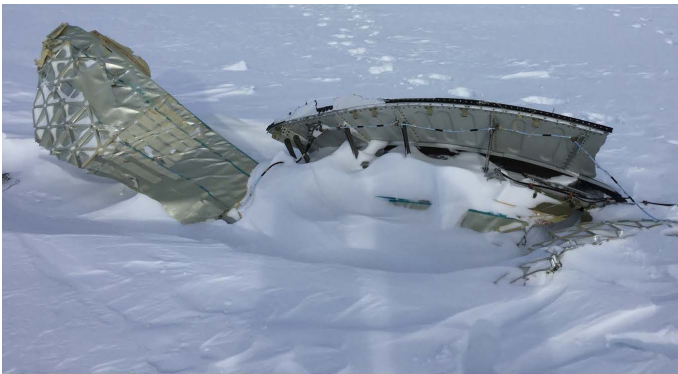
Fig. 10: inlet cowl aft bulkhead and fan containment case fragment

- ❑ N° 1: Bulkhead and fan containment case fragment: N61°45'40.1 W046°48'29.4 (Fig. 10)
- ❑ N° 2: Inlet part: N61°45'46.1 W046°47'52.2 (Fig. 11)
- ❑ N° 3: Part of composite cowl: N61°45'34.2 W046°48'22.6 (Fig. 12)
- ❑ N° 4: Kevlar belt: N61°46'08.9 W046°47'40.4 (Fig. 13)

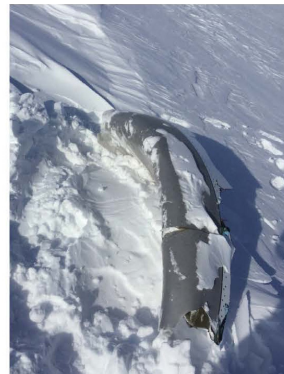
Fig. 11: inlet part

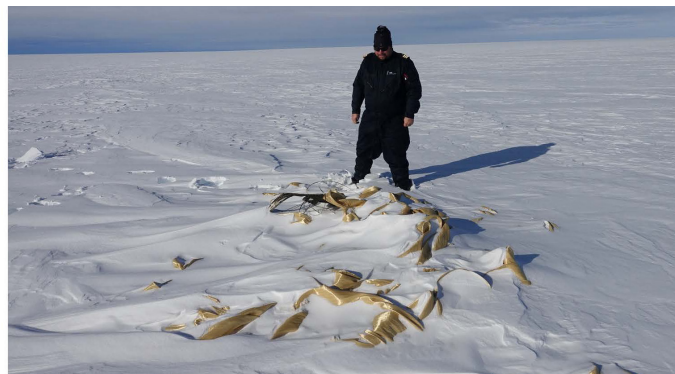
Fig. 13: kevlar belt

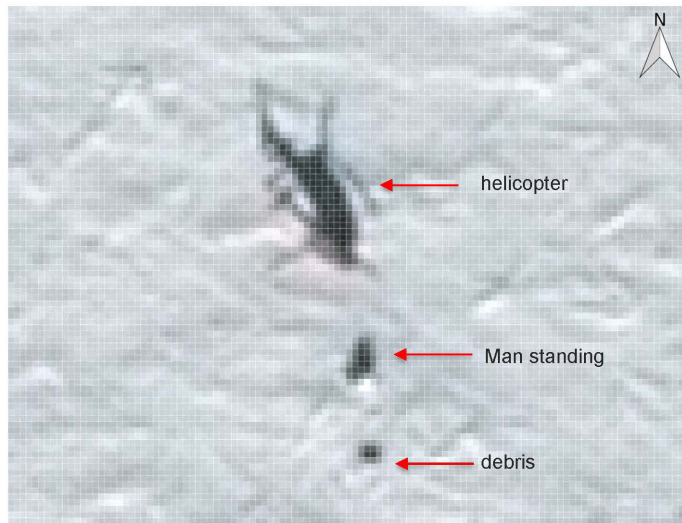
Fig. 14: Pléiades satellite image of search area, dated October 11, 2018

Fig. 15: detail of red box in Fig. 14 - 1 pixel size is 50 cm by 50 cm

Even so, October 11 images were looked at, without any findings being made. The only feature spotted is shown in Fig. 14. It corresponded to a helicopter, probably Air Greenland AS350 which was onsite for part recovery that day. One can probably distinguish a man standing by debris, south of the helicopter (Fig. 15).

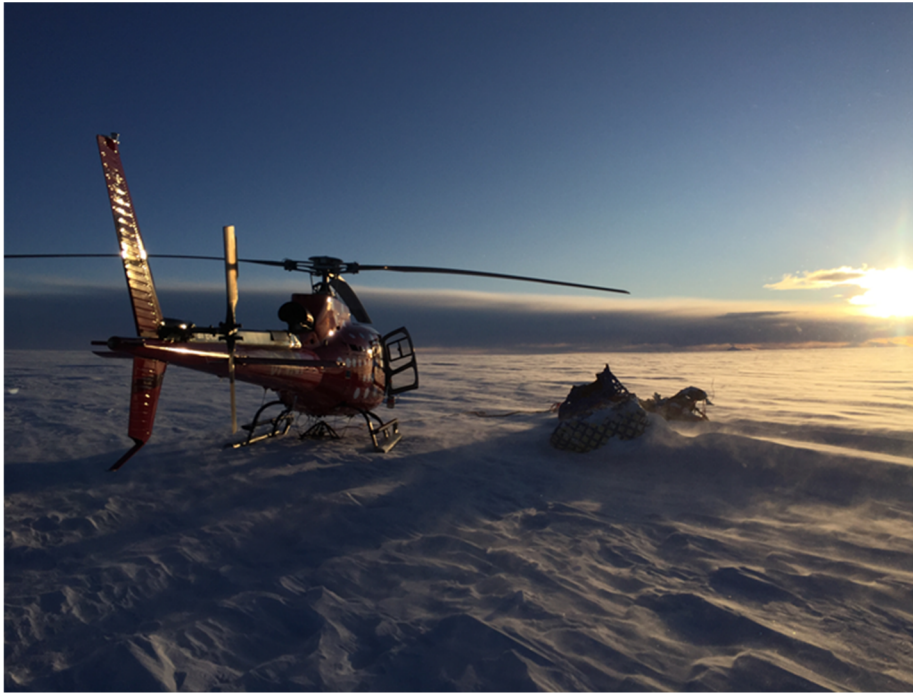
Fig. 29: recovering debris on ice sheet, October 2017. Photo courtesy of Air Greenland/AIB-D

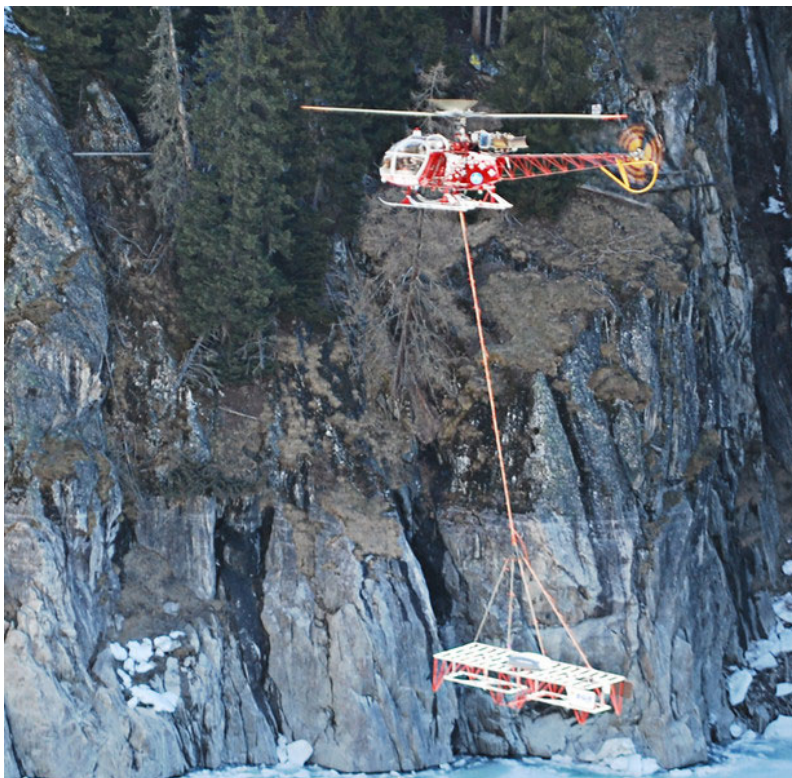
Fig. 36: Hera-G radar system (RST) operated by helicopter

Considering the size of the hub fragments, probably smaller than 1 m in size, and the depth of their probable location (around two to three meters below the snow layer), this solution was deemed not appropriate.

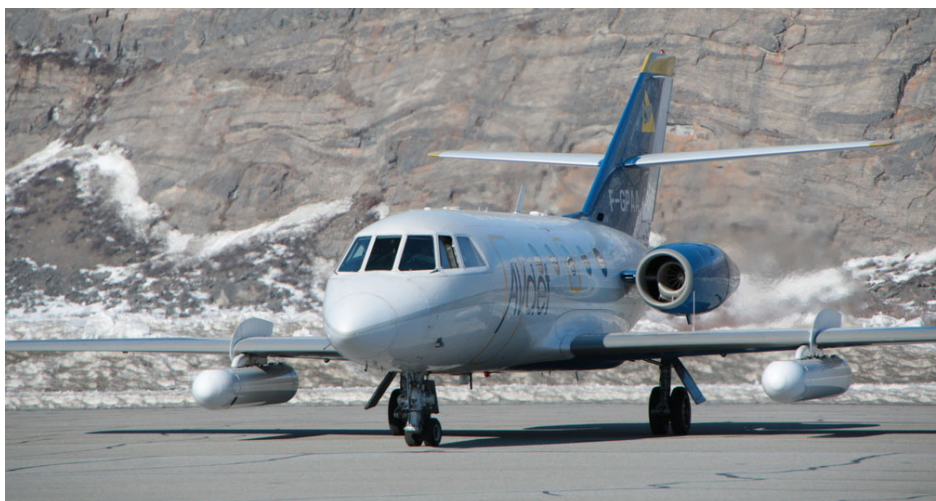
Fig. 37: AVDEF Falcon 20 F-GPAA

Launched in 2007, the SETHI project is based on an adapted Falcon 20 jet aircraft (Fig. 37). This aircraft, rented from a private company called AVDEF, an Airbus subsidiary and located on Nîmes Garons Airport, has been adapted to accommodate two underwing pods, about three meters long and 300 kg each.

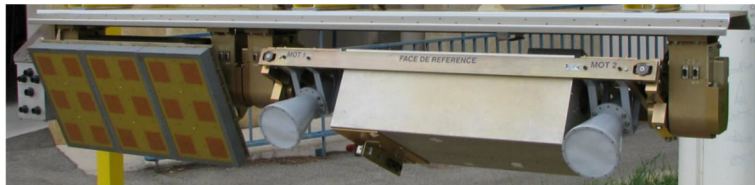
Fig. 39: X band radar payload (right) and L band (left) integrated in right pod

Radar bands operated on the SETHI system are UHF, L and X bands, with polarimetry capability. The UHF radar is integrated in the left pod (Fig. 38) and the X+L radars are in the right pod (Fig. 39).

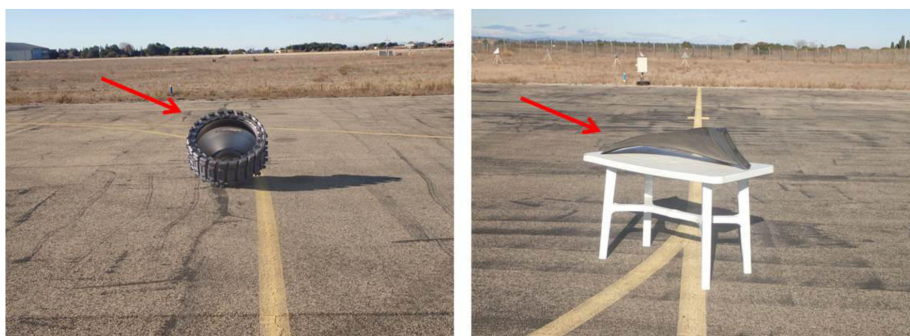
Fig. 41: a fan hub and a fan blade on Nîmes-Garons airport for detection testing

The testing operation was carried out at Nîmes-Garons Airport, from the end of November to mid-December 2017. As it was an opportunistic test, there was no possibility of burying the parts in snow or ice. The parts were simply positioned on a taxiway of the airport (Fig. 41) which was not representative of the situation to be encountered in Greenland. But the possibility of carrying out this test at such short notice was unexpected and very beneficial. The effect of snow and/or ice on the radar response was not evaluated during these tests but they were nevertheless estimated from available scientific literature (see paragraph 3.3.2).

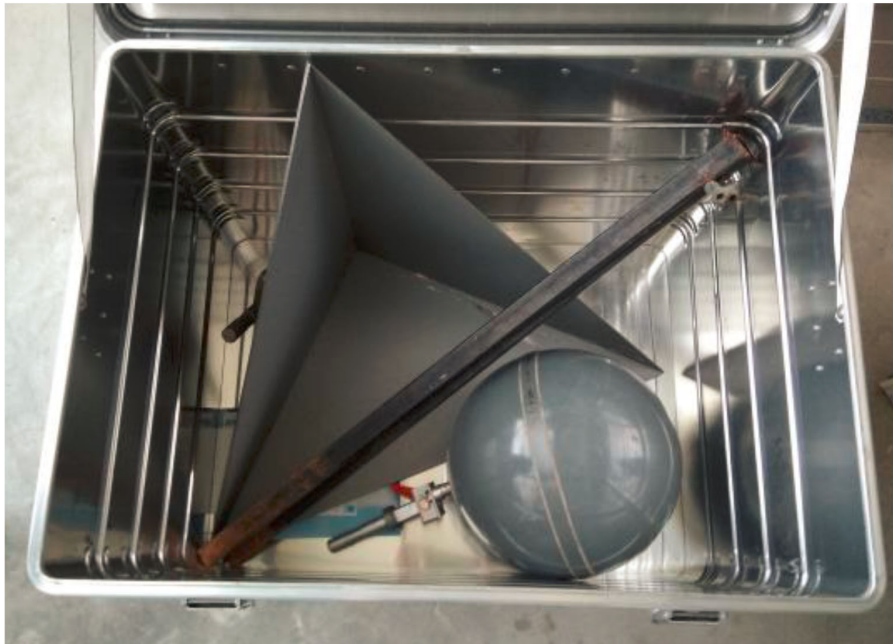
Fig. 46: trihedral and sphere in their transport crate

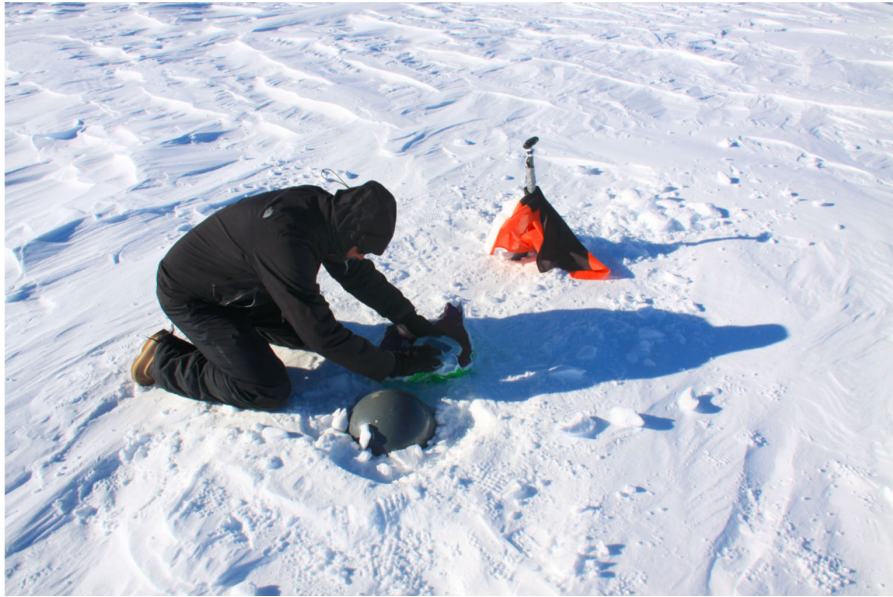
Fig. 47: GEUS member burying Luneburg sphere on ice sheet

GEUS proposed to bury these items during a short reconnaissance mission, shortly before the measurement period in order to limit the shift of the targets due to ice sheet movements (Fig. 47). A test hub fragment (made from a 93% scale part, see Fig. 48) was provided by EA and was also buried on site, as a reference, as its GPS location was known.

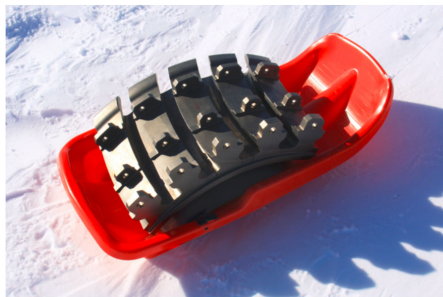
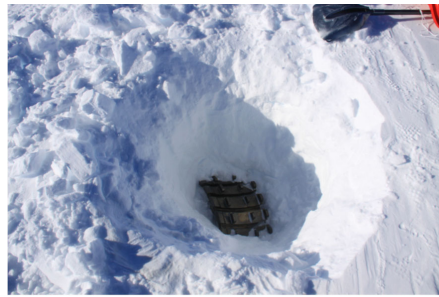
Fig. 48: part of a fan hub mock-up on its sledge, later referenced as “test hub” (left picture), and once buried (right picture)

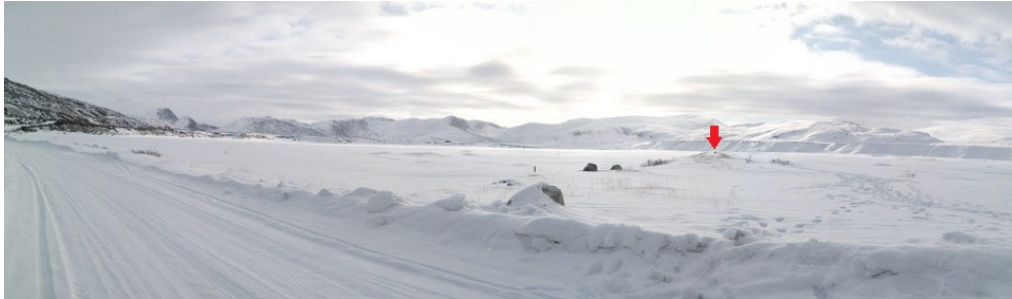
Fig. 51: trihedral position

For this purpose, a second trihedral (a first trihedral was already buried under the snow on the search area) was accurately positioned on Kangerlussuaq Golf course (67°01'27.14729»N 52°38'1.29678»W), aligned with 062° (Fig. 51).

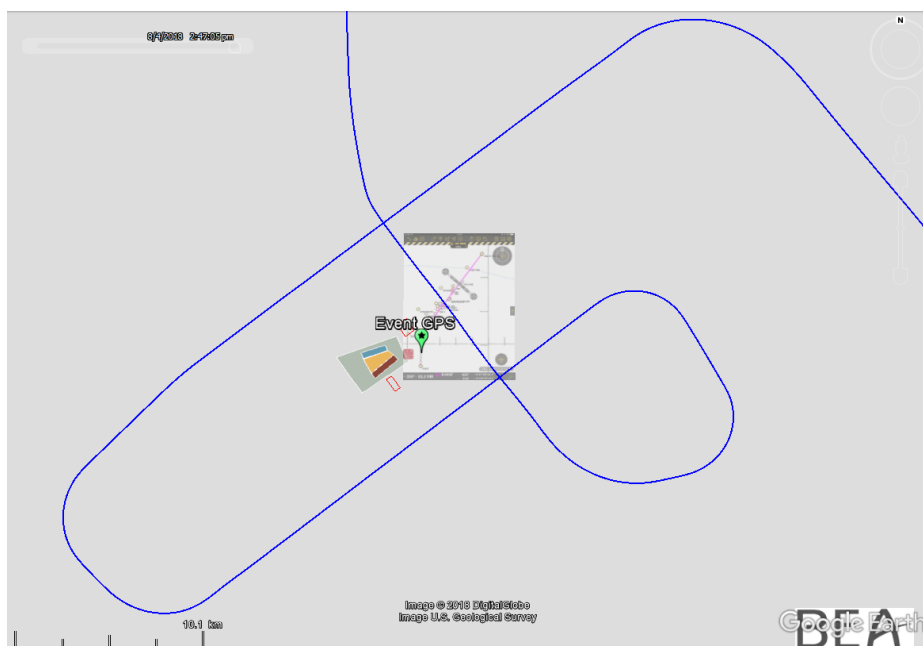
Fig. 55: L and UHF (P) band measurement passes – aircraft trajectory (return flight)

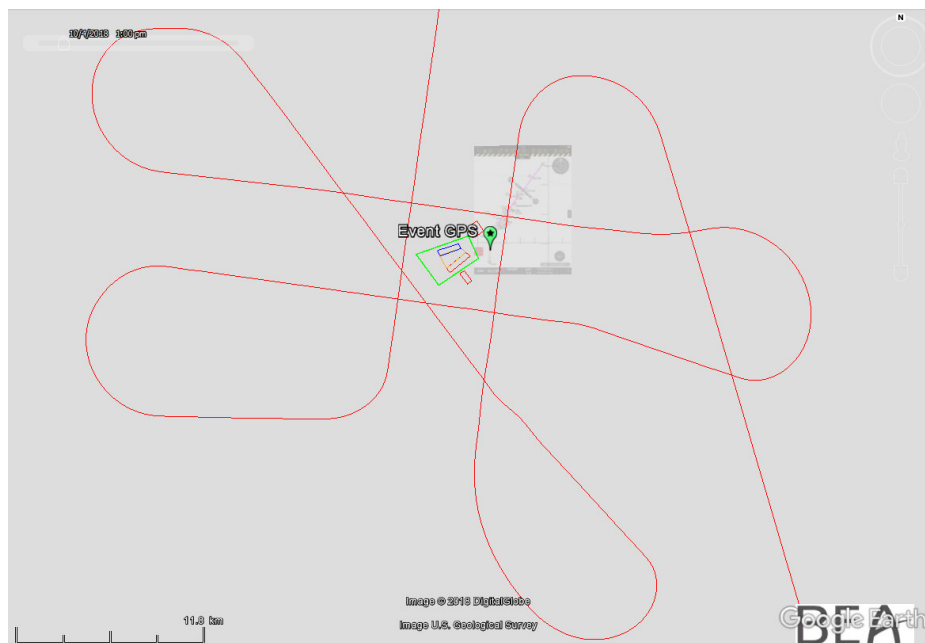
Fig. 58: first flight of set (SFJ-UAK): five passes with UHF(P) and L band

The first flight of this second set was performed on April 10 with UHF(P) and L band measurements. The aircraft trajectory is shown in Fig. 58. The corresponding radar coverage is shown in Fig. 59. Due to weather, the aircraft was not able to take-off again on the same day as the first flight. The next flight was performed the day after, on April 11, in the morning. Weather conditions permitted a local flight (Fig. 60) and acquisition of the six missing X band passes (Fig. 61). The aircraft landed at UAK again.

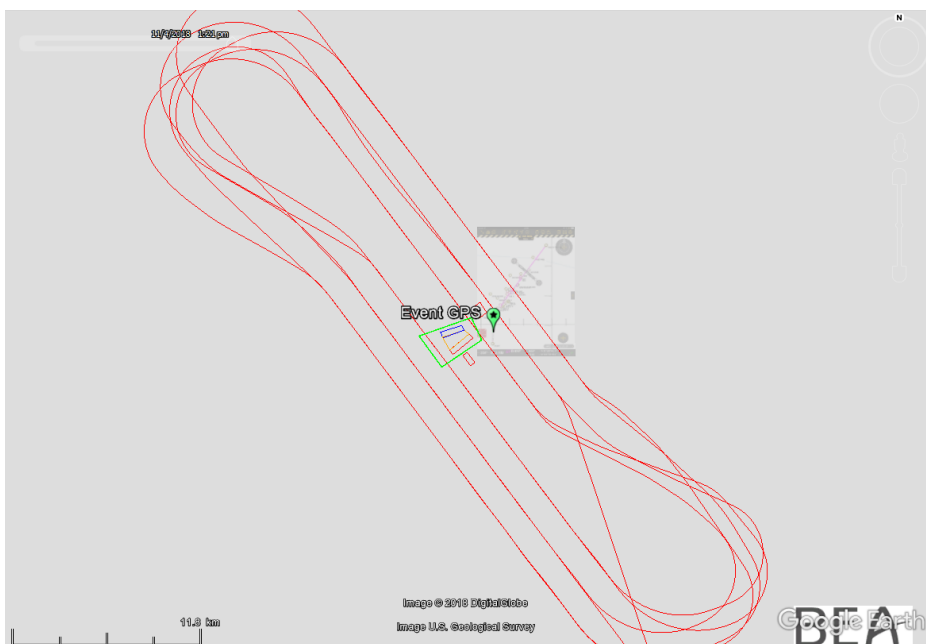
Fig. 60: second flight of set (UAK-UAK), six passes in with X band – aircraft trajectory

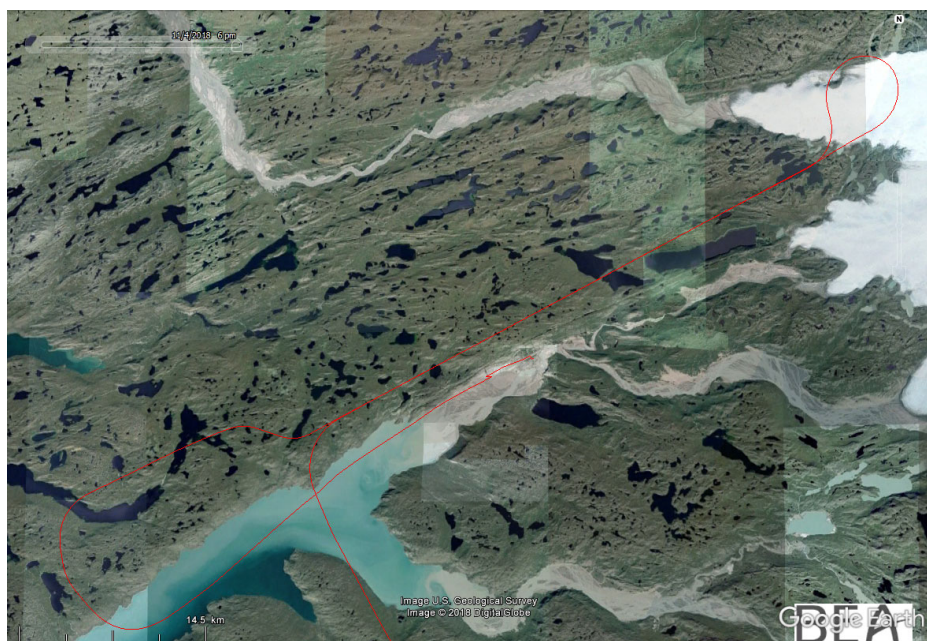
Fig. 63: third flight of set, calibration over Kangerlussuaq

Finally, the aircraft took off again from UAK on the same day for the return flight to SFJ, just before the weather degraded rapidly (Fig. 62). This third flight of the set was dedicated to calibration with the 50° radar depression angle. Passes were performed over the trihedral again, disposed on the golf course for that purpose. The calibration flight path is shown in Fig. 63.

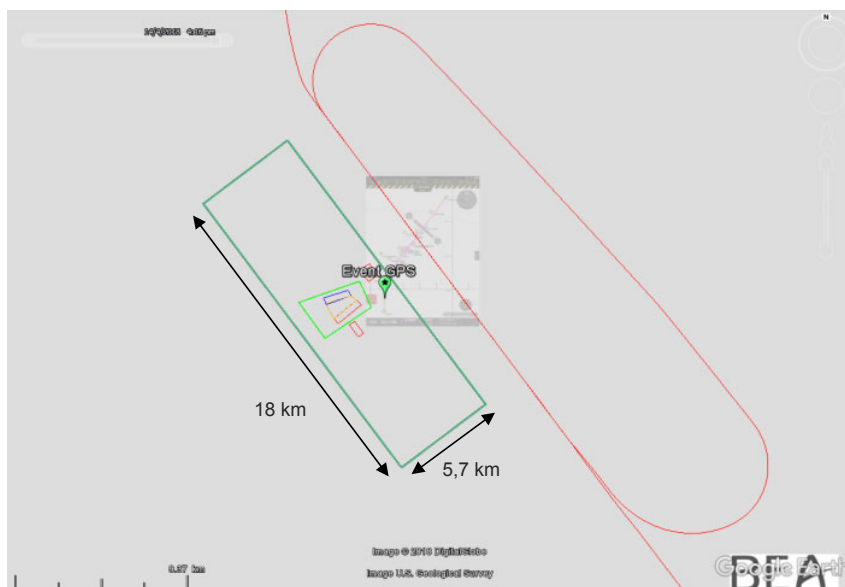
Fig. 67: UHF(P) and L band coverage and second flight trajectory for interferometric measurements

The return flight (Narsarsuaq – search zone – Kangerlussuaq) was performed the same day. The trajectories and radar coverage are presented in Fig. 66 & Fig. 67.

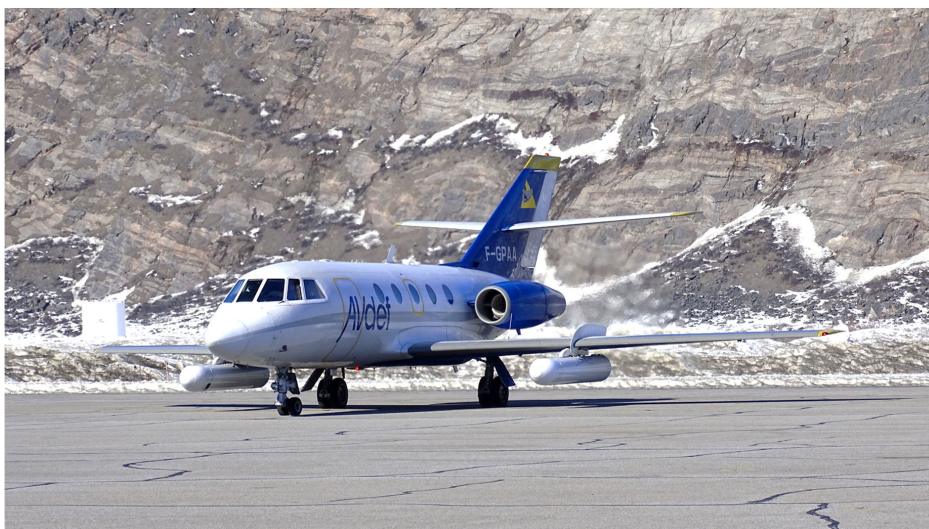
Fig. 68: Avdef Falcon 20 equipped with its two radar pods, back at Kangerlussuaq Airport

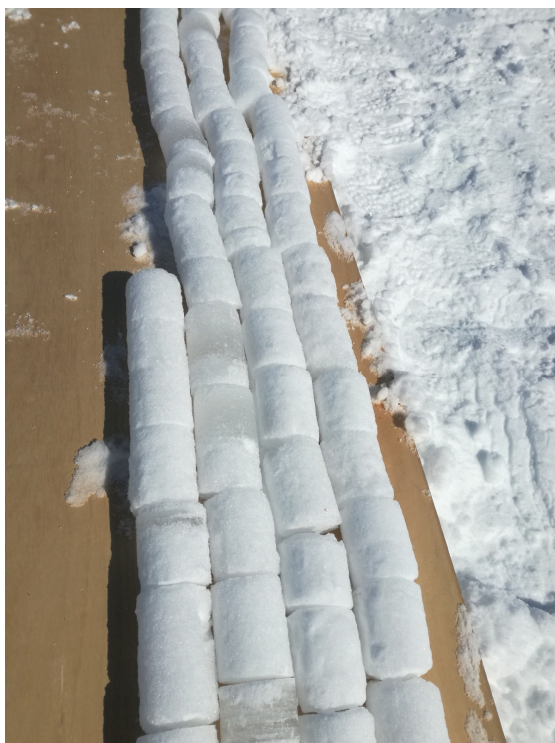
Fig. 72: snow samples for density measurement (photo credit: GEUS)

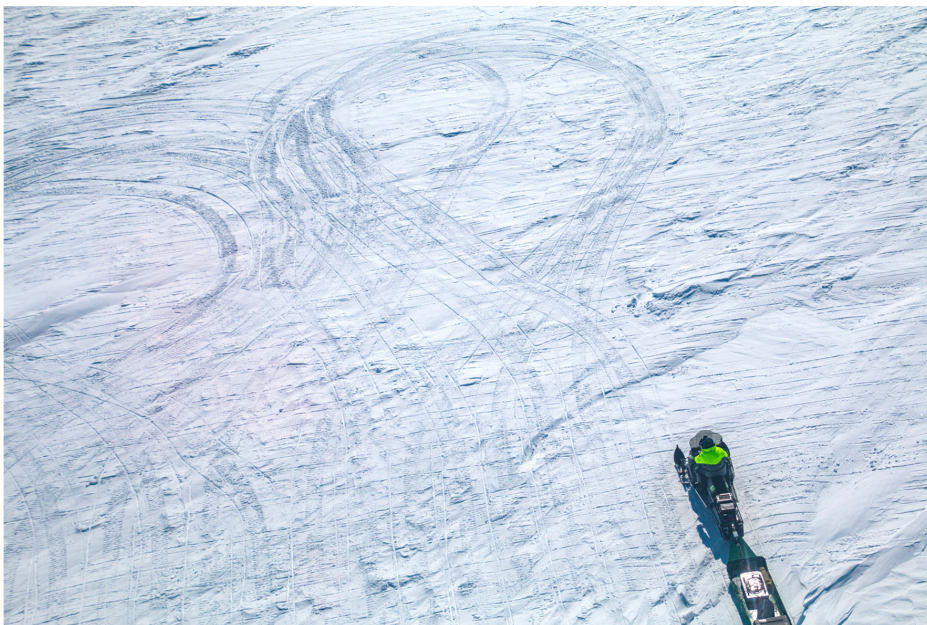
Fig. 74: dense grid scanning

At that time, given the fact that no ONERA target had been confirmed to be a piece of debris, the back office team decided to convert the ground campaign into a systematic blind search. However, also given the need for a denser radar grid than expected (see an example of dense grid scanning in Fig. 74), and given the time constraint, it was necessary to define smaller priority areas for a systematic search compared to the initial priority areas. It was clear that the initial priority areas as defined in Fig. 75 were too extensive to be completed before the end of the campaign.
