**CONTEMPORARY PRACTICES IN STAIRWAY DESIGN:
BEHAVIOR OF STAIR USERS IN PUBLIC BUILDINGS**

Karen Kim
December 2013

Master of Architecture

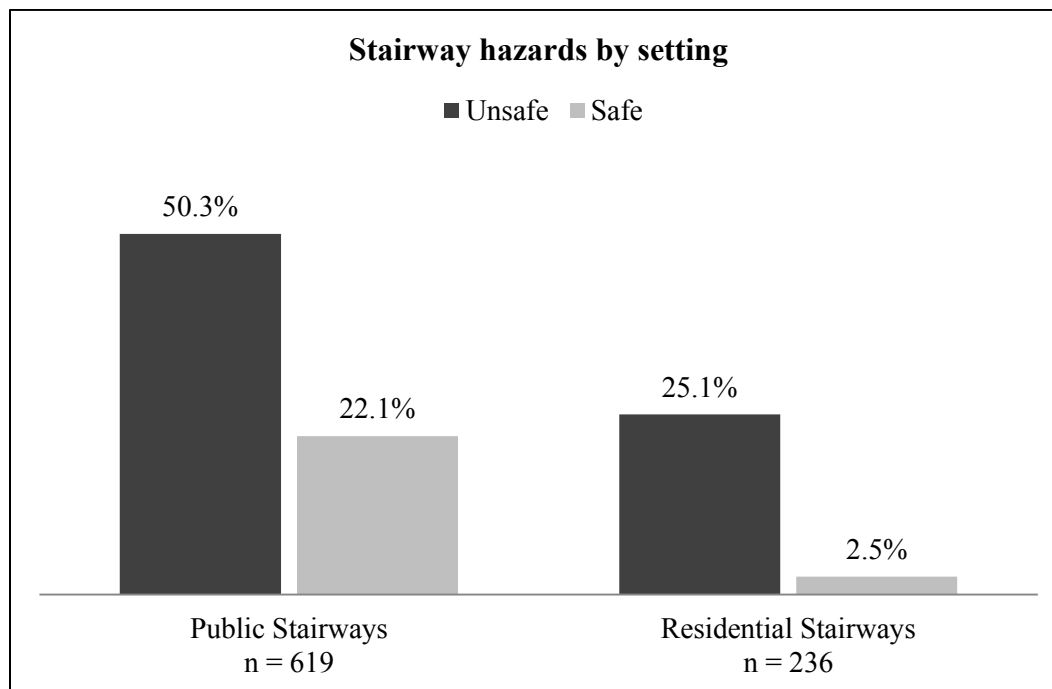
Figure 2. Stairway hazards by setting ($N = 855$ stairways).

Eight hundred fifty-five stairways were found that met the screening criteria. Of these, 72% were public stairs and 28% were residential stairs. Seventy-five percent of all stairways had at least one noticeable stairway hazard and were classified as unsafe (see Table 1). Of these, 50% were public stairs and 25% were residential stairs, which means that only 3% of residential stairs were free of visible hazards (see Figure 2). It should be noted that journals like *Architectural Record* focus primary on high-end residences.

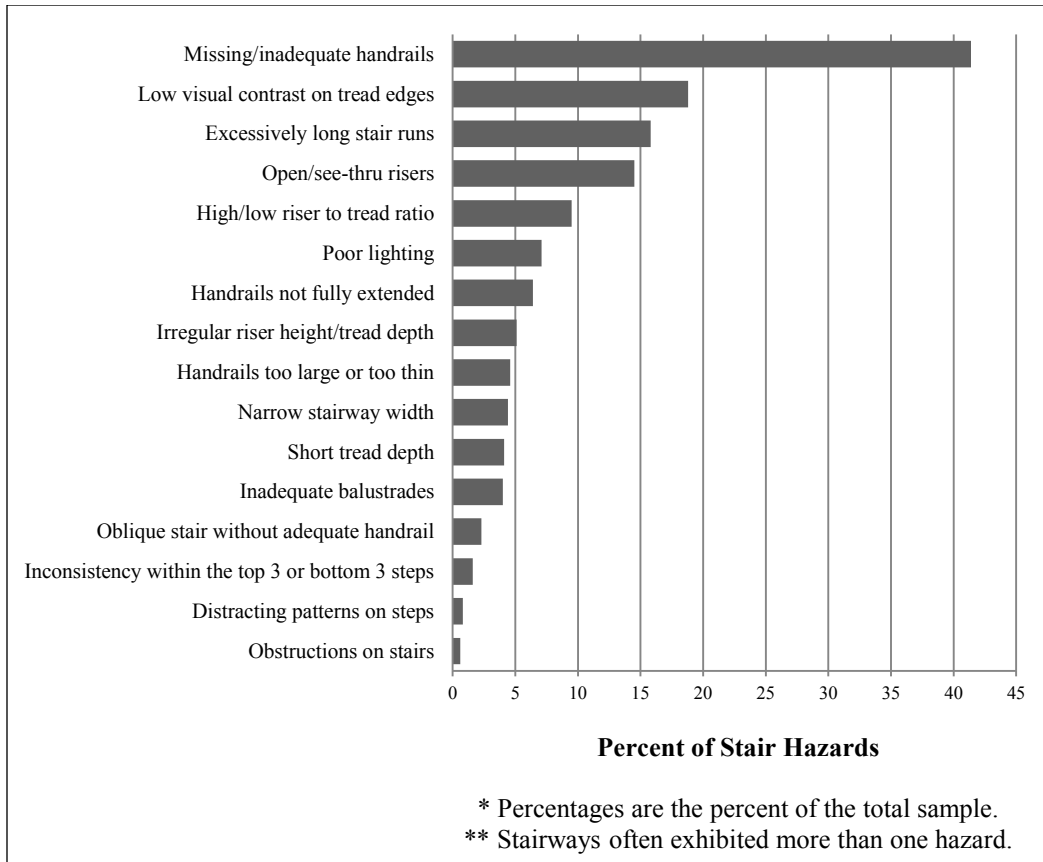
Figure 3. Most common stairway hazards in *Architectural Record* (2000-2010).

The three most common unsafe stairway design practices were missing and/or inadequate handrails (41%), low visual contrast on tread edges (19%), and excessively long stair runs (16%) (see Figure 3). While the vast majority of the stairways had one (45%) or two (31%) stairway hazards out of the sixteen that were identified for this study (see Table 3), the number of hazards should not be used as a means to rate stair safety since a misstep or a fall can occur as a result of one grievous condition or several minor hazardous conditions.

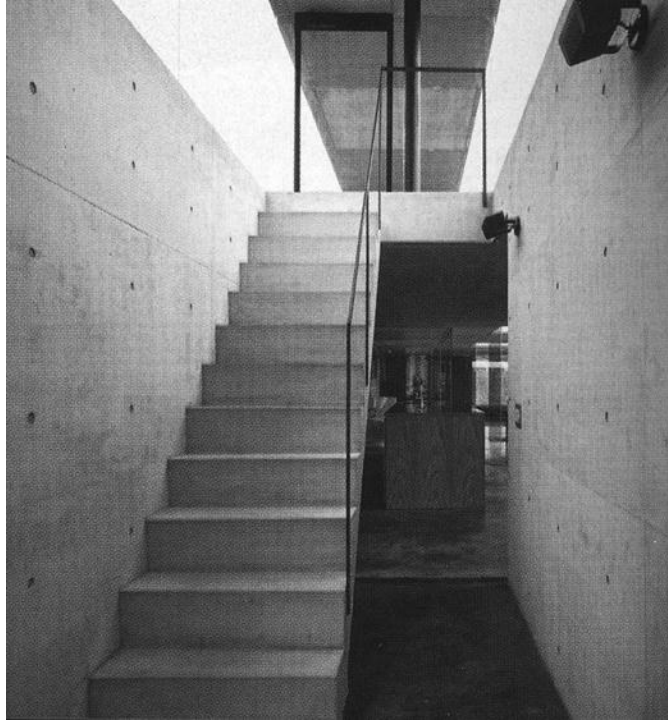
Figure 4. A stairway with a thin truncated handrail, inadequate balustrades, and low visual contrast on the tread edges (Photographer: Toshiyuki Yano).

The balustrade was missing or inadequate in 4% ($n = 34$) of the stairways. The majority of these were in homes (67%) where the practice of omitting balusters was more common, additional evidence of a stylistic preference toward minimalism. In the simplest designs, only a railing was provided with no protective balustrade. Another variation on this theme was a railing with balusters spaced several stair treads apart and large enough for a person to easily fall through. This is also seen in the stairway in Figure 4 (on page 20).

The study found that low visual contrast on tread edges was the second most unsafe stairway design practice (19%) (see Figure 4 on page 20). A stairway painted completely white is an example of many stairways in the sample that were clearly designed to

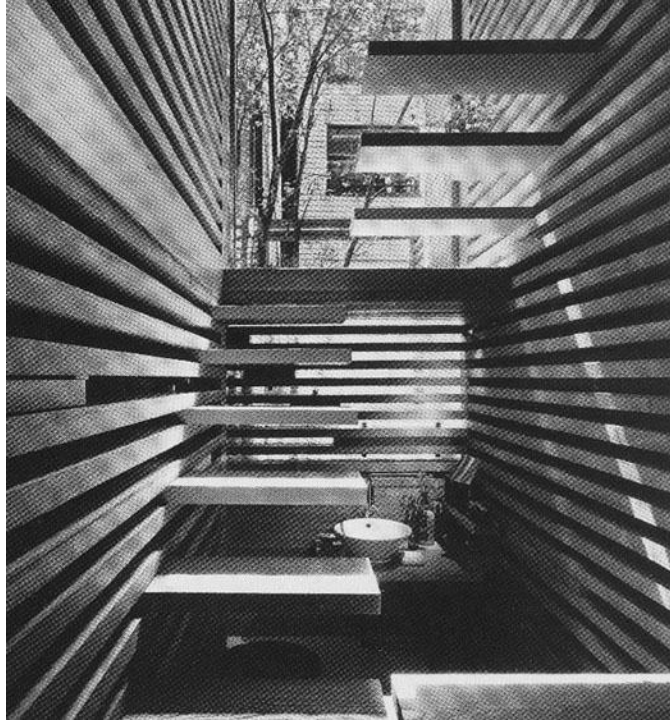
Figure 5. Visual distractions in an open riser stairway (Photographer: Kouji Okamoto / Techni Staff).

The fourth-ranked unsafe stairway design practice (14.5% or $n = 124$) was the use of open risers where visual distractions behind the stairway were likely to occur due to overstimulating views in the background as can be seen in Figure 5. Over 50% ($n = 70$) of these stairways were in residential settings where children and elderly people are especially vulnerable to slips and falls. It was noted that in many of these cases, riser openings appeared much larger than is allowed, possibly exceeding the 4 inch sphere rule.

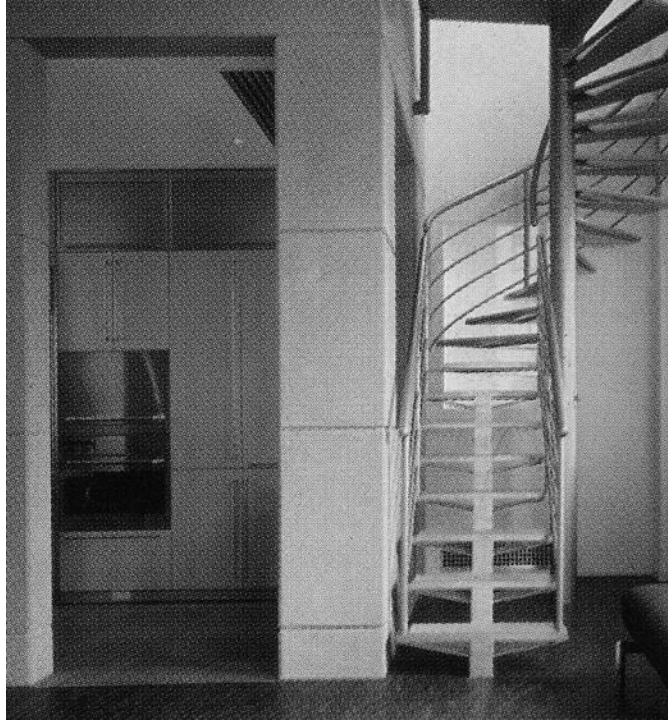
Figure 6. A narrow stairway with variation in tread size (Photographer: Michael Moran Photography).

Nearly 5% ($n = 44$) of the stairways in the sample had obvious irregularities in step geometry—17 (39%) straight flights and 27 (61%) curved flights. In this study, the use of rectangular treads in combination with winder treads was also considered a relevant hazard where other stairway design deficiencies were present, such as a narrow stairway width as seen in Figure 6. This stairway, located in a residential setting, provides a familiar environment in which people are likely to pay less attention to the changes in tread size. As with other criteria, the study was limited in that it did not actually measure risers and treads so it is probably underrepresenting the frequency of dimensional irregularities.

The study found that 4.4% ($n = 38$) of the stairways were narrow—24 (63%) of which were without handrails, and 11 (29%) had winder treads. Narrow stairways without handrails can create problems in implementing handrail retrofits in the future. For example, adding handrails to the open riser stairway in Figure 5 (on page 24) may not be possible without creating discomfort since handrails take up at least 3 inches (76 mm) on each side of the stairs (Templer, 1992), and this would reduce the effective width of the stairs even more. A narrow stairway width in spiral configurations forces the user closer to the inside radius where the tread becomes too small for safe walking, as seen previously in Figure 6.

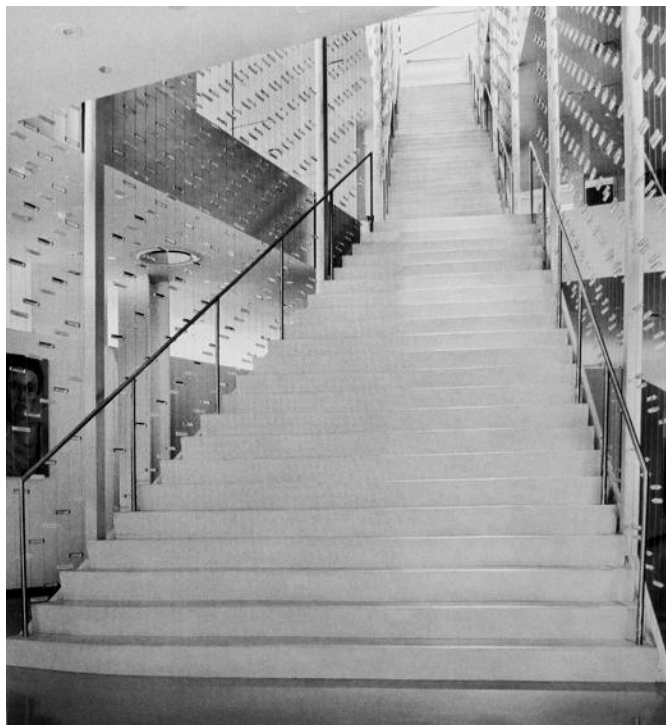
Figure 7. A stairway with an excessive stair run length (Photographer: Elizabeth Felicella).

The study found that excessive stair run length was the third most unsafe stairway design practice (15.8% or $n = 135$). In designing the criteria, the study limited the number of risers to fifteen for an acceptably safe stairway, and therefore stairways exceeding the criteria were deemed excessively long and unsafe such as the one shown in Figure 7, which has a total of twenty two risers.

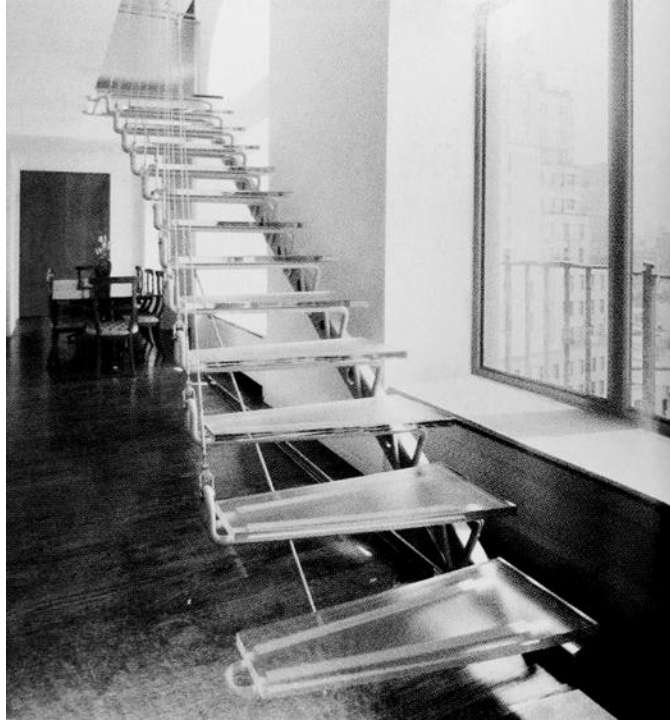
Figure 8. A stairway with glass treads (Photographer: Roy Wright Photography, Inc.).

New technologies allow the use of unusual materials for stair treads. Glass, in particular, was identified in this study as a growing practice ($n = 21$ or 2%) that reduces visibility of the tread edge (see Figure 8). Although nonslip treatments are available for glass used as a walking surface, where users are likely to track water in during bad weather, these treatments may not be adequate. Research is needed to determine if glass is a safety hazard due to camouflage of tread edges or reduced friction between shoes and treads, especially under wet conditions.

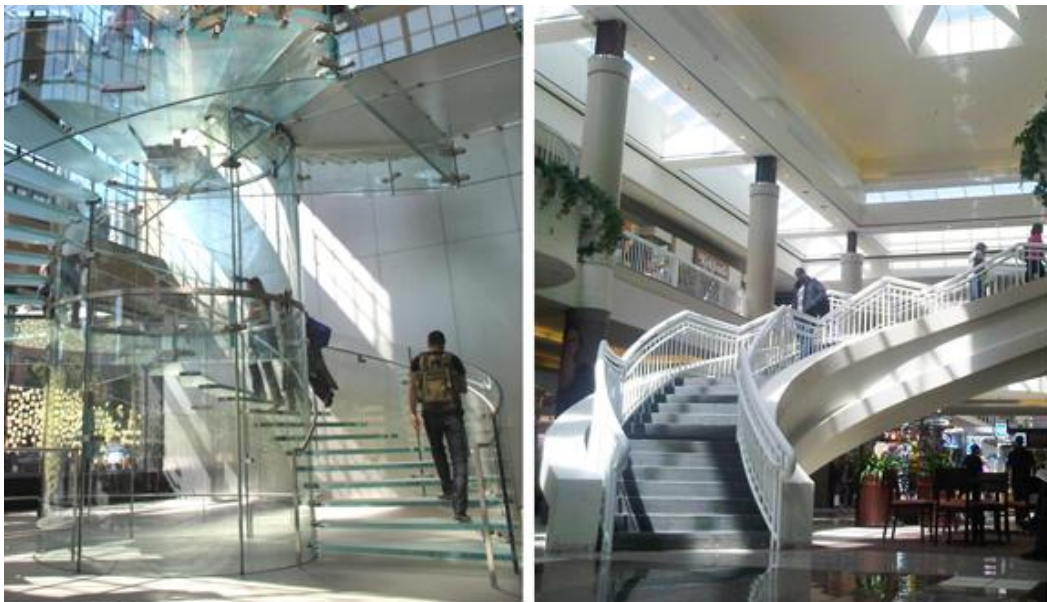
Figure 9. Selected stairway sites for cross-site comparison of stair use: glass stairway at an Apple Retail Store (left) and a conventional stairway at a shopping mall (right).

Another winding public stairway at a shopping mall in the Buffalo area was identified for the study. This stairway was constructed in a conventional manner and was used as the comparison site (see Figure 9).

Selection of the comparison site was based on the winding stair configuration, presence of views from the stairs, prominent location of the stairs, and high frequencies of use, which are conditions similar to those in the Apple store. Both stairways are open to the

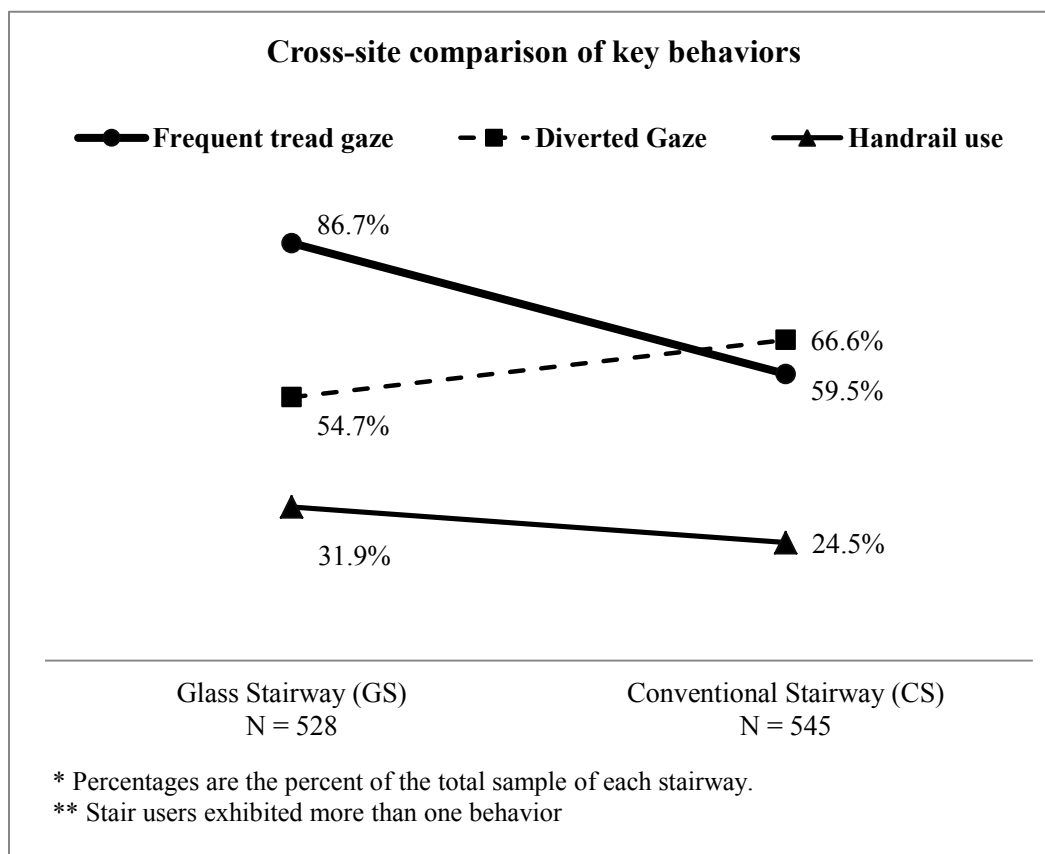
Figure 11. Cross-site comparison of key behaviors.

Handrail use was generally infrequent in both stairways, but higher in the glass stairway (GS: 32% vs. CS: 25%) (see Figure 11). This supports research findings that handrail use is often minimal (Templer, 1992; Cohen & Cohen, 2001). Finally, it was noted that 1.5% (8) of stair users in the glass stairway descended to their left side where the treads were wider. This was clearly a cautionary behavior. The study did not find any significant patterns in typical user behaviors (talking, using electronic devices, and carrying things).

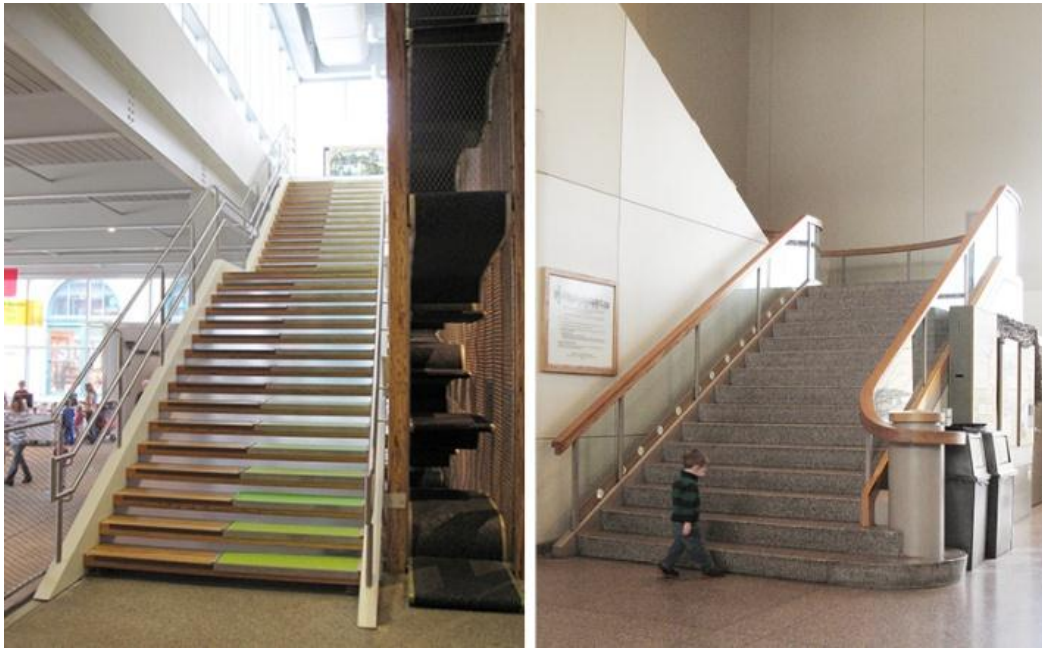
Figure 12. Interactive stairways at a Children's Museum (left) and a Science Museum (right).

Two interactive stairways, one at the Children's Museum of Pittsburgh (CM) and one at the Science Museum in Boston (SM), were selected as the sites for observations (see Figure 12). One other public stairway at the University at Buffalo Student Union (SU) was identified as the comparison site.

The Children's Museum stairway (CM) was equipped with sensor stair pads made of vinyl composition tile in green color that activate sounds of children's voices from speakers when pressure is applied to the surface. The stair pad system was installed only on one side of the stairway, for the right-side ascending path, and does not stretch across the entire stair width. This results in an uneven tread surface and a trip hazard along the middle of the stairway. This stairway has sixteen risers per flight, two flights of stairs, and handrails for both adults and children in a relatively enclosed space that obscures surrounding views (see Table 7).

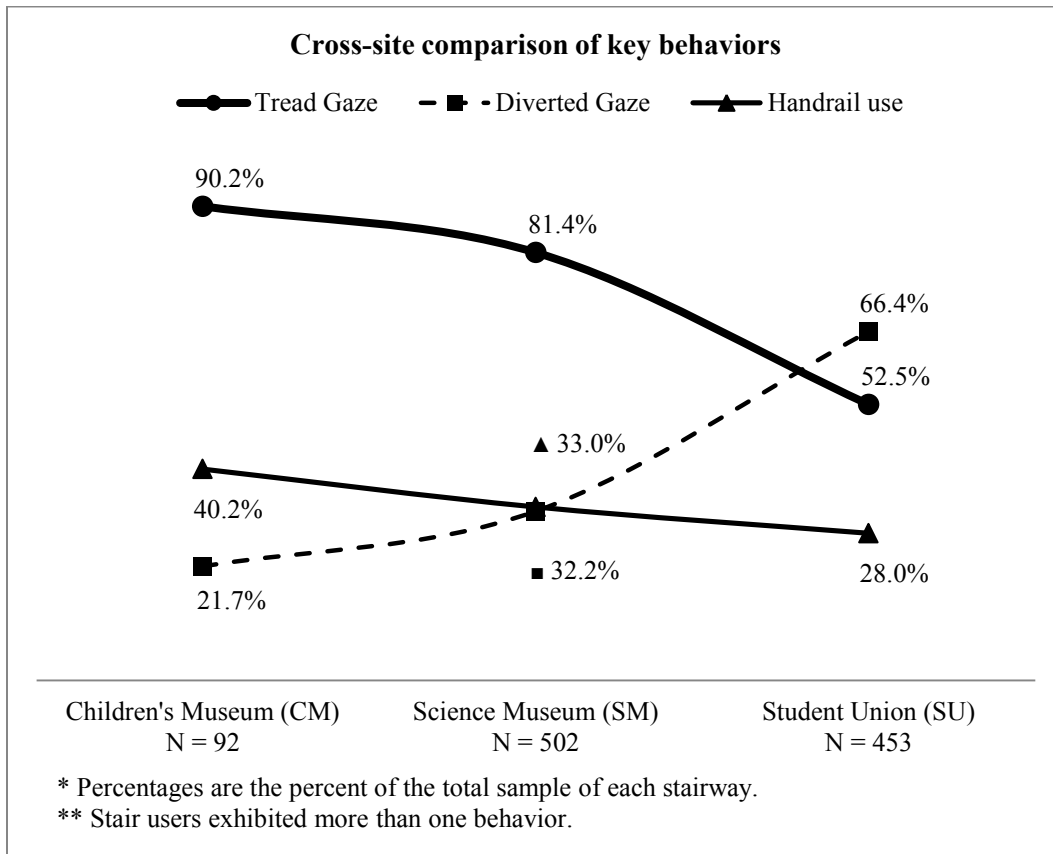
Figure 14. Cross-site comparison of key behaviors.

On the interactive stairways, more stair users glanced down at the interactive steps than the conventional steps (CM: 90%, SM: 81% vs. SU: 53%) (see Figure 14). It was noted that frequent tread gaze was involved in most of the stair incidents in the museum buildings (CM: 100% or $n = 2$, SM: 82% or $n = 9$) compared to 42% (5) of the incidents that occurred in the conventional stairway; in the Student Union, incidents were more associated with infrequent tread gaze (58%).

Fewer stair users diverted their gaze away from the stairs (CM: 22%, SM: 32% vs. SU: 66%) (see Figure 14). When returning attention to the stairway, users may have a tendency to re-orient themselves by glancing at the stairs. It was noted that diverted gaze was involved in fewer stair incidents in the museum buildings (CM: 50% or $n = 1$, SM: 36% or $n = 4$), and it was involved in almost every stair incident in the Student Union (92% or $n = 11$).

Handrail use was highest in the Children's Museum and lowest in the Student Union (CM: 40% vs. SM: 33%, SU: 28%) (see Figure 14). The rate of handrail use in the conventional stairway supports research findings that handrail use is often minimal (Templer, 1992; Cohen & Cohen, 2001). The results support the hypothesis that stair users would display more compensatory behavior by looking at the tread more and less at the surrounding environment, and by using the handrail more. The study did not find any significant patterns among age groups as well as in typical user behaviors (talking, using electronic devices, and carrying things).

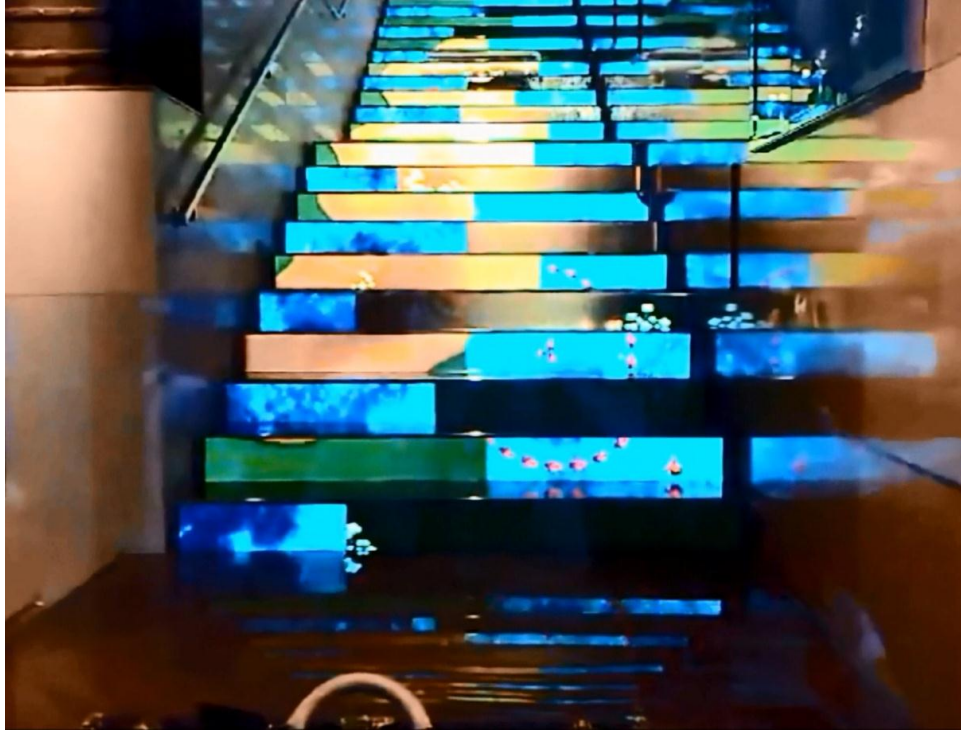
Figure 15. A stairway with LED color displays on stair risers (Source: YouTube user heinv, retrieved from [youtube.com/watch?v=uGEGyaxV9SU](https://www.youtube.com/watch?v=uGEGyaxV9SU))

It should be noted that there are interactive stairway designs that are much more dangerous than those studied. For example, LED color displays (see Figure 15) and, at the Albright-Knox Art Gallery in Buffalo, NY, a stairway was turned into an art piece by

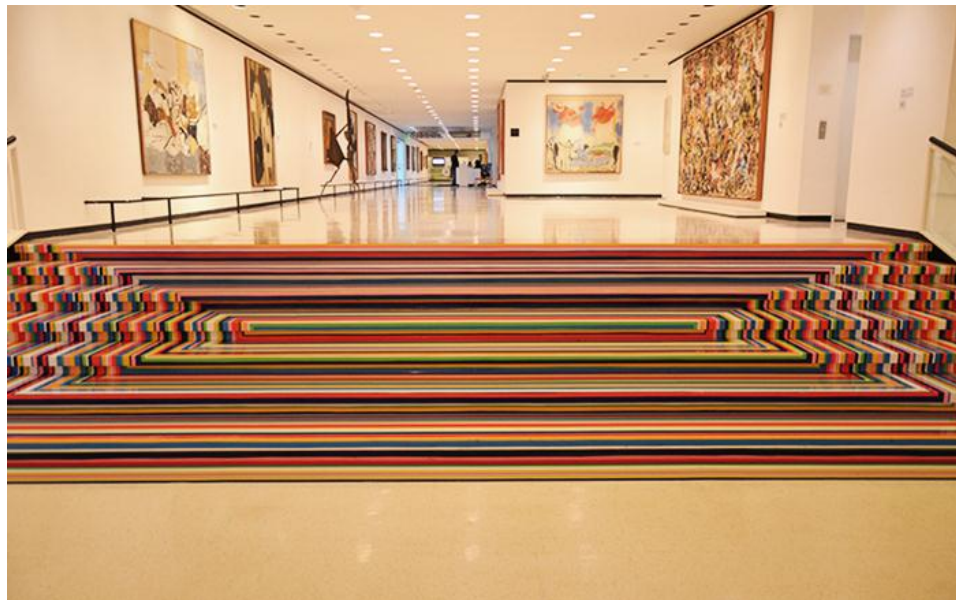
Figure 16. A stairway with confusing tread pattern at the Albright-Knox Art Gallery (Source: M. Frederick)

painting it with a striped design that creates optic effects in the manner of Op Art, making it literally impossible to see the edges of the treads (see Figure 16). Additional research in this area could be very beneficial to identify what is dangerous and what is not, but education for museum administrators is also needed to acquaint them with the potential hazards and how to suitably protect people from exposure to risk, e.g. use of signs, barriers and do's and don'ts.
