U.S. Fire Administration/Technical Report Series

The East Bay Hills Fire

Oakland-Berkeley, California

USFA-TR-060/October 1991

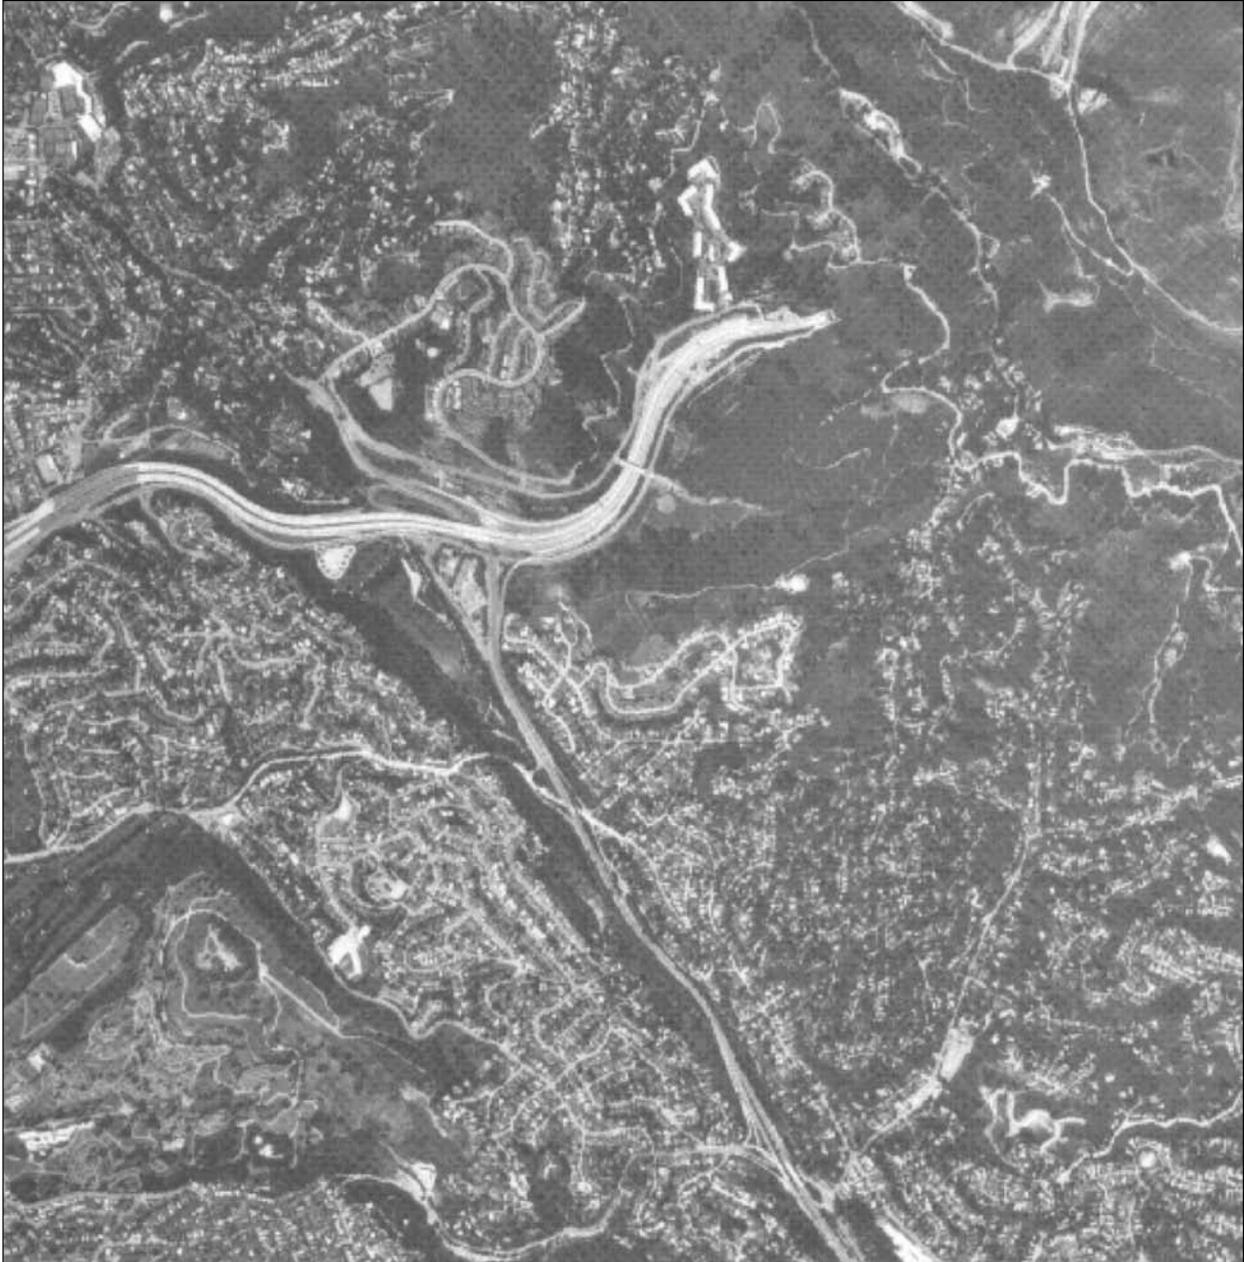
This is an aerial photograph of the East Bay Hills area taken before the fire. By comparing it with the map on page 3 the reader will be able to identify the Hiller Highlands, the Parkwood Apartments, Lake Temescal, the Claremont Hotel, and major roads. A similar photograph, taken after the fire, appears on page 64.

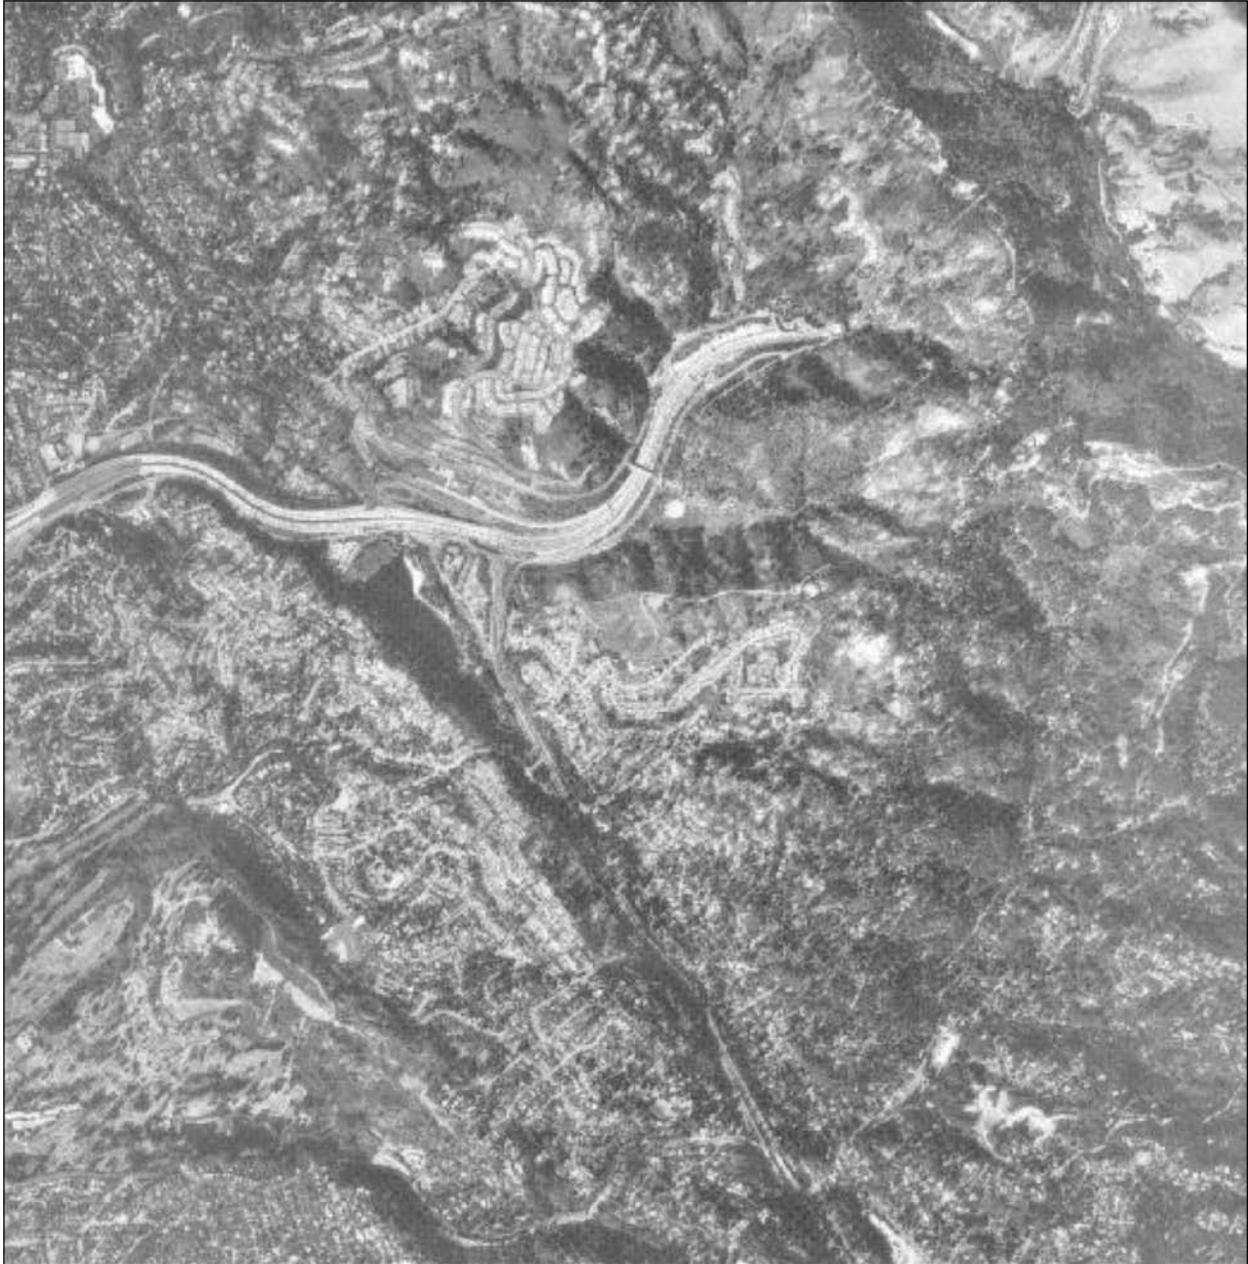
**Aerial photograph taken after the fire. Area shown is the same as on page 9.
In total, 3,354 structures were destroyed.**

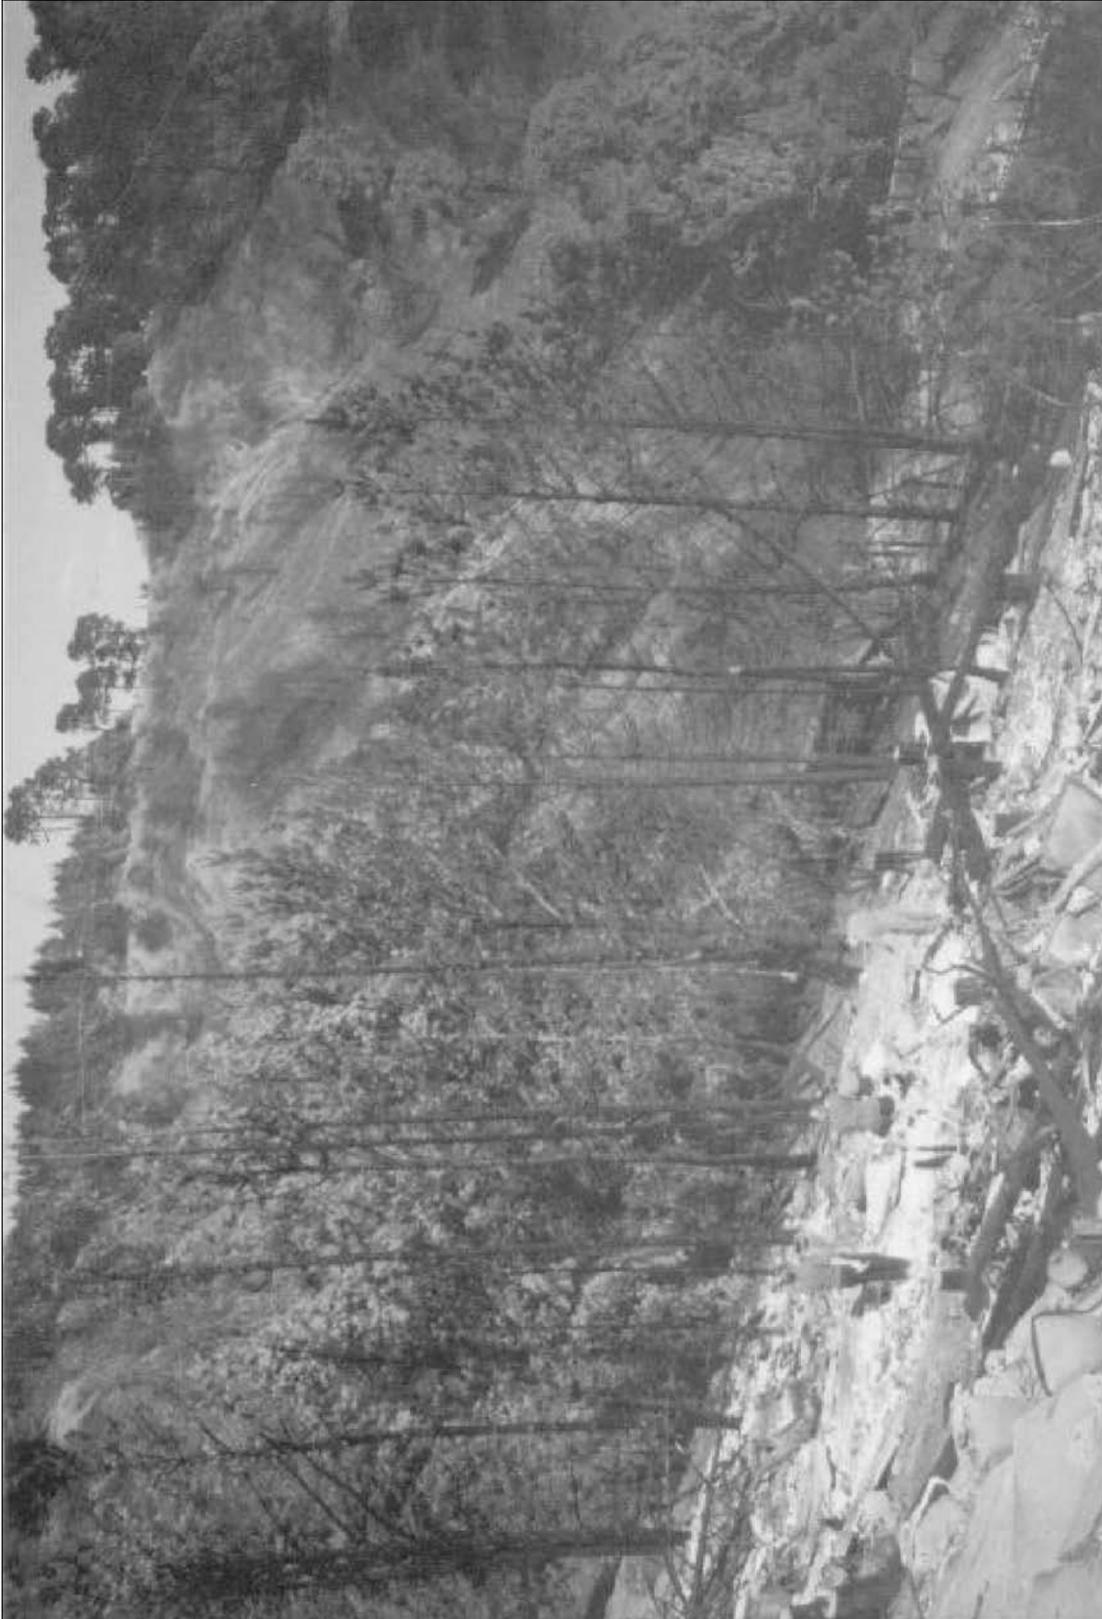
View looking toward the area of fire origin – on the grassy slope in the background. The left flank of the fire spread laterally behind the homes on Buckingham Boulevard and up toward the area in the foreground.

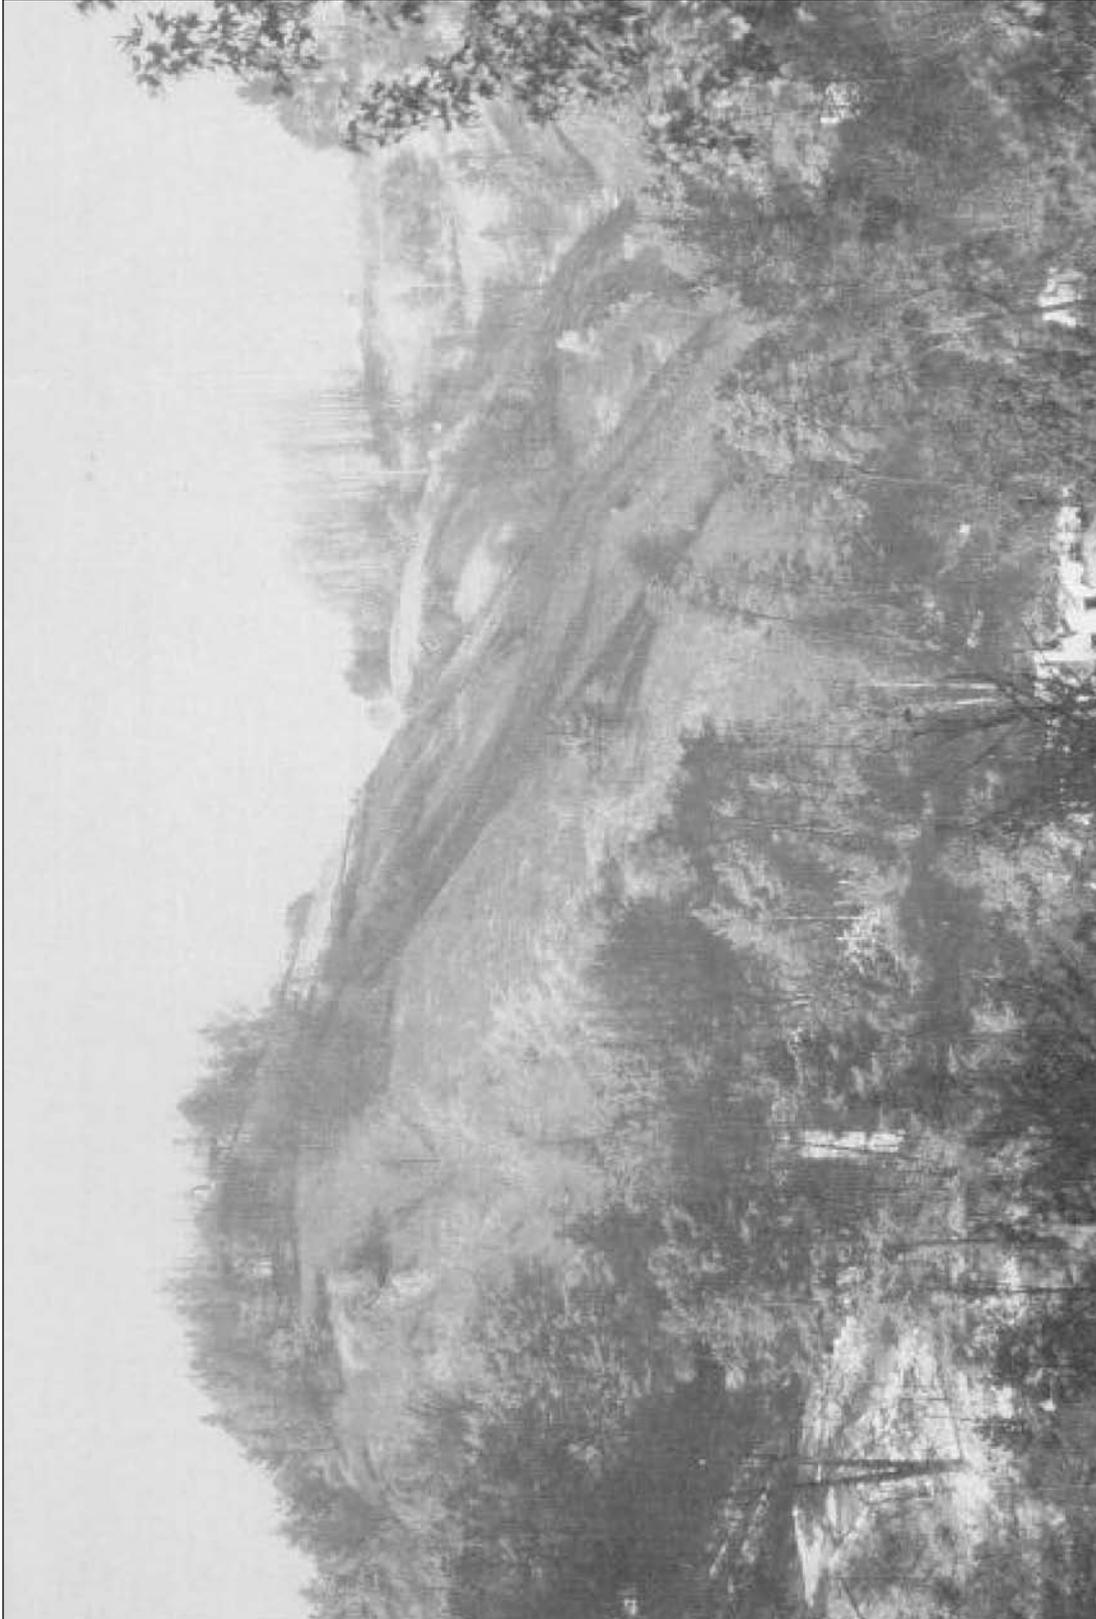
View of the area of fire origin as seen from the Parkwood Apartments. The Saturday fire burned up the grassy slope on the hills toward Marlborough Terrace and the radio tower on Grizzly Peak. The fire on Sunday broke out in the lower part of the original burn area.

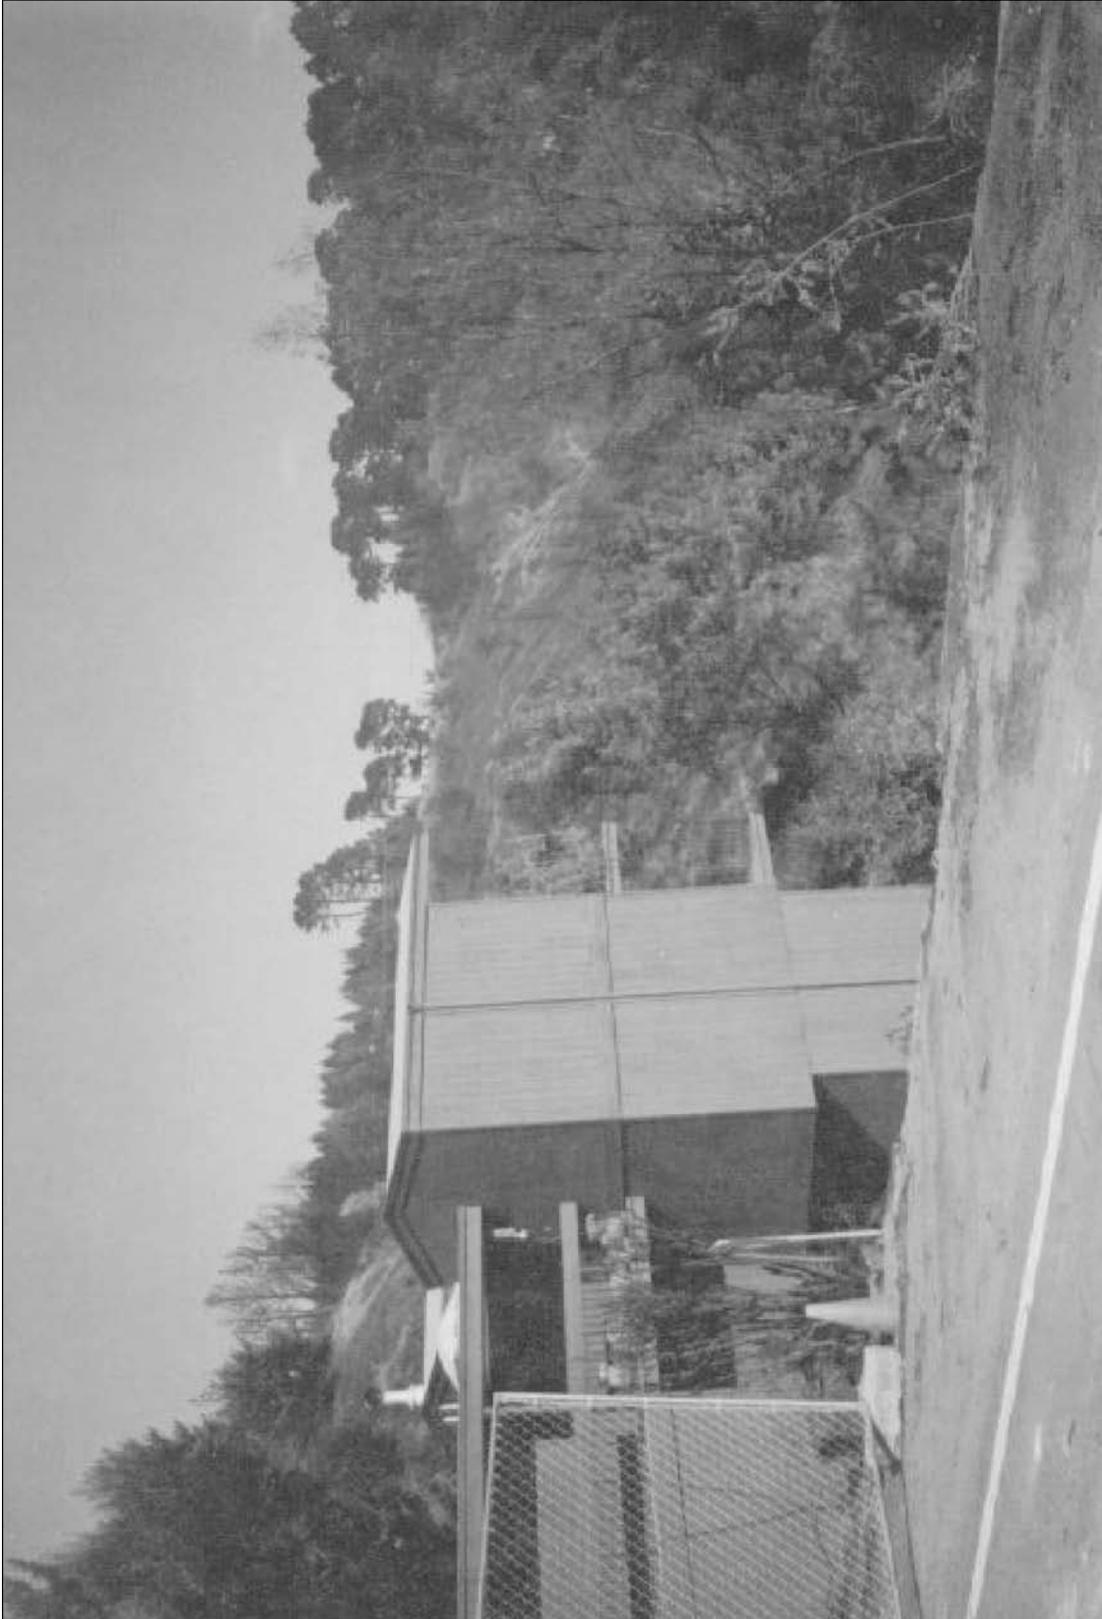
One of the few homes on Marlborough Terrace that was not destroyed by the fire. Houses on both sides burned to the ground.

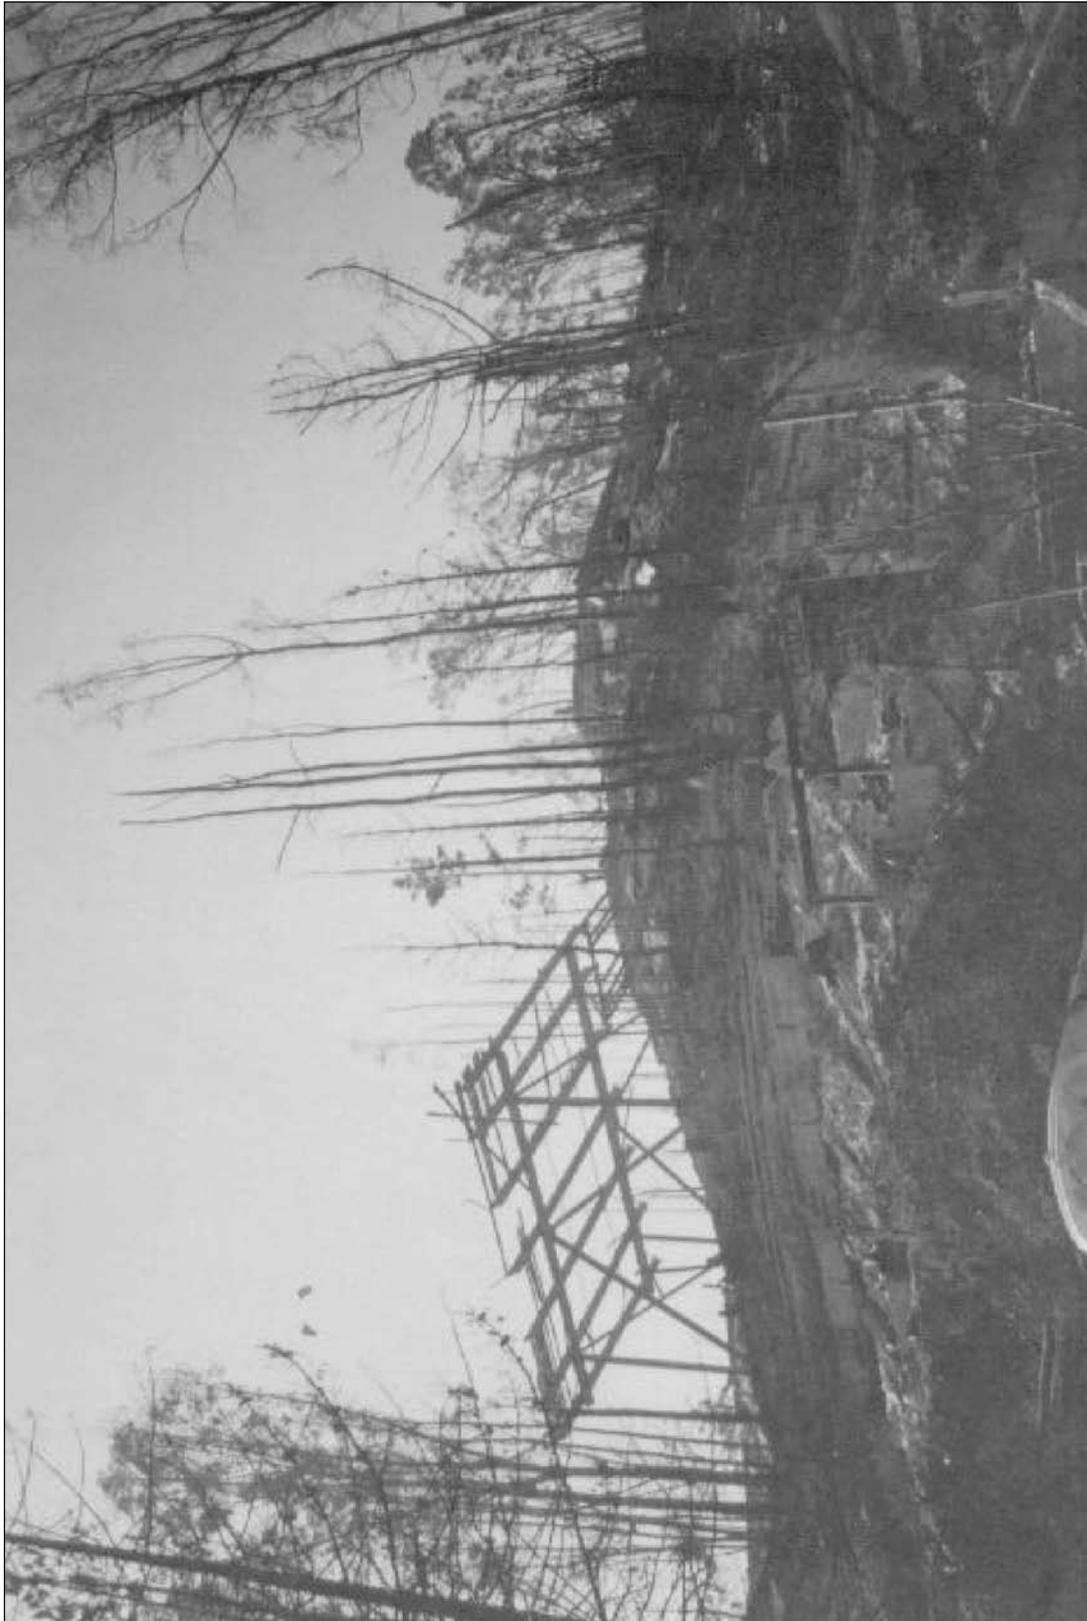
All that remains of one hillside home is the steel supporting structure for the main floor.

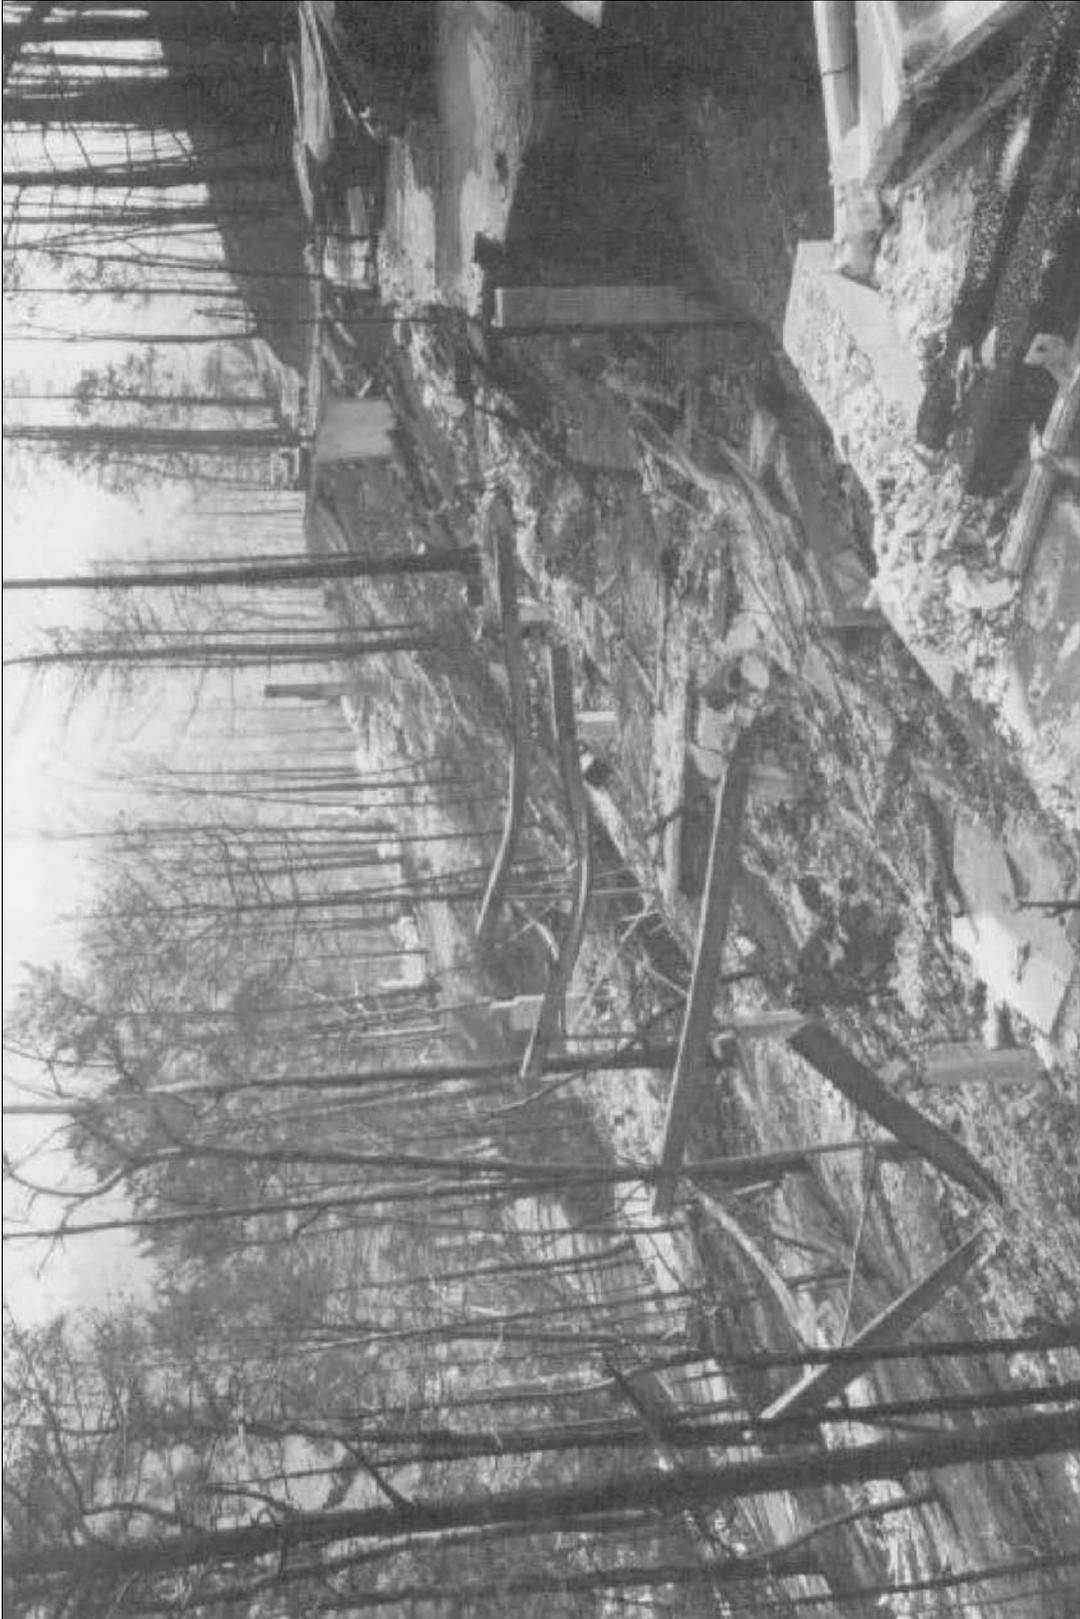
Buckled steel beams mark the location of a destroyed home on Buckingham Boulevard.

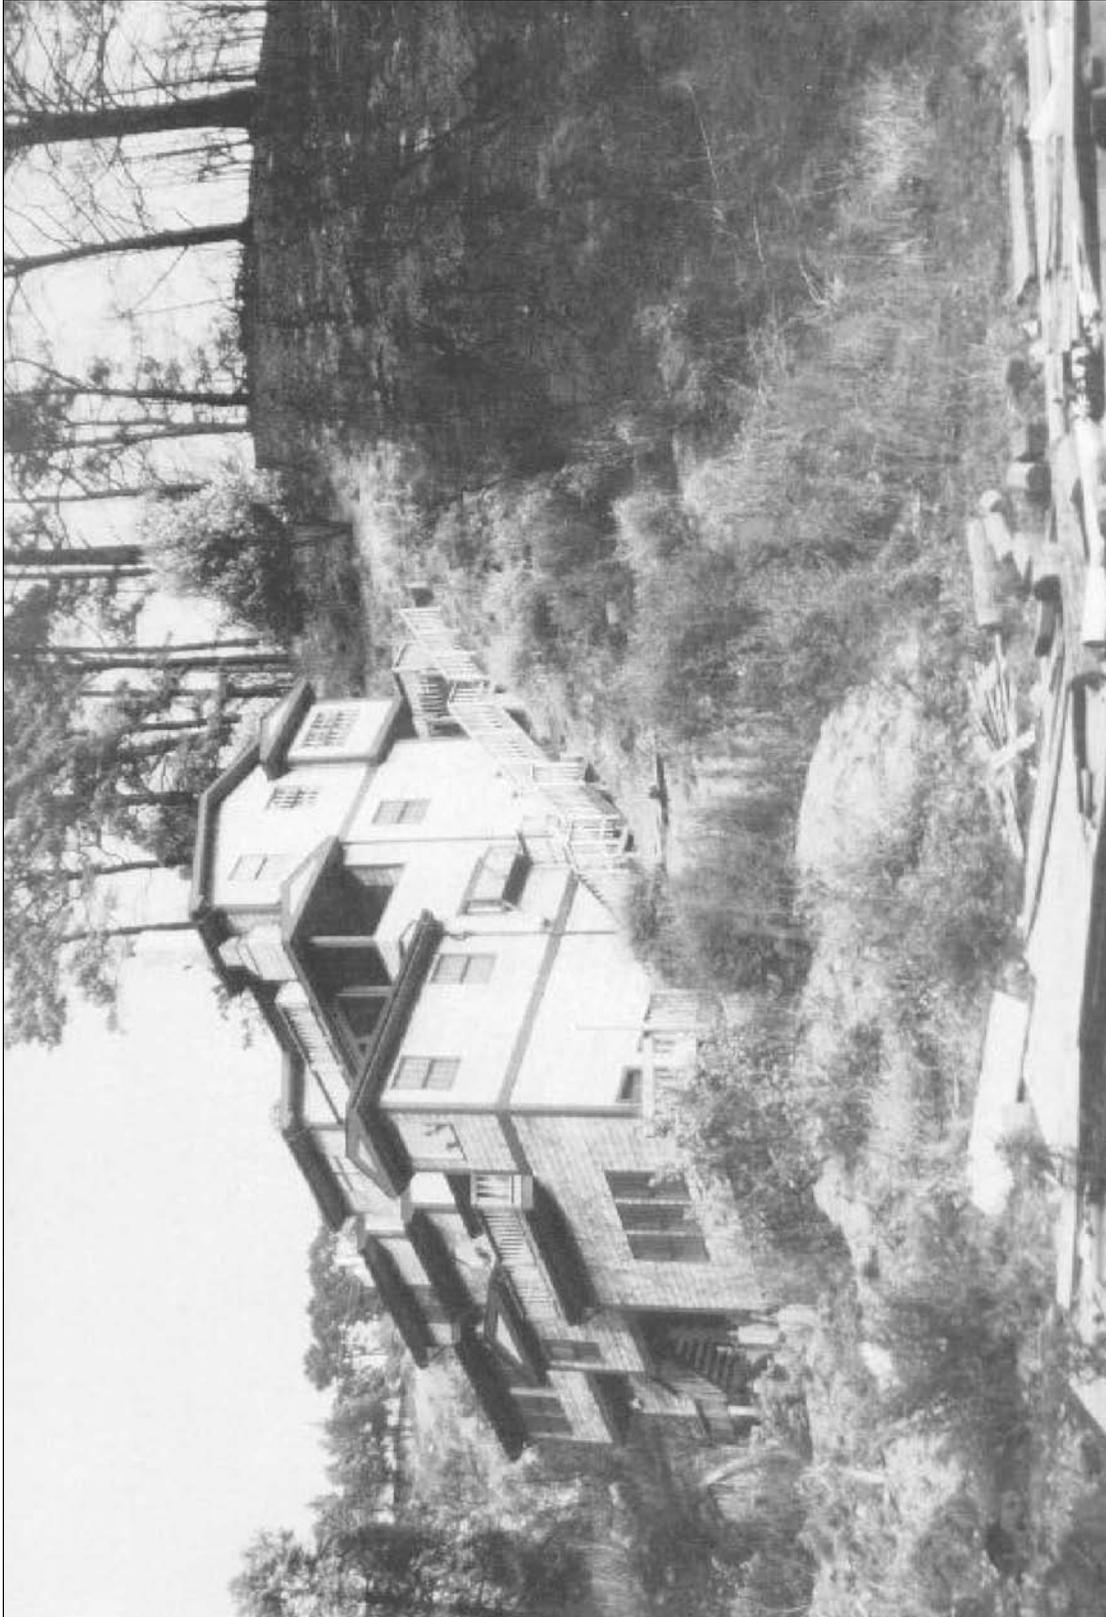
One of the few surviving structures on Buckingham Boulevard, near the area of fire origin. This is the house where firefighters and residents took refuge, using all available water flow to protect the surface as the fire front passed over.

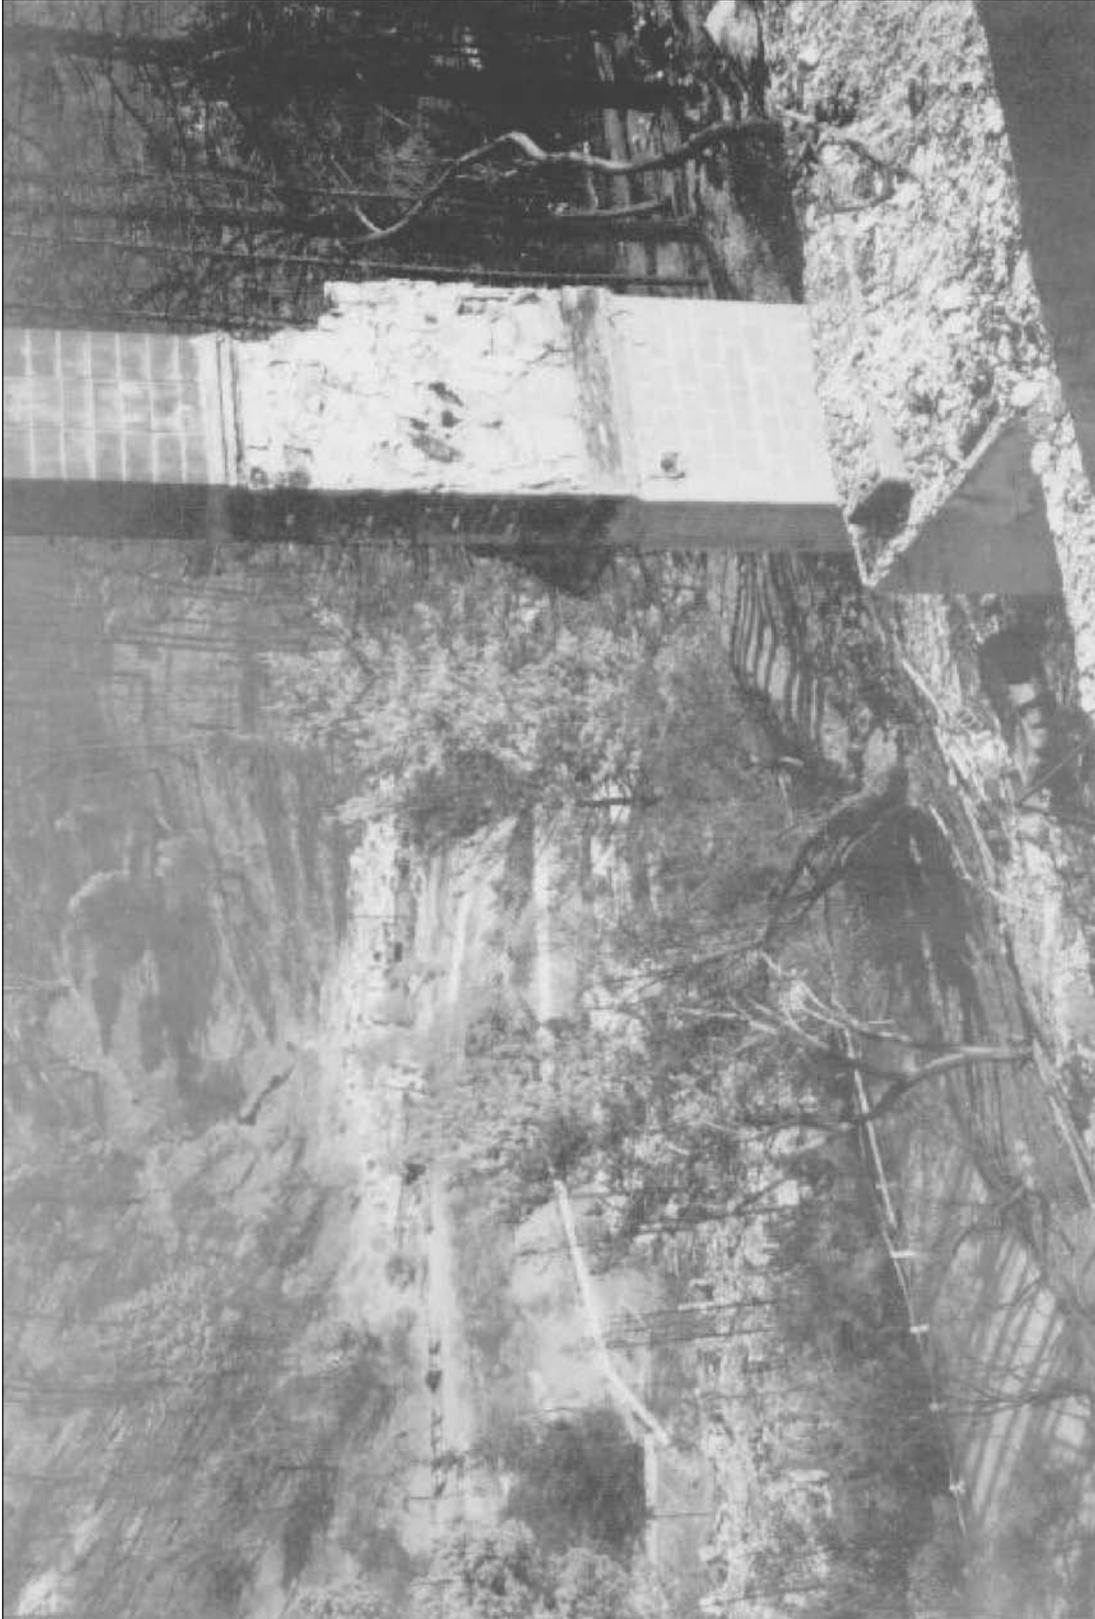
Looking down on the ruins of the Parkwood Apartments from Buckingham Boulevard. Tunnel Road is visible in the lower left corner.

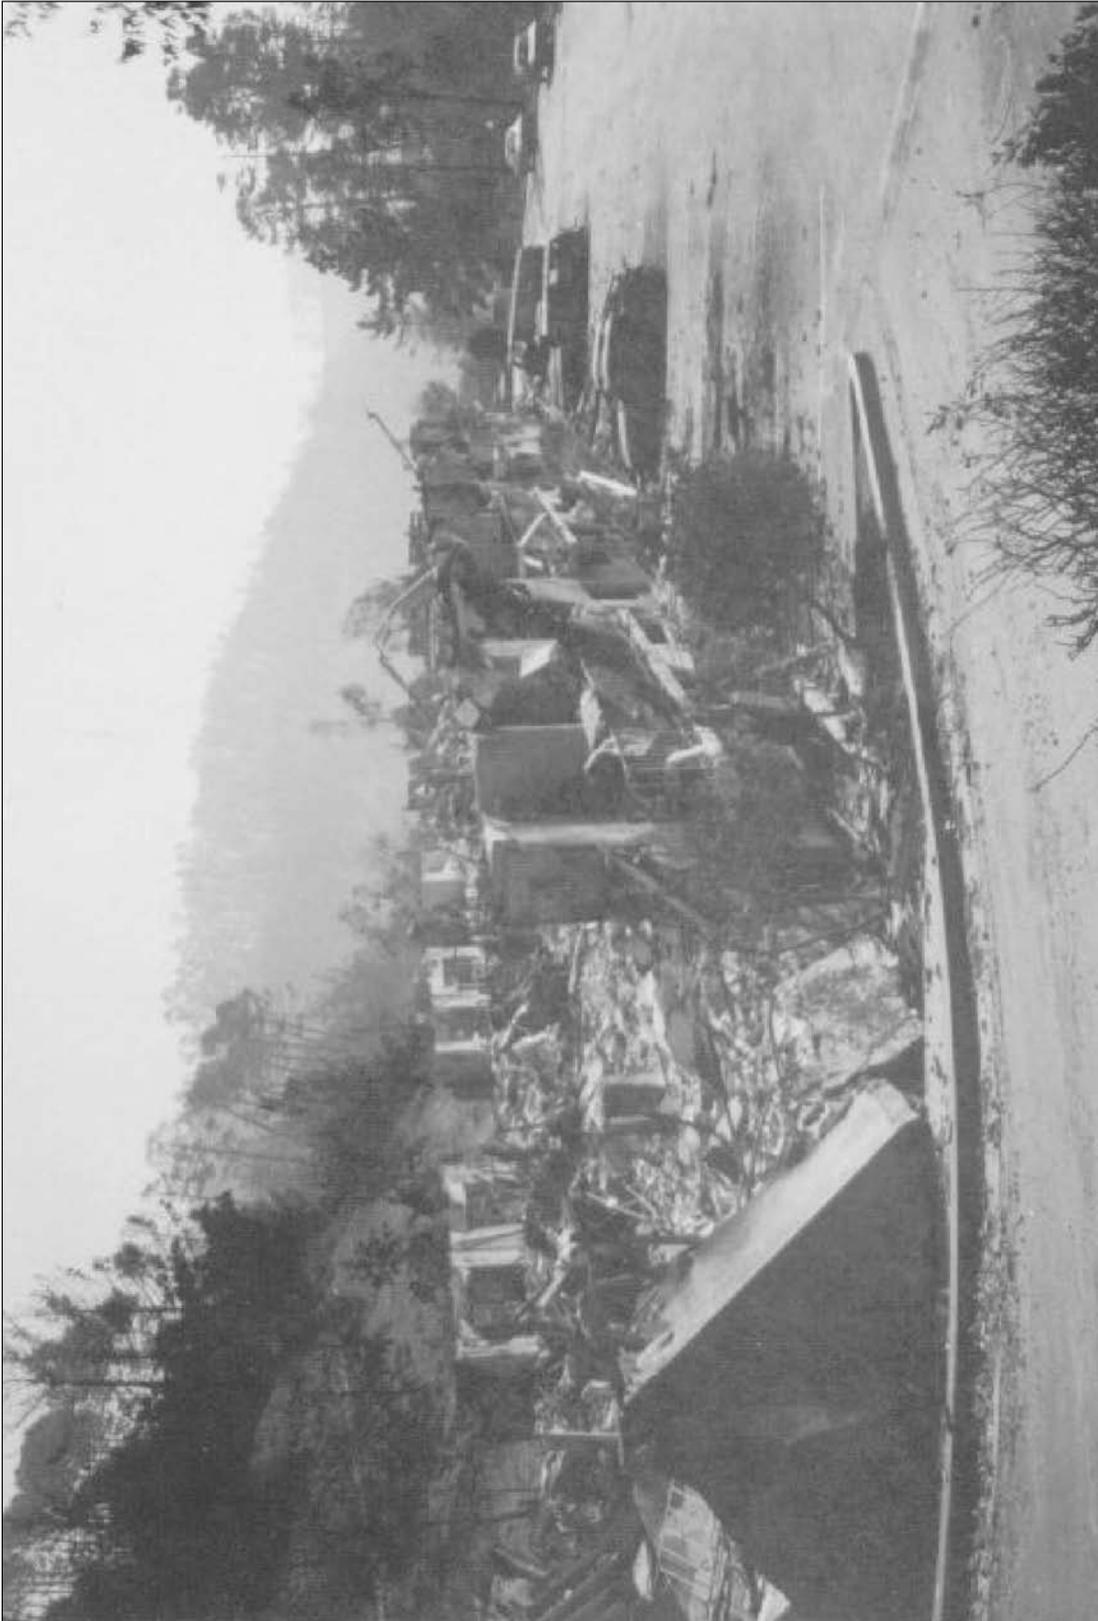
Ruins of the Parkwood Apartments; previously four-story buildings.

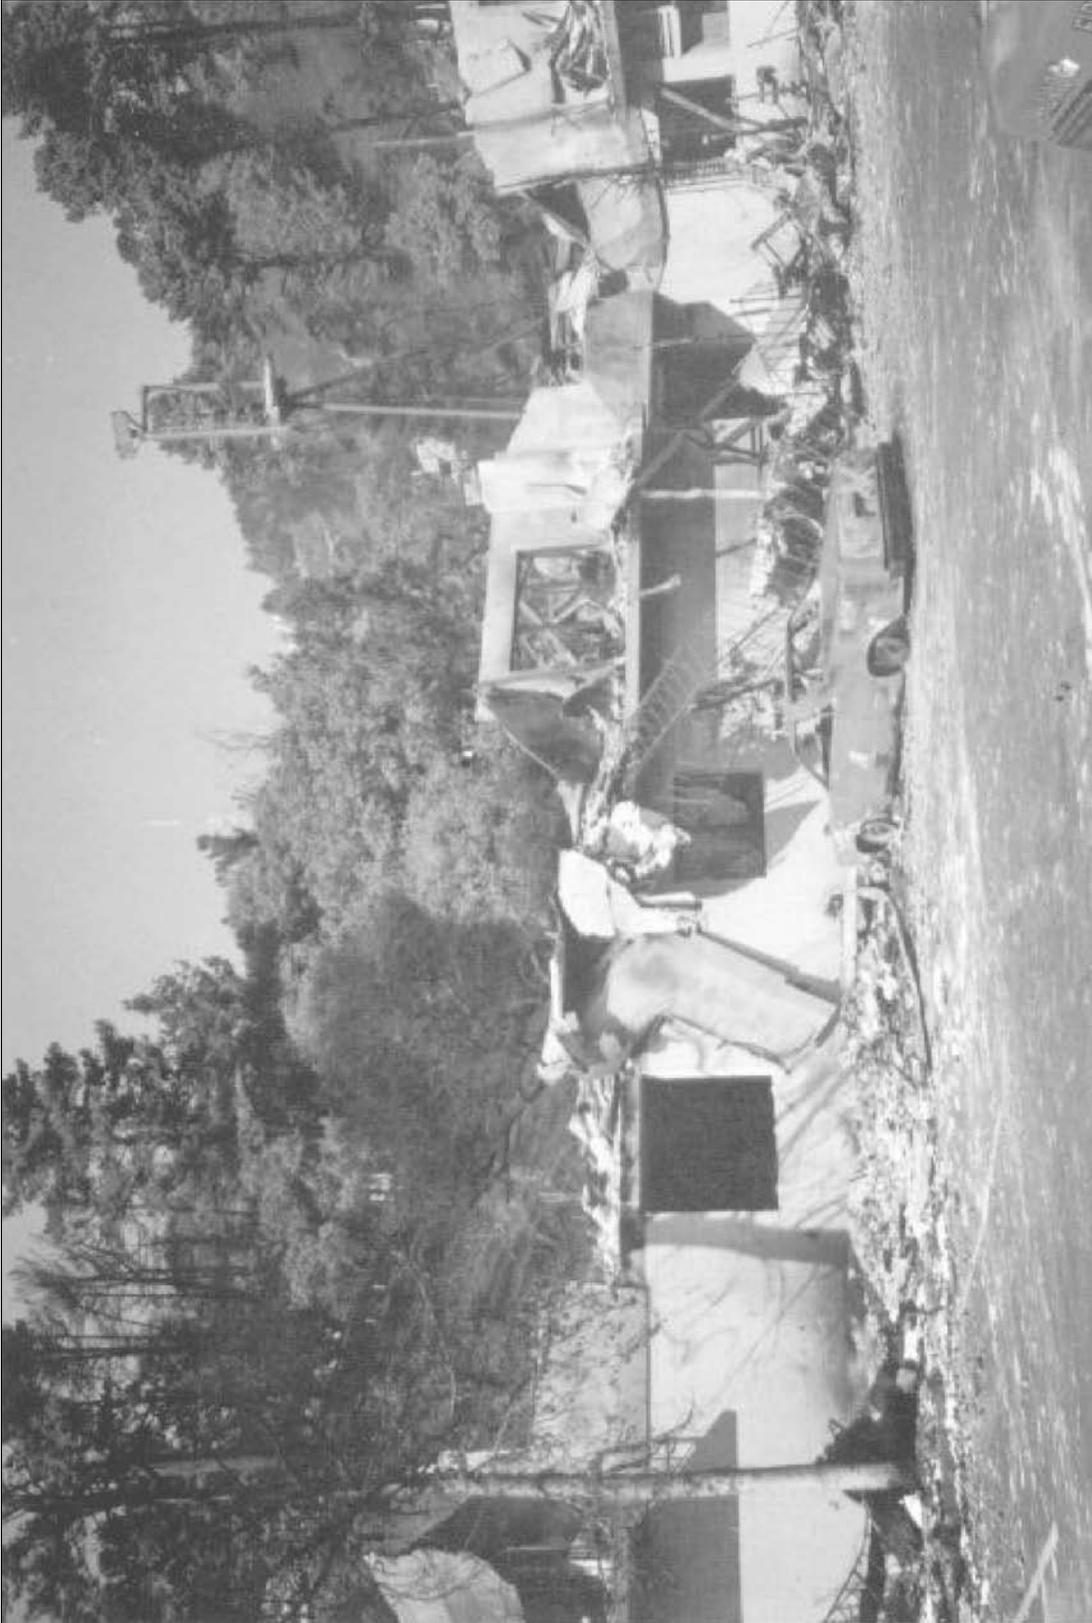
Ruins of the Parkwood Apartments; previously four-story buildings.

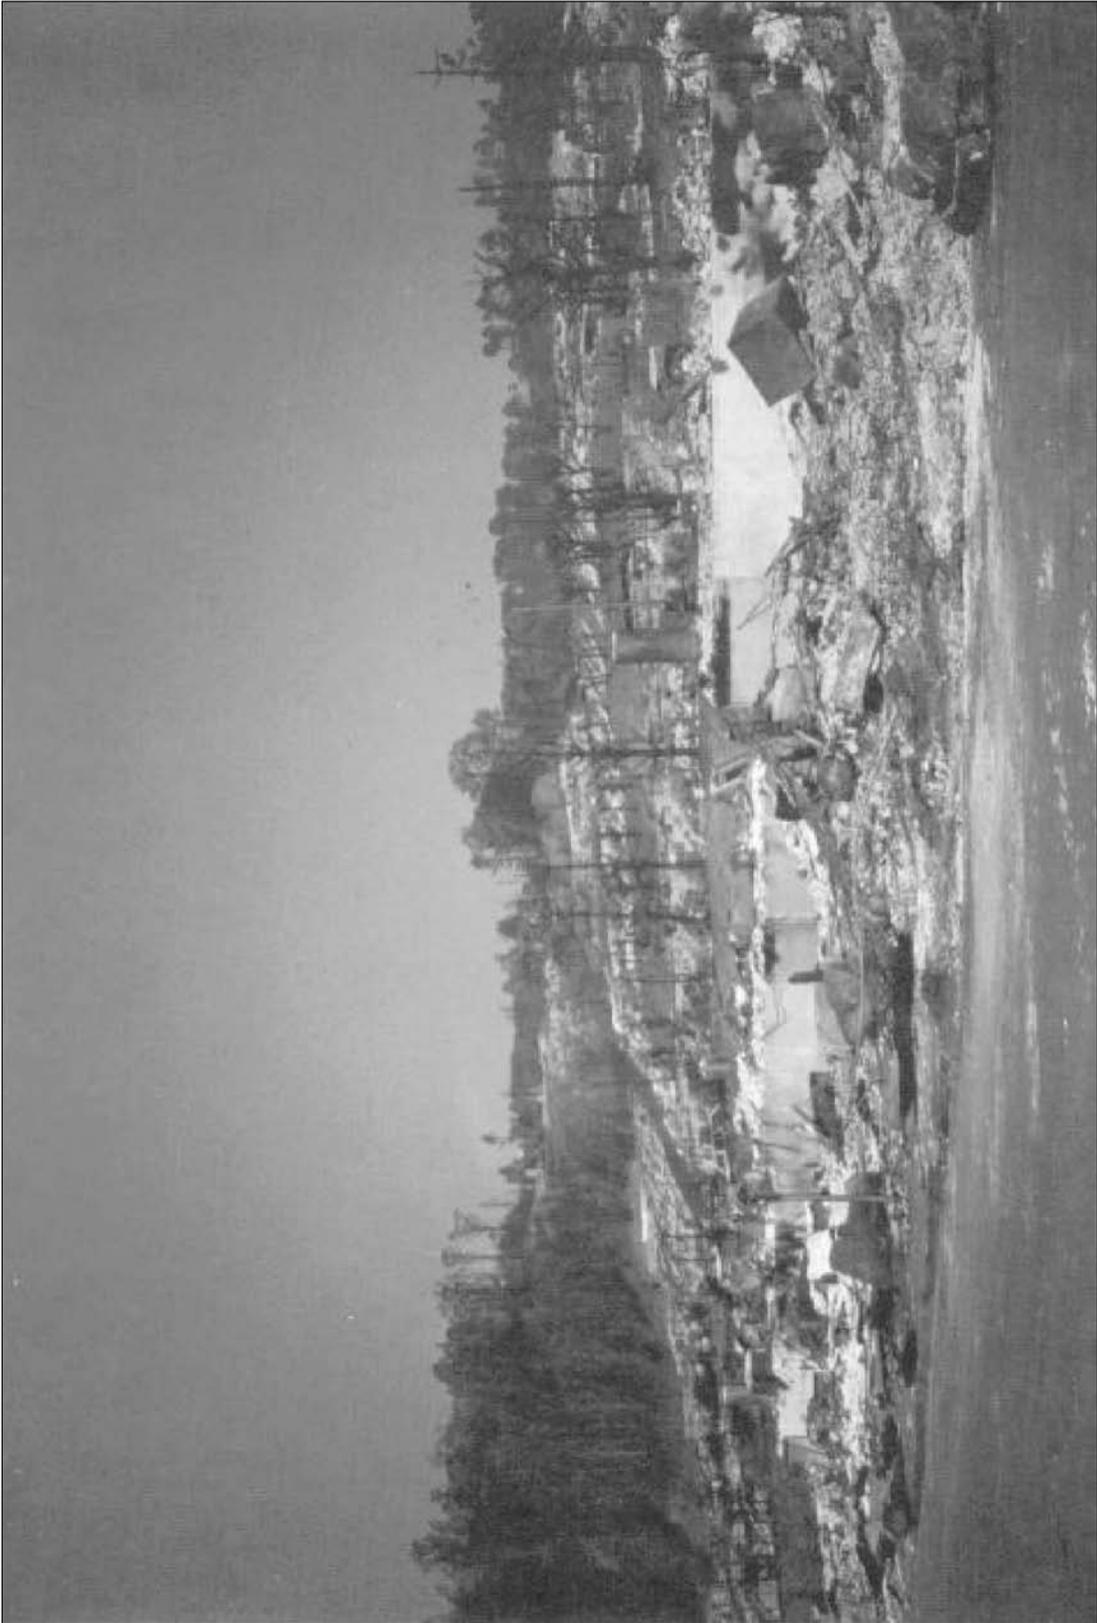
Total destruction of Hiller Highlands complex.

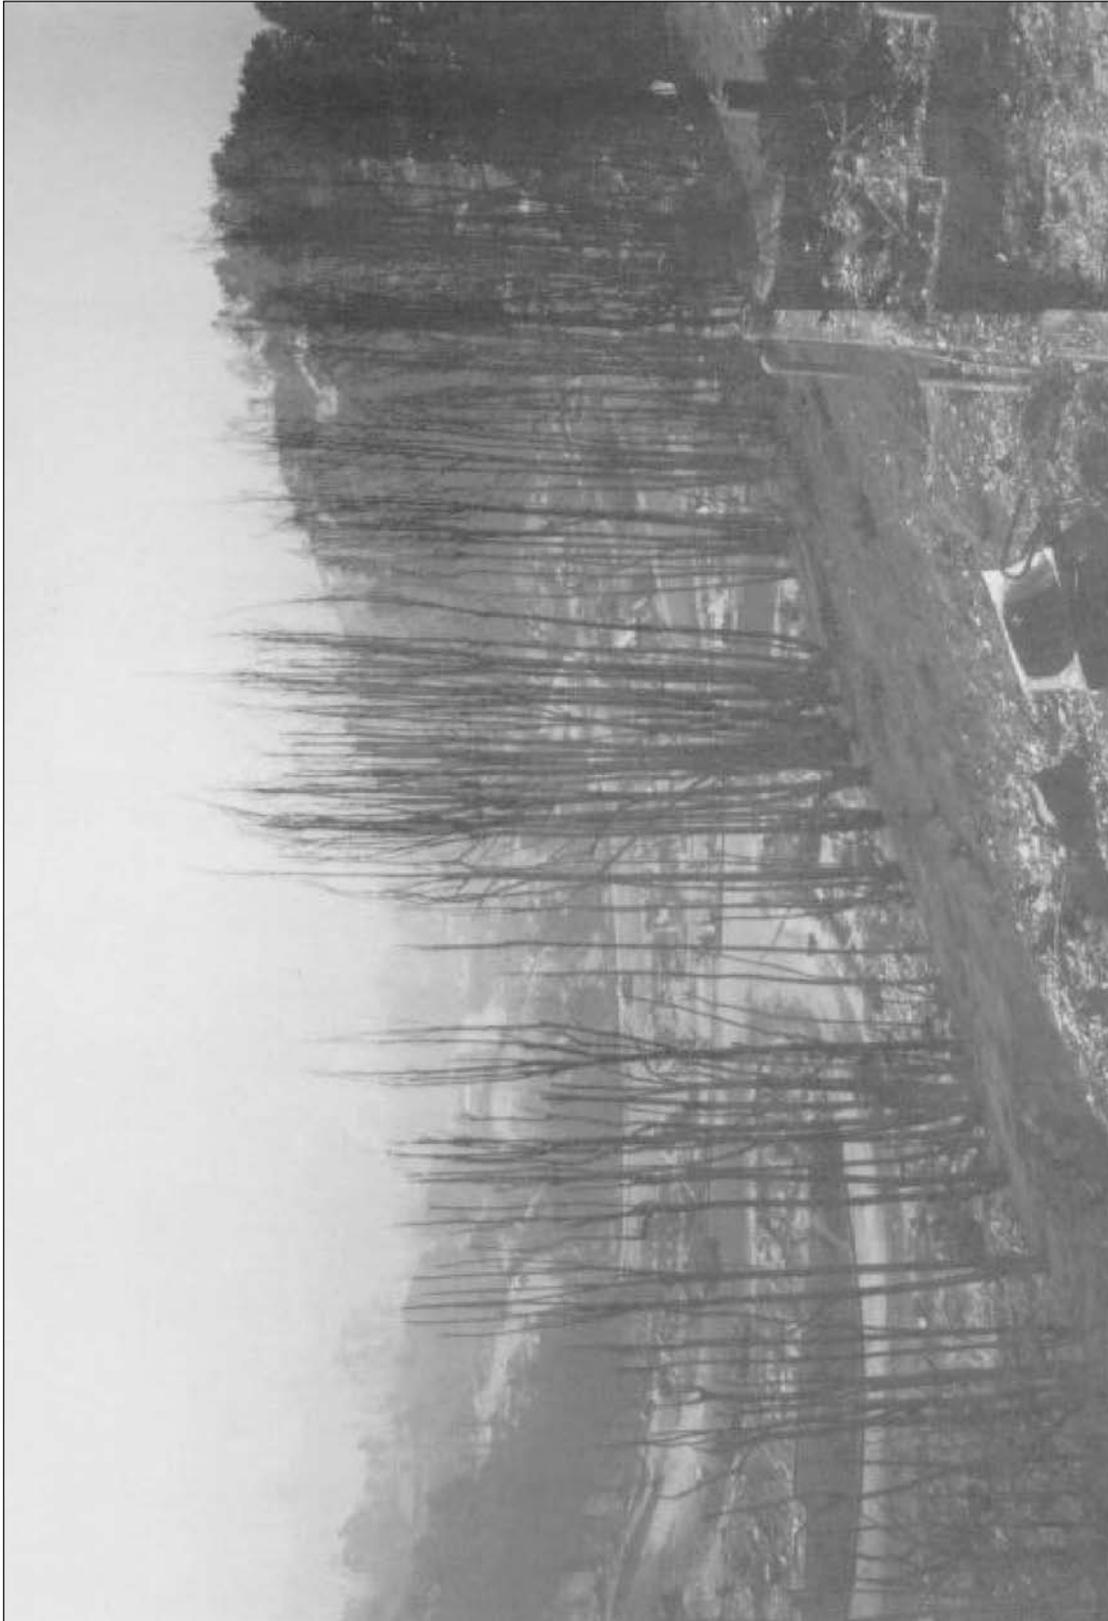
Total destruction of Hiller Highlands complex.
