U.S. Fire Administration/Technical Report Series

The East Bay Hills Fire

Oakland-Berkeley, California

USFA-TR-060/October 1991

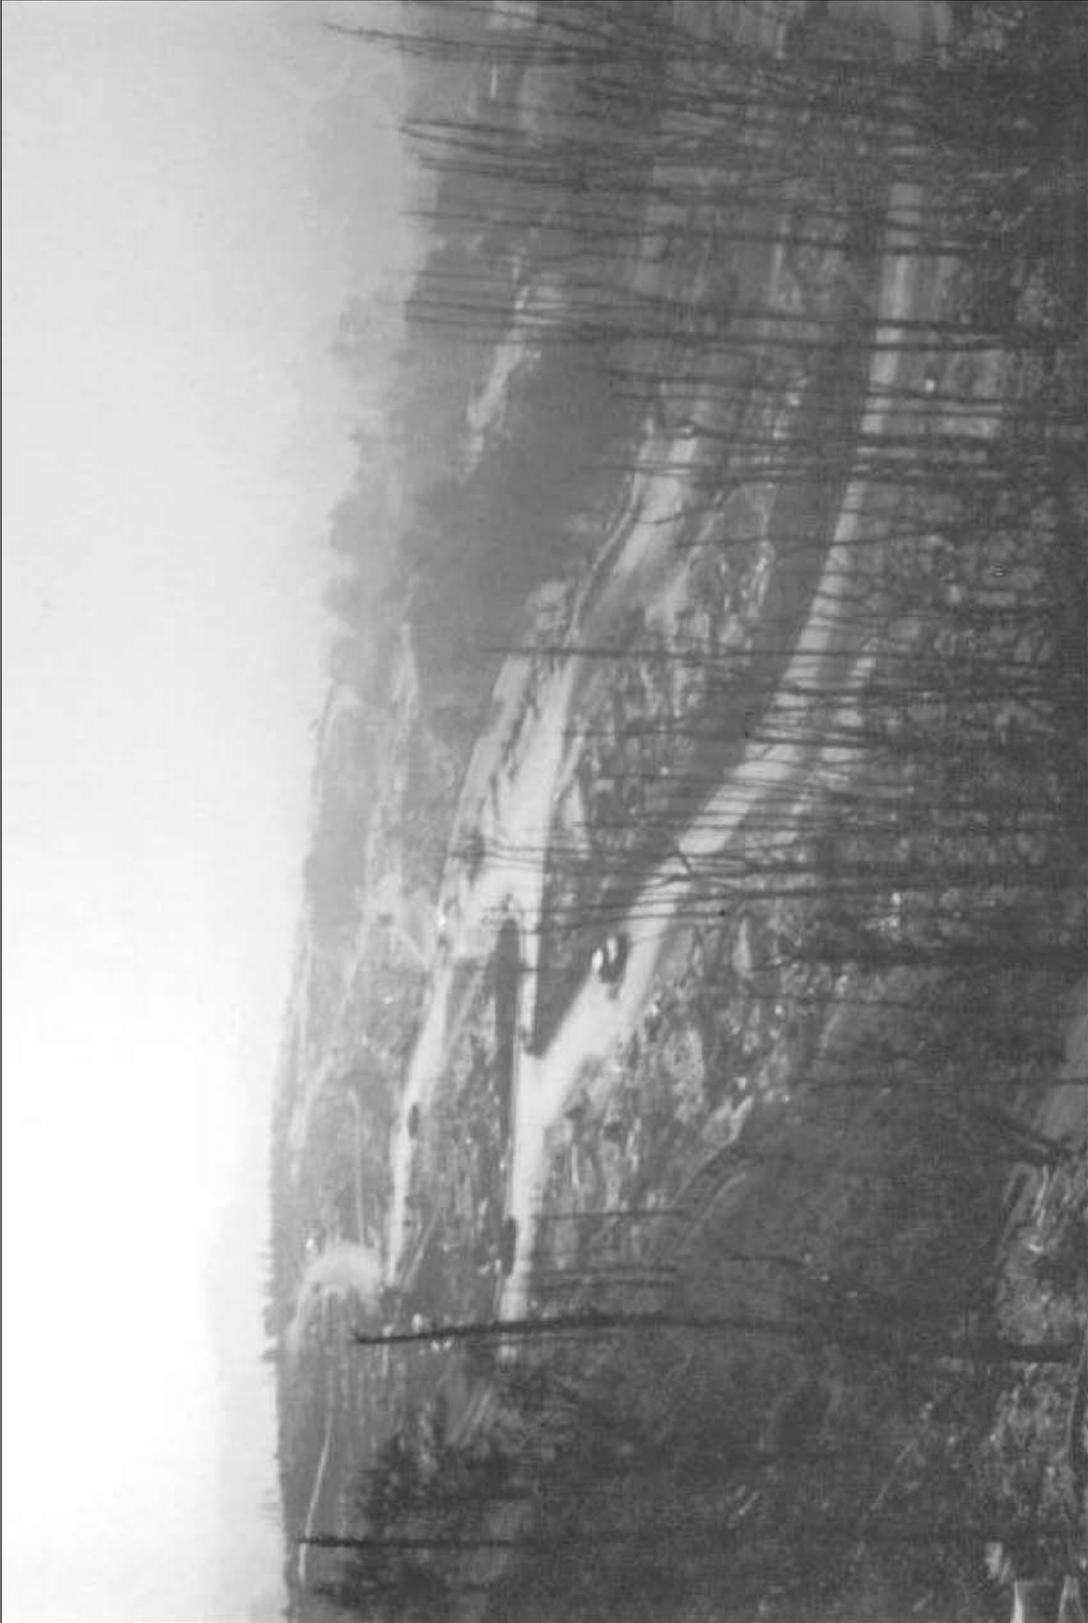
Total destruction of Hiller Highlands complex.

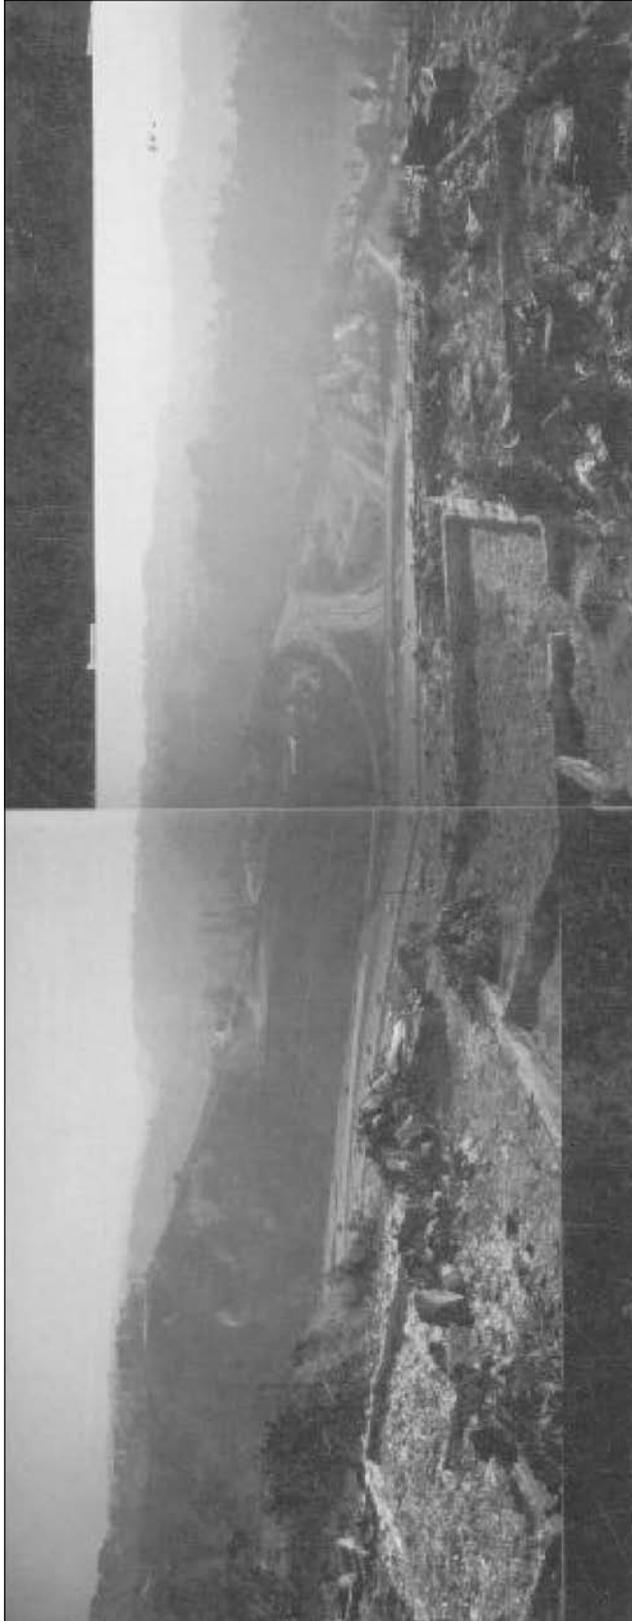
View from Hiller Highlands, looking down on interchange of Highway 24 and Highway 13. Entrance to Caldecott Tunnel is to the left. Lake Temescal and Rockridge District in the background. Fire jumped from Hiller Highlands to the trees beyond Lake Temescal, a distance of approximately 2,000 feet.

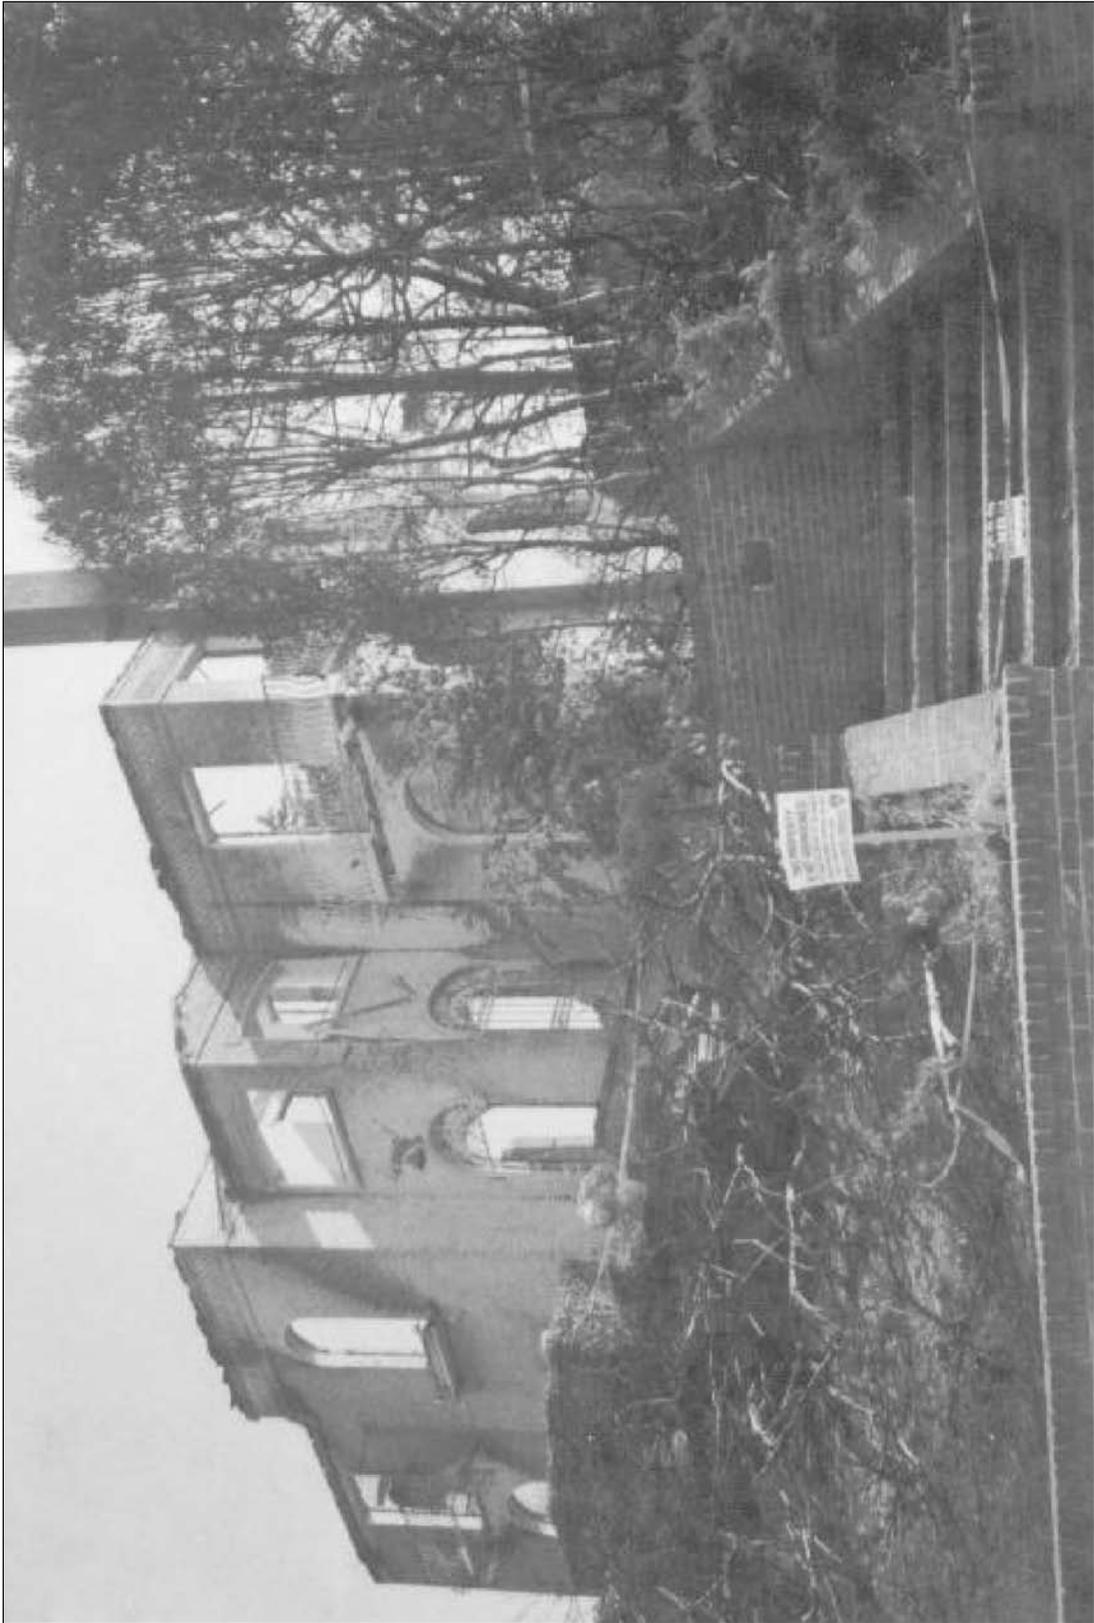
Ruins of large two-story home in Rockridge district.

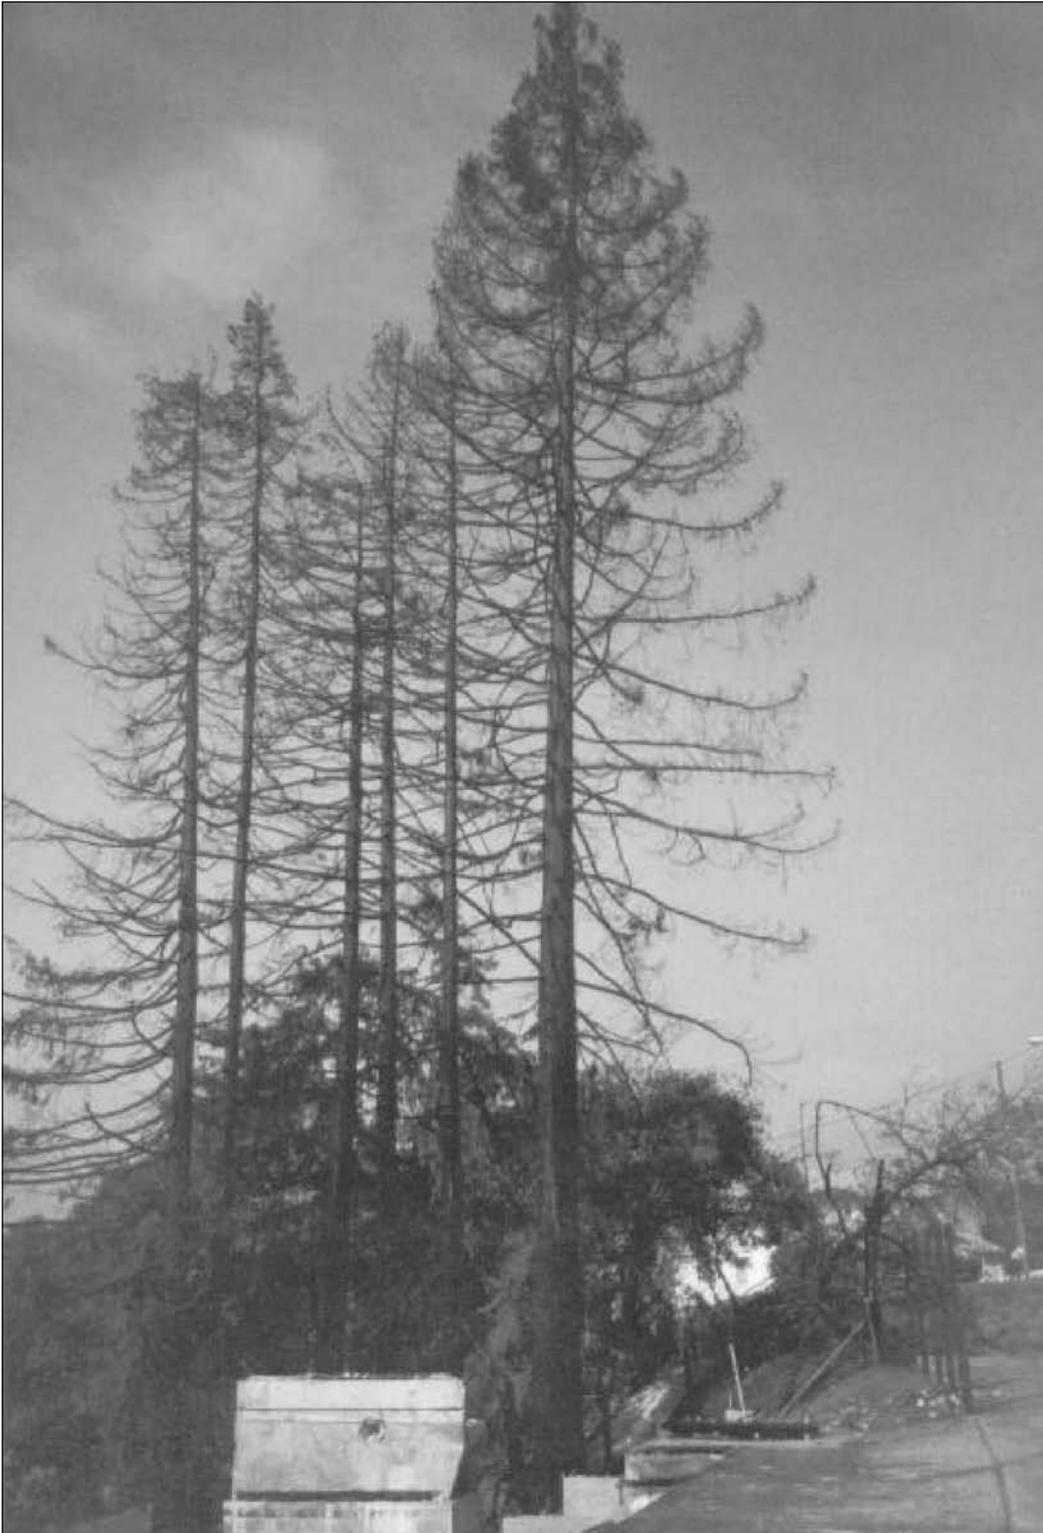
Huge pine trees in the Rockridge district ignited and accelerated the fire spread in this area.

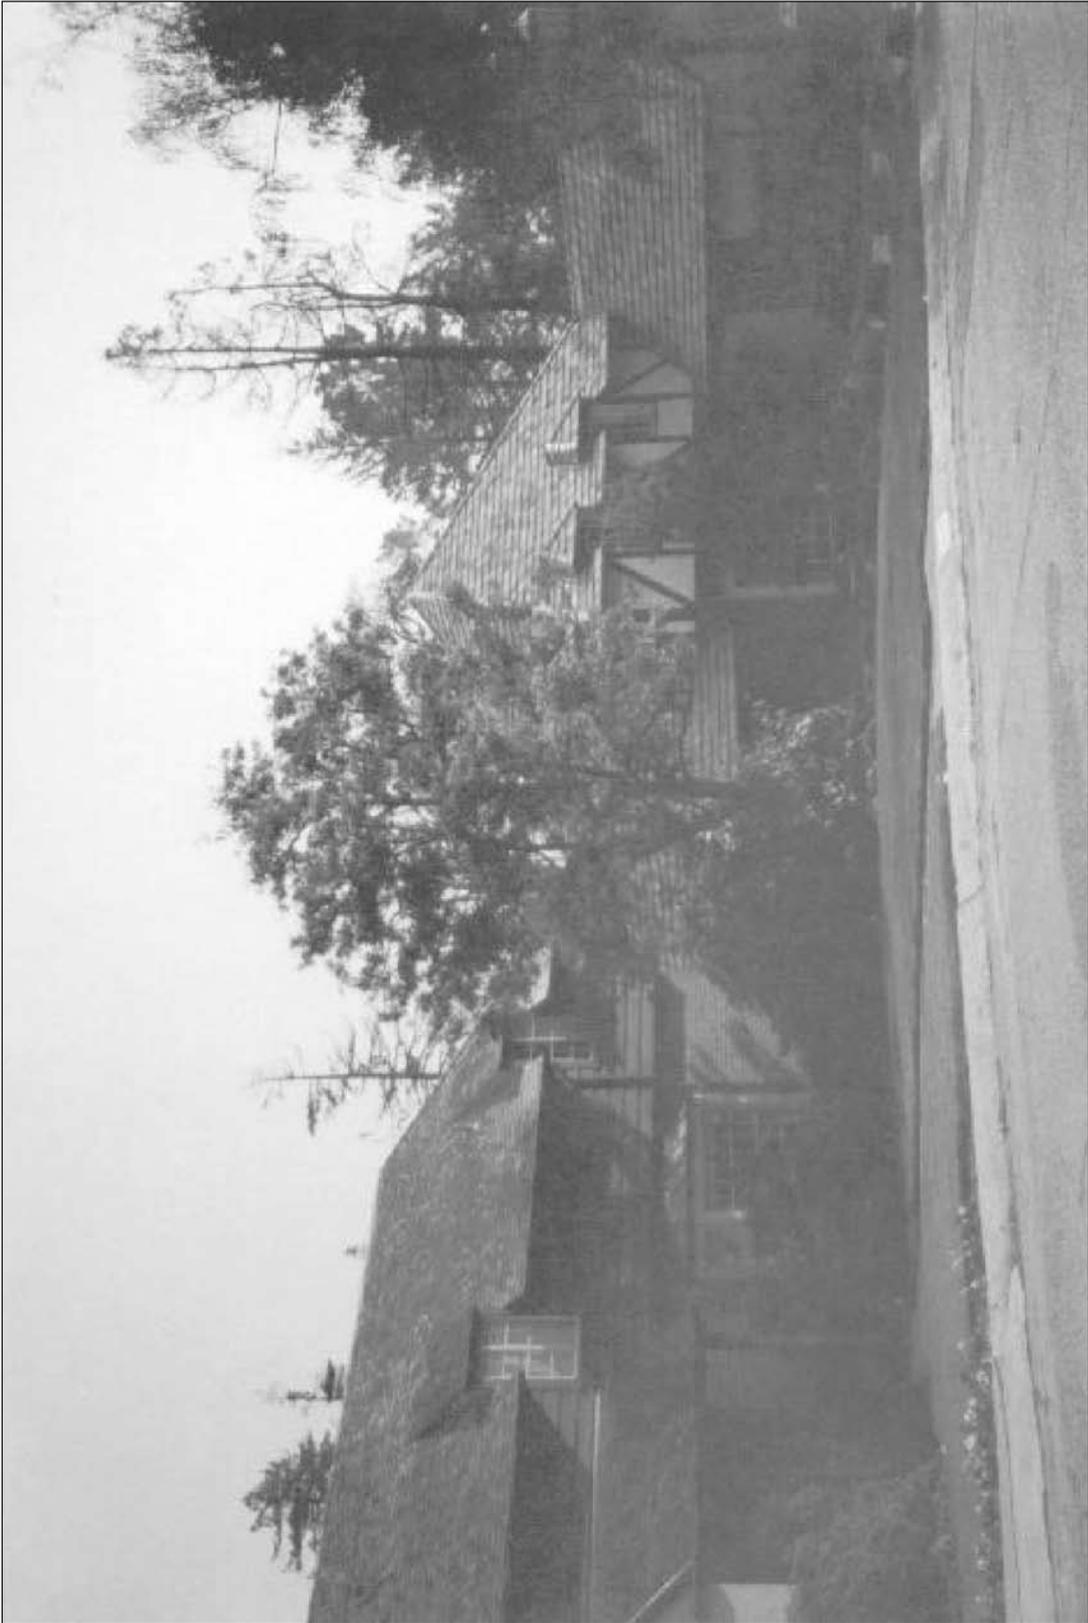
Examples of development in the fire area – wood shingle roofs.

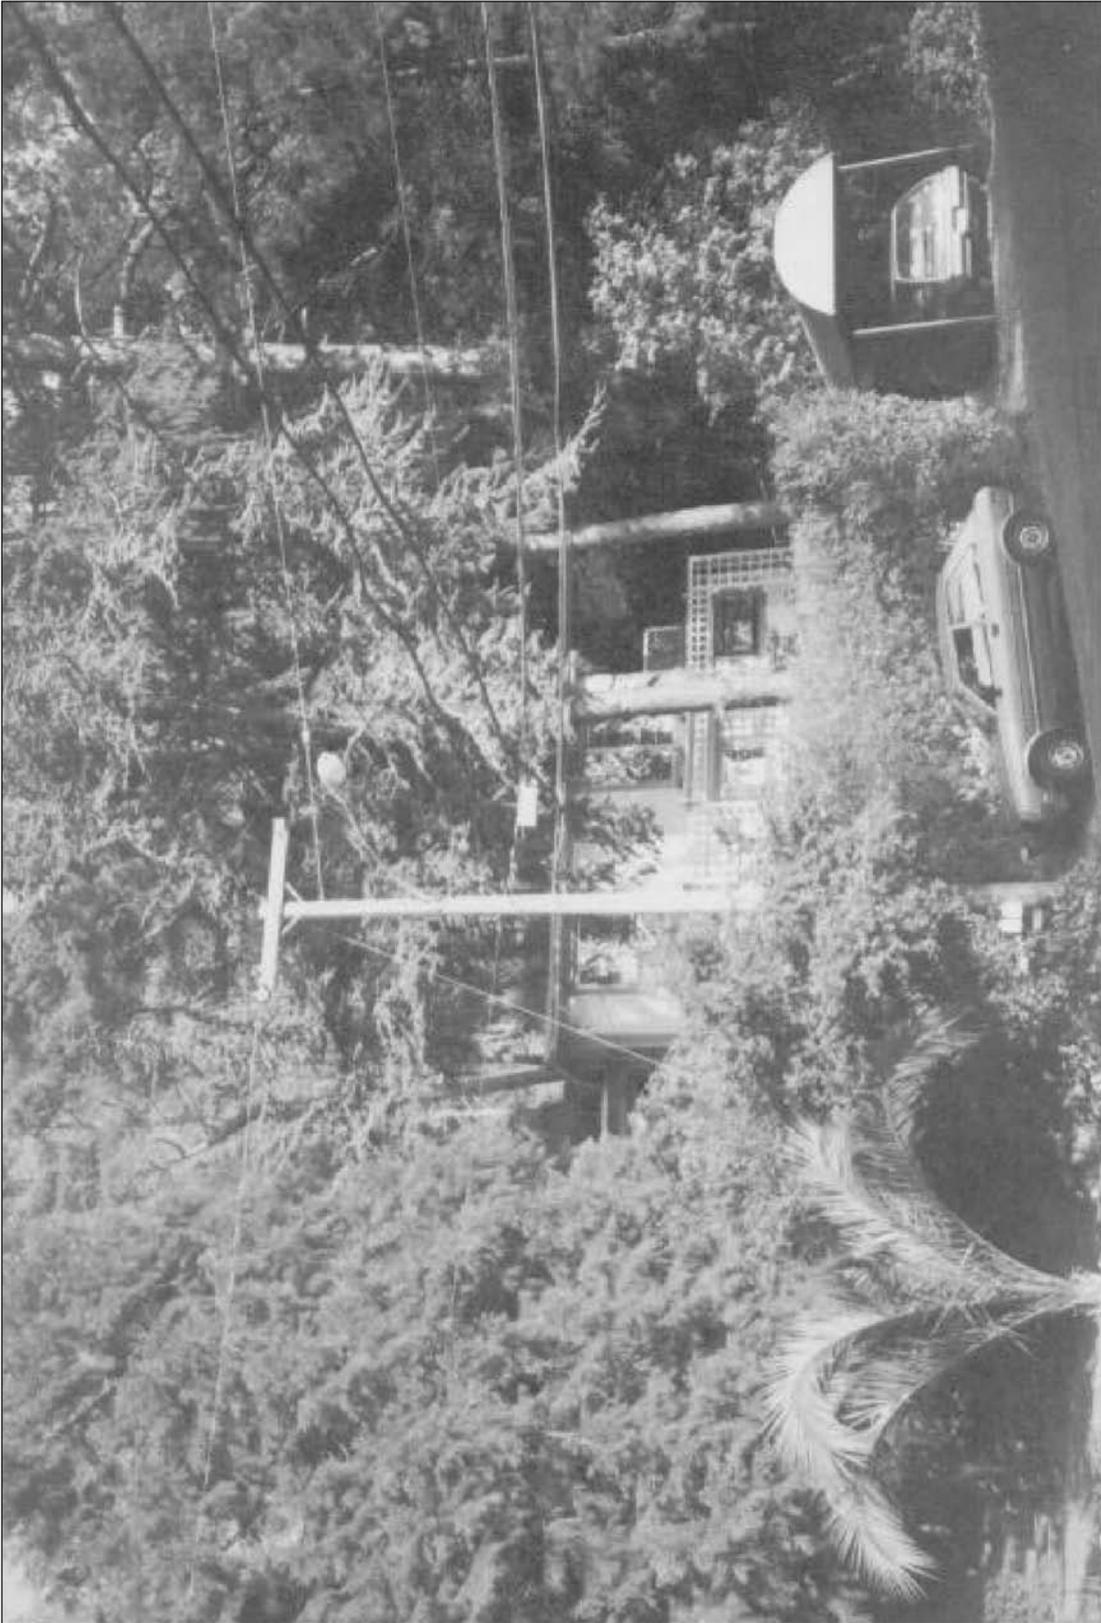
Home enveloped in natural vegetation.

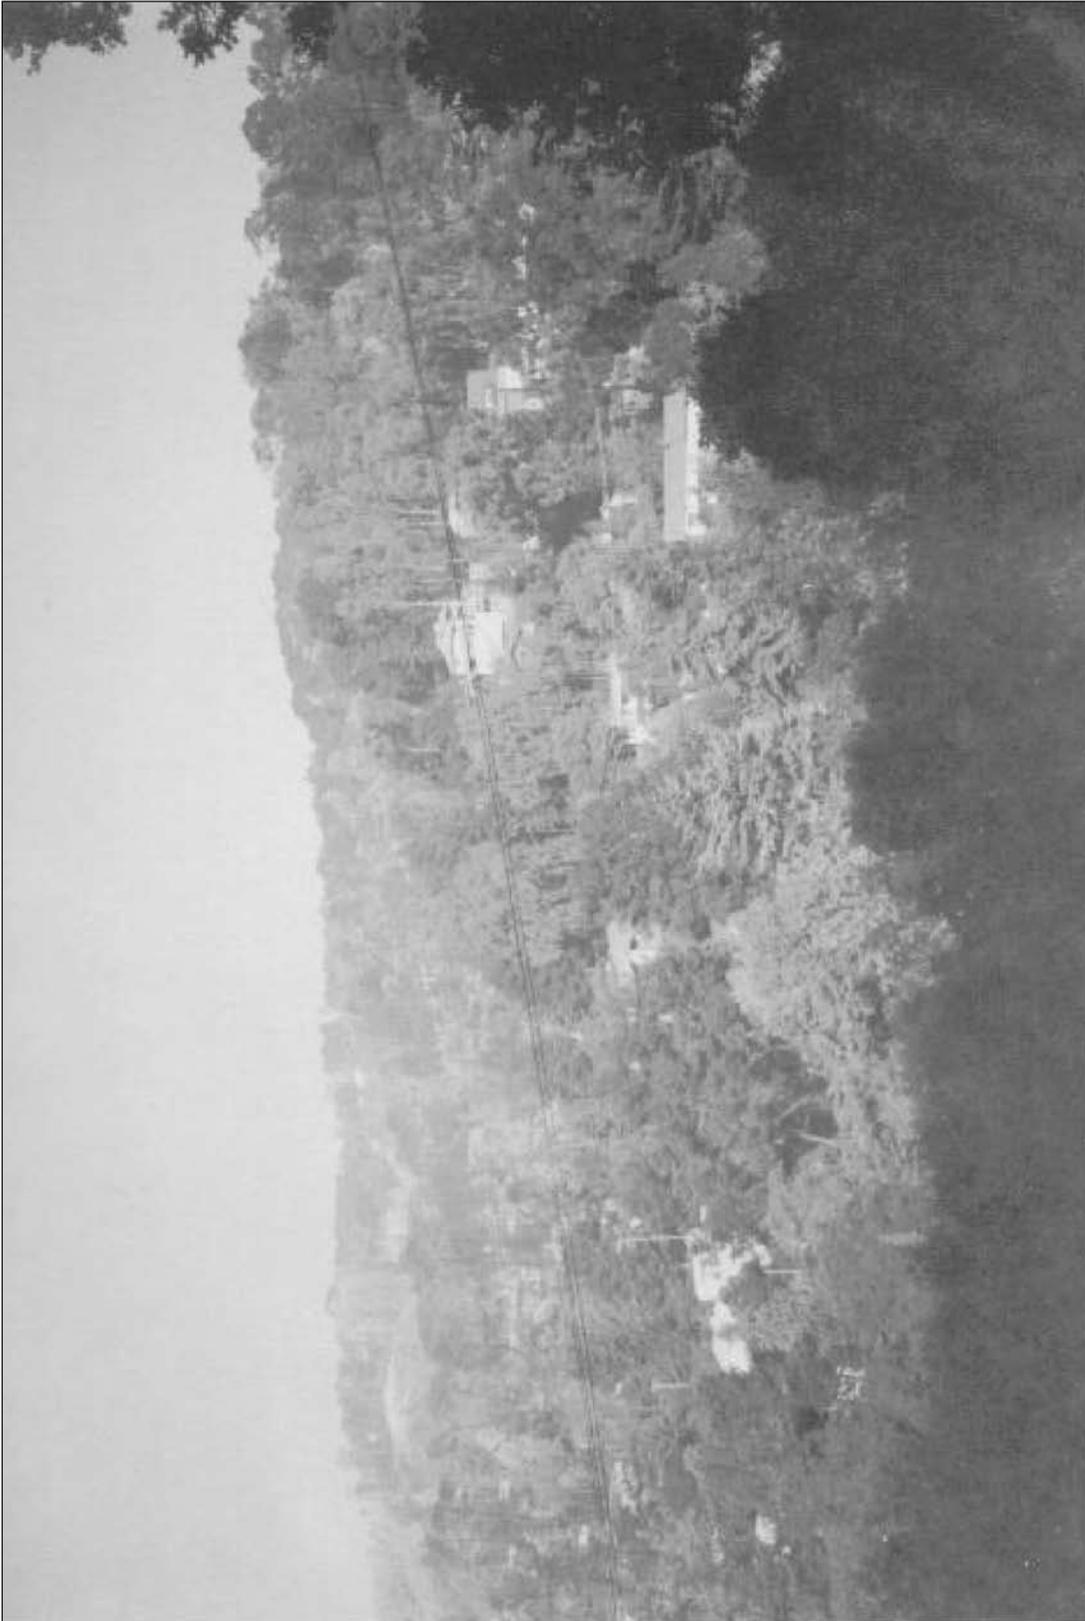
Homes enveloped in natural vegetation – fire area in background.

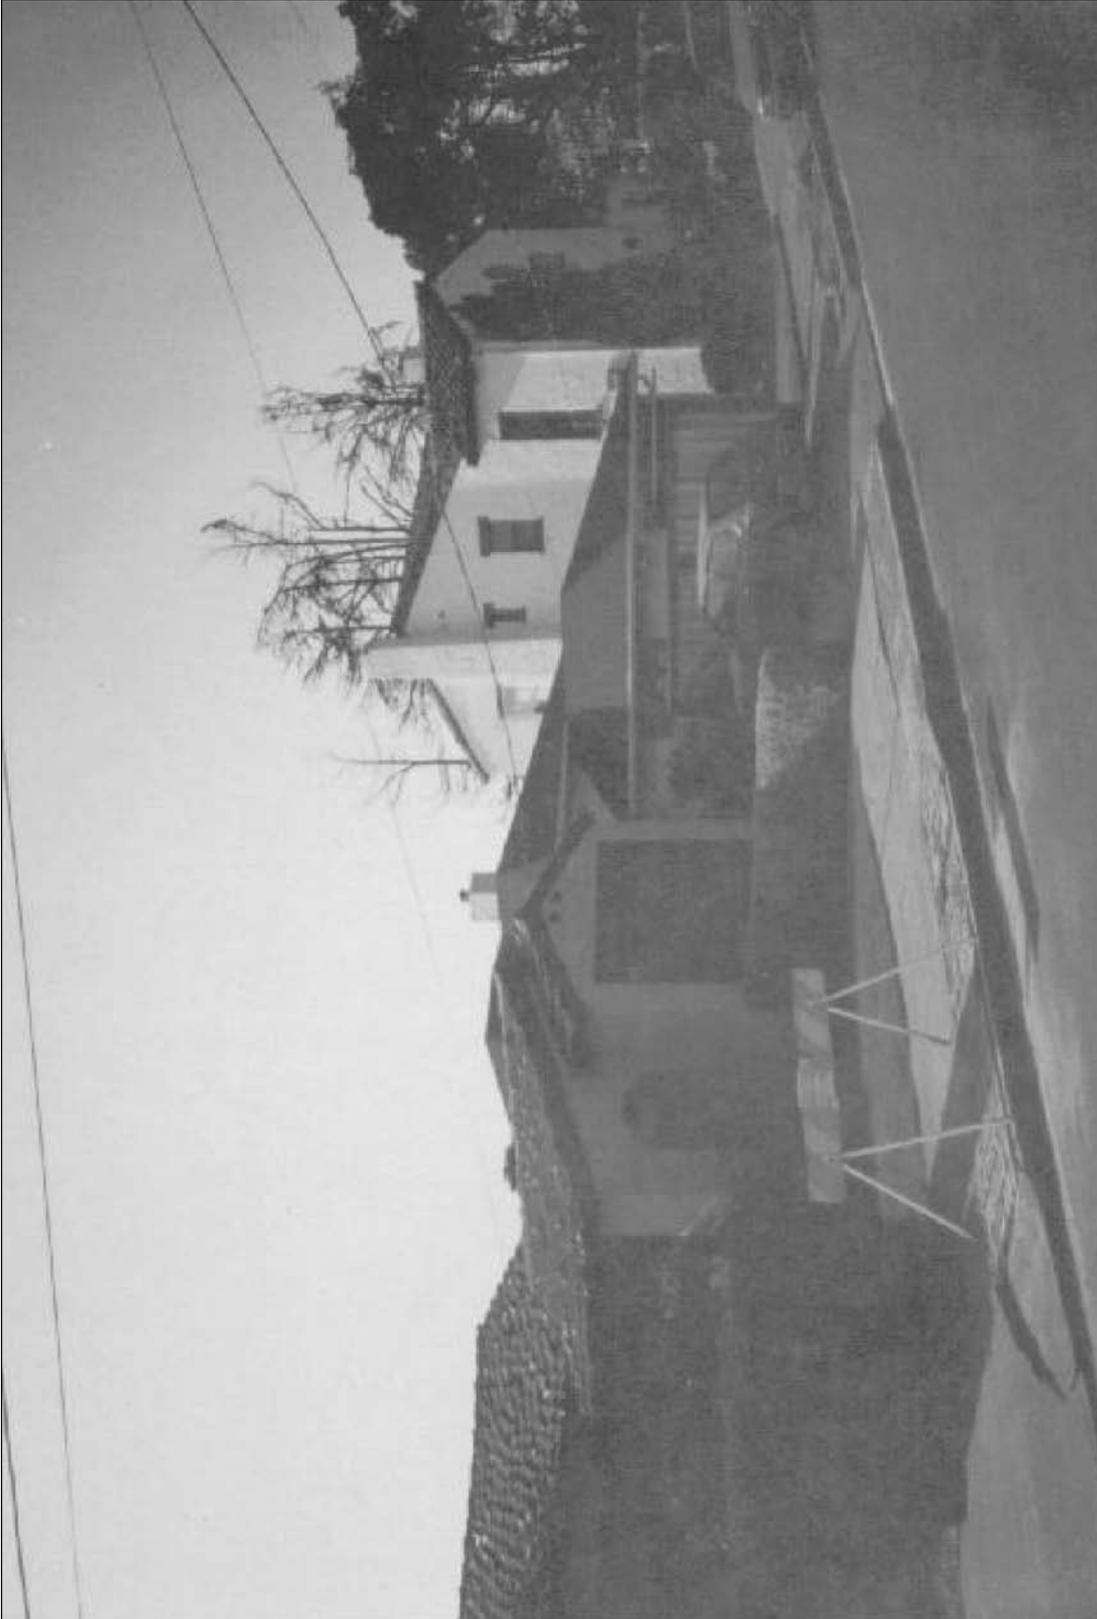
Homes saved within fire area – note non-combustible roofs.

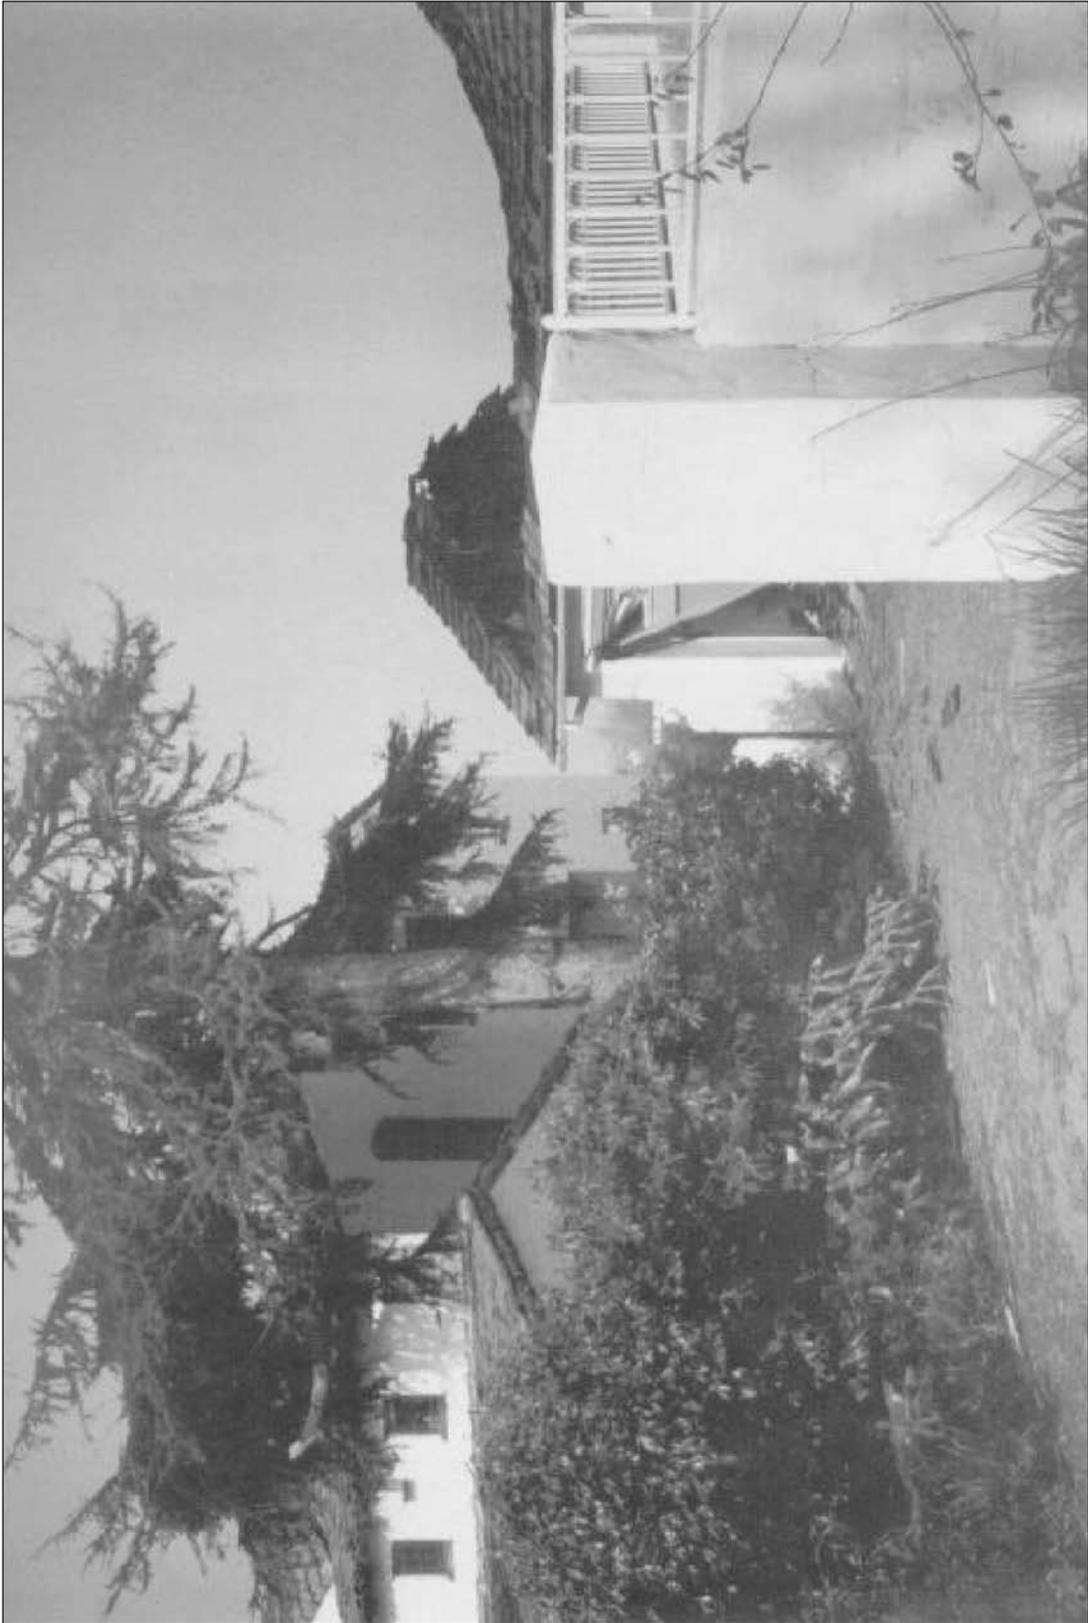
Home with wood shingle roof destroyed. Neighboring home with tile roof saved.

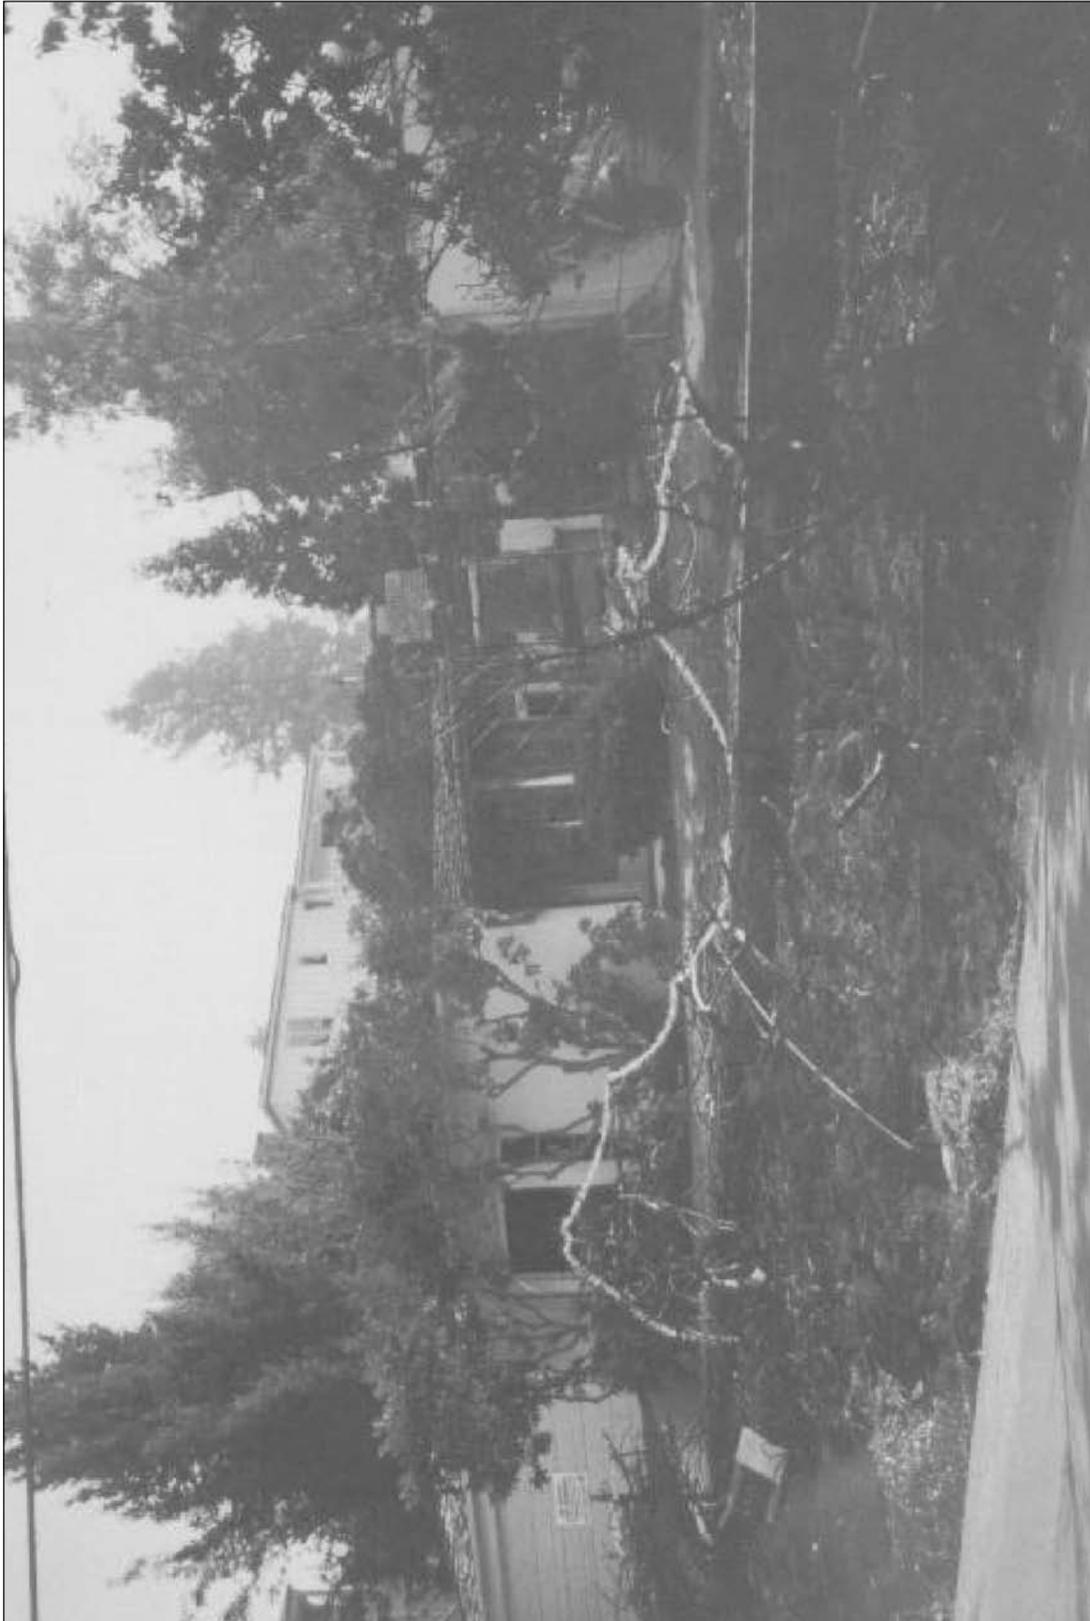
Home with wood roof burned off.

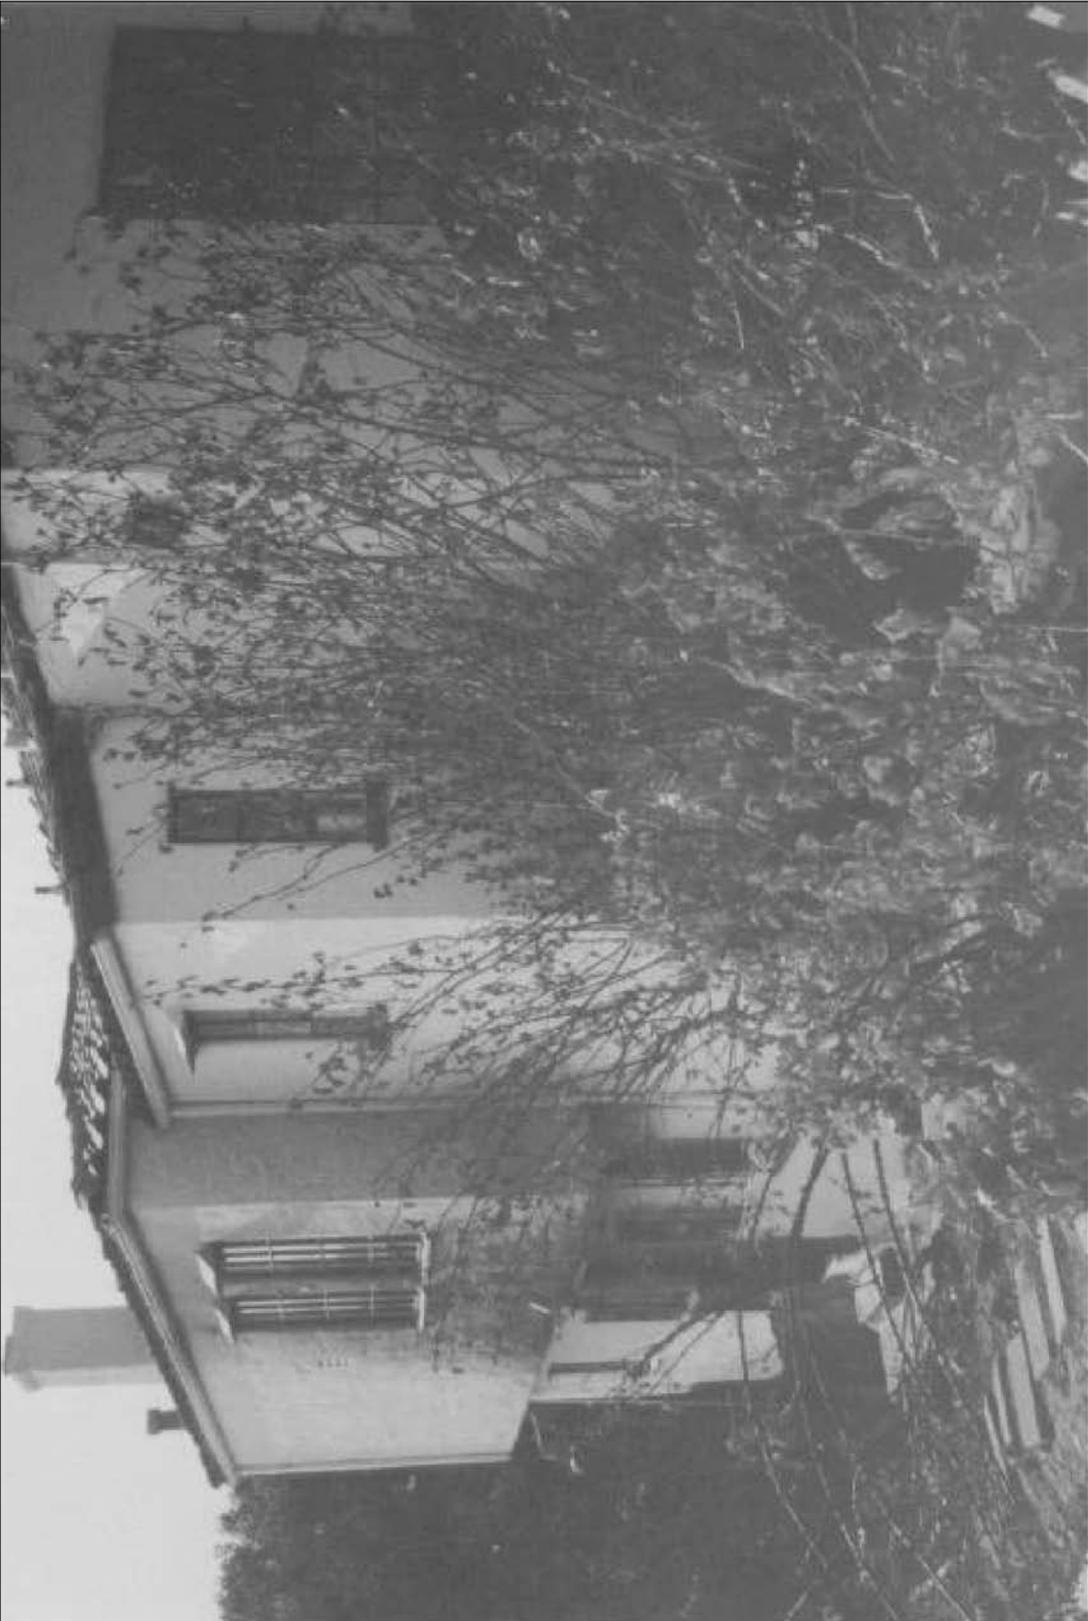
Large home saved by firefighters after vegetation became involved.

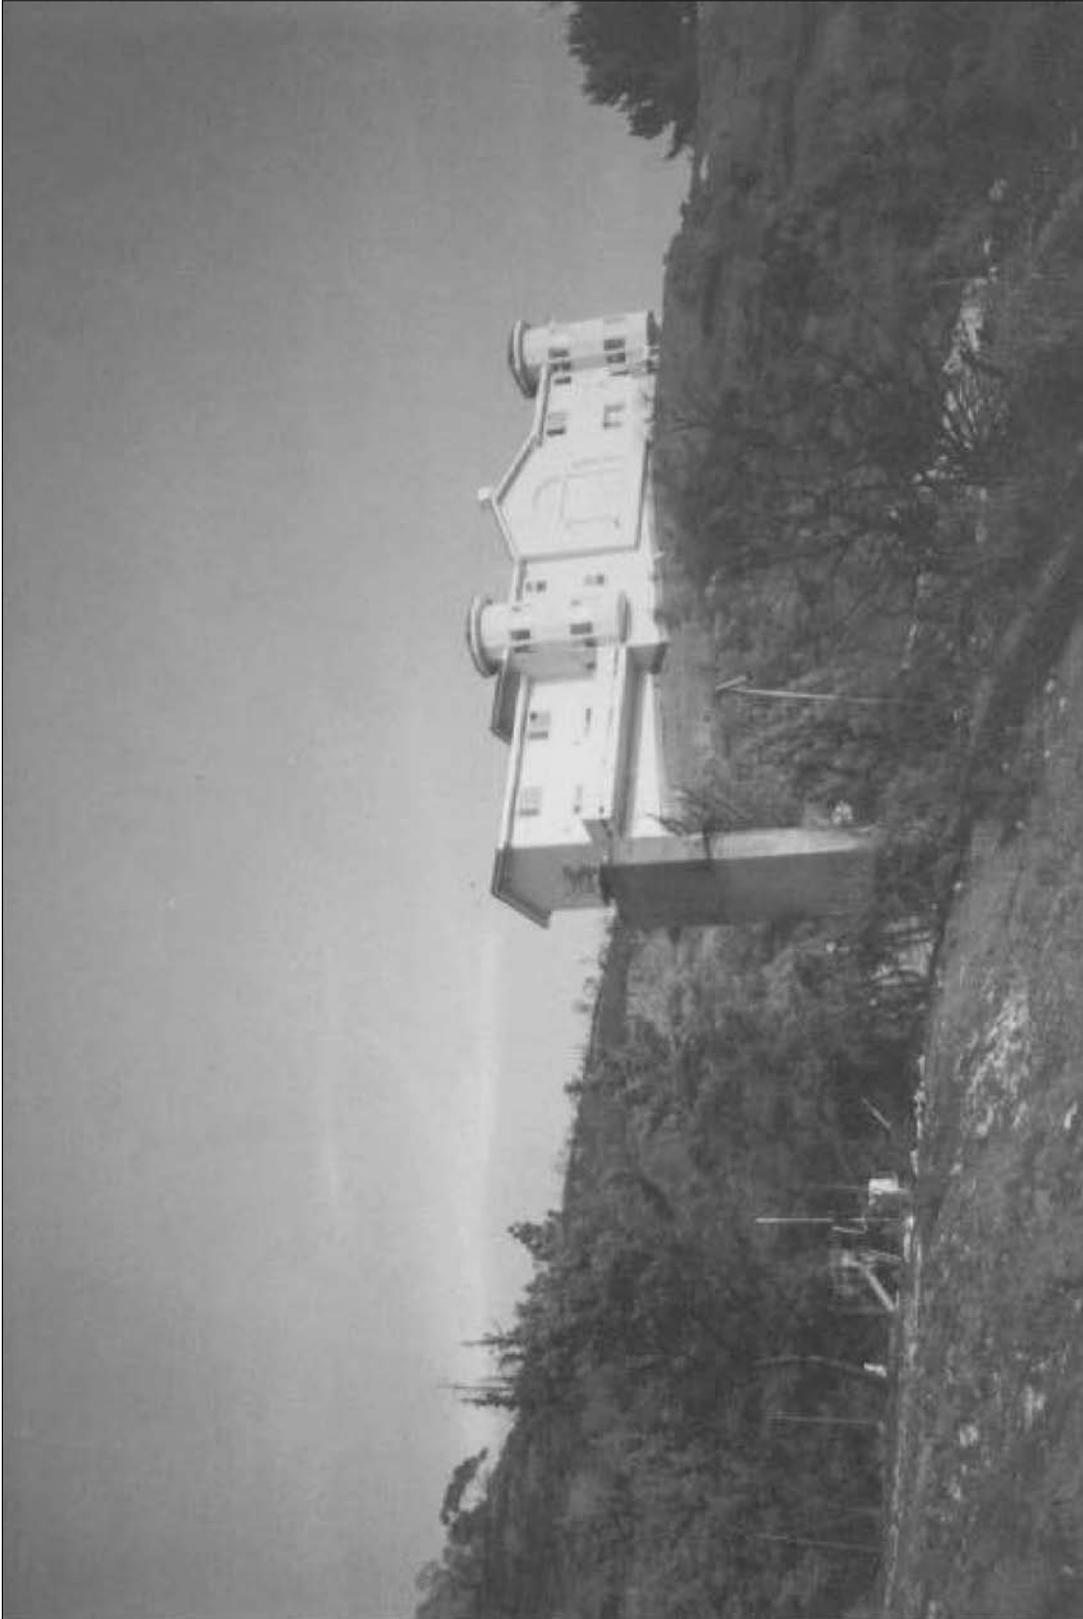
Large home saved by clear area around structure.

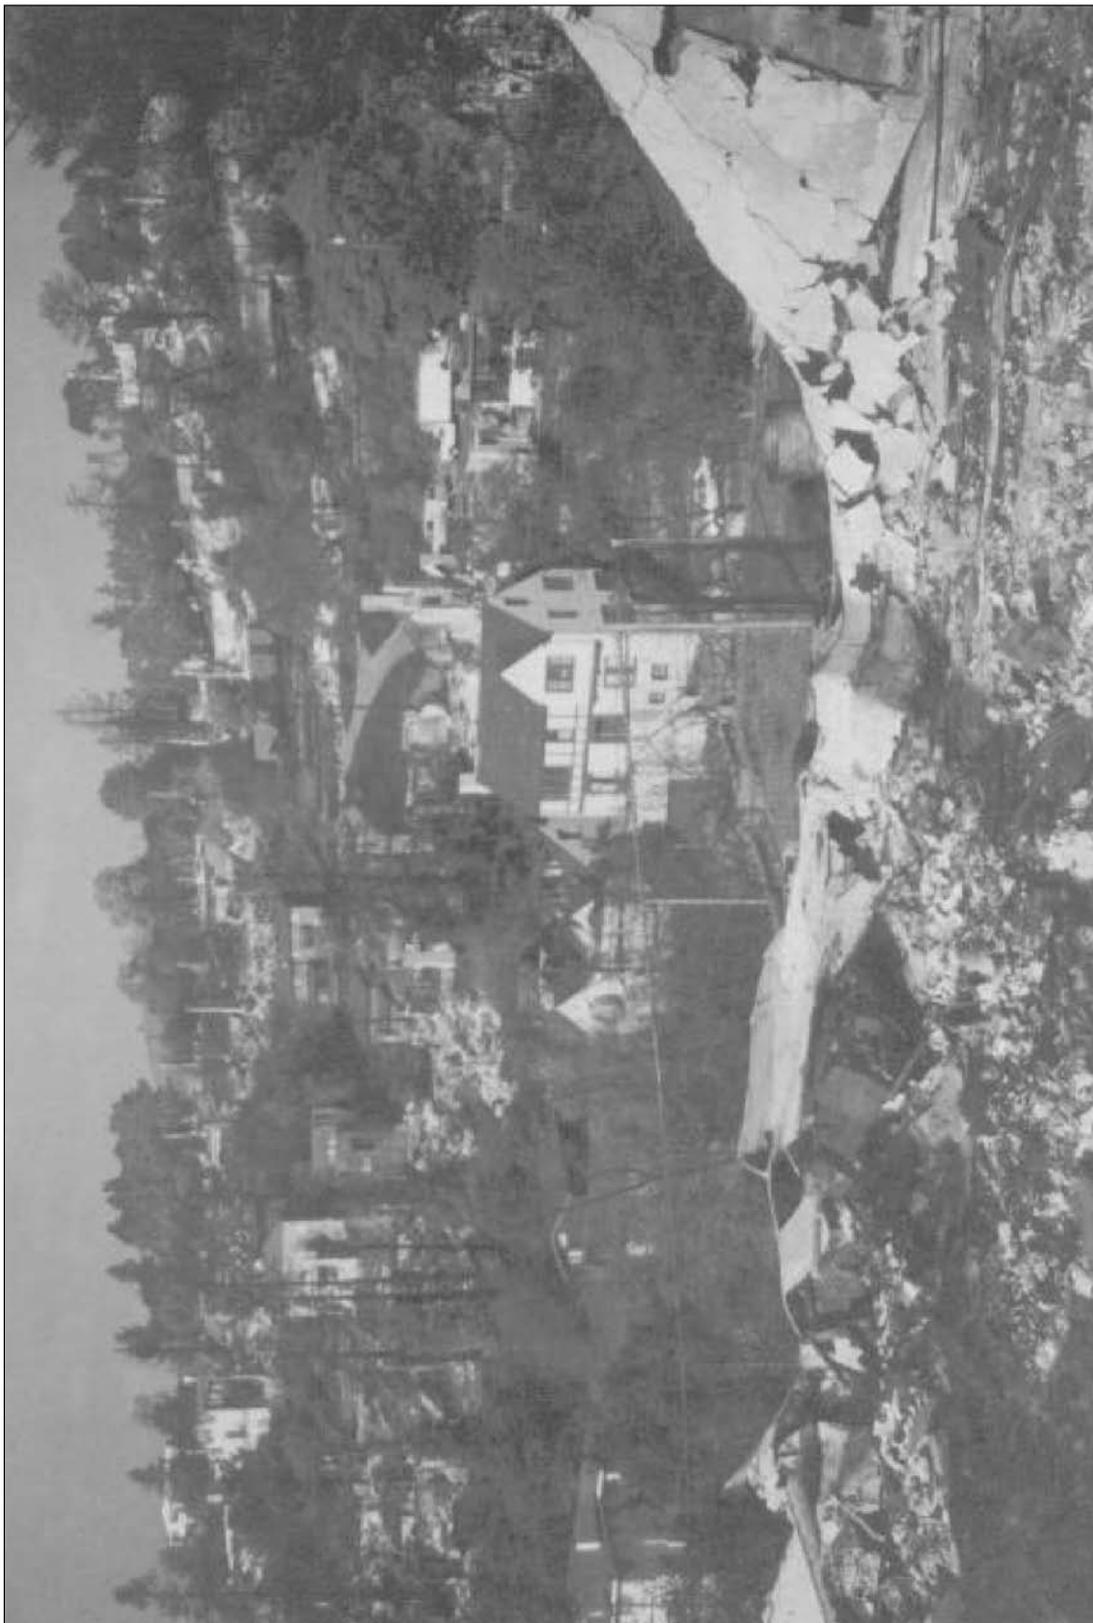
West limits of fire area – groups of homes saved, others lost.
