U.S. Fire Administration/Technical Report Series

The East Bay Hills Fire

Oakland-Berkeley, California

USFA-TR-060/October 1991

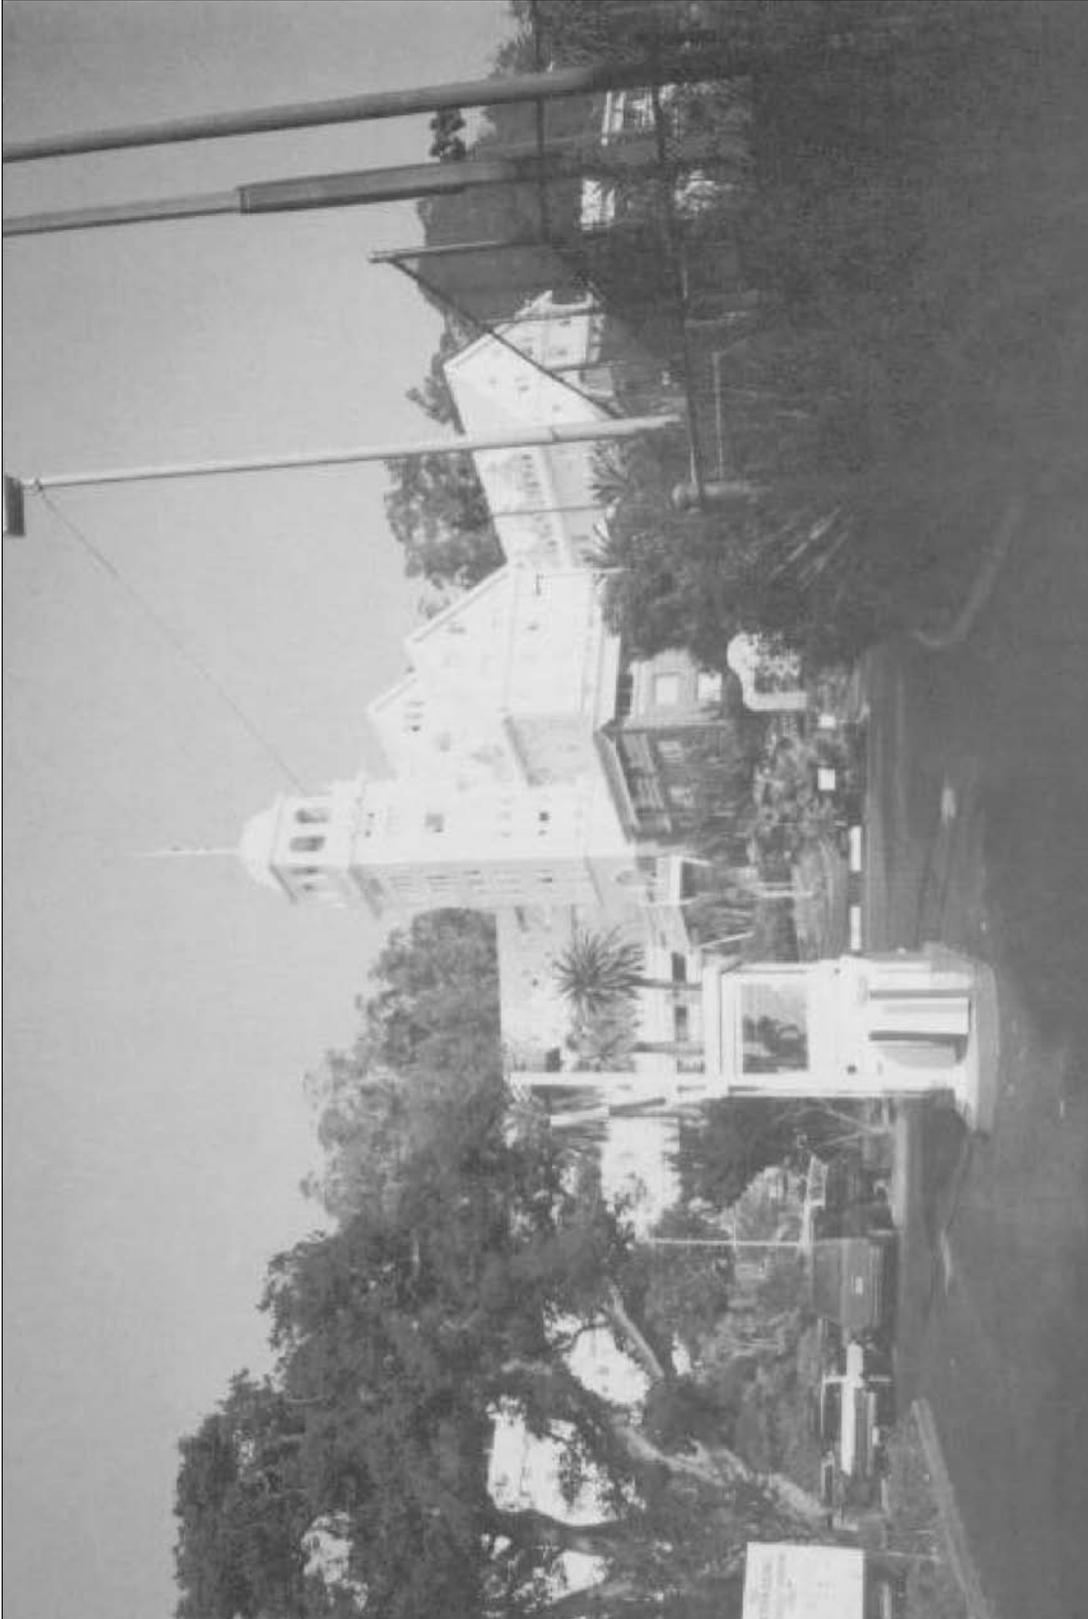
The Claremont Hotel – Five-story wood frame structure in the path of the fire, considered a “conflagration breeder.”

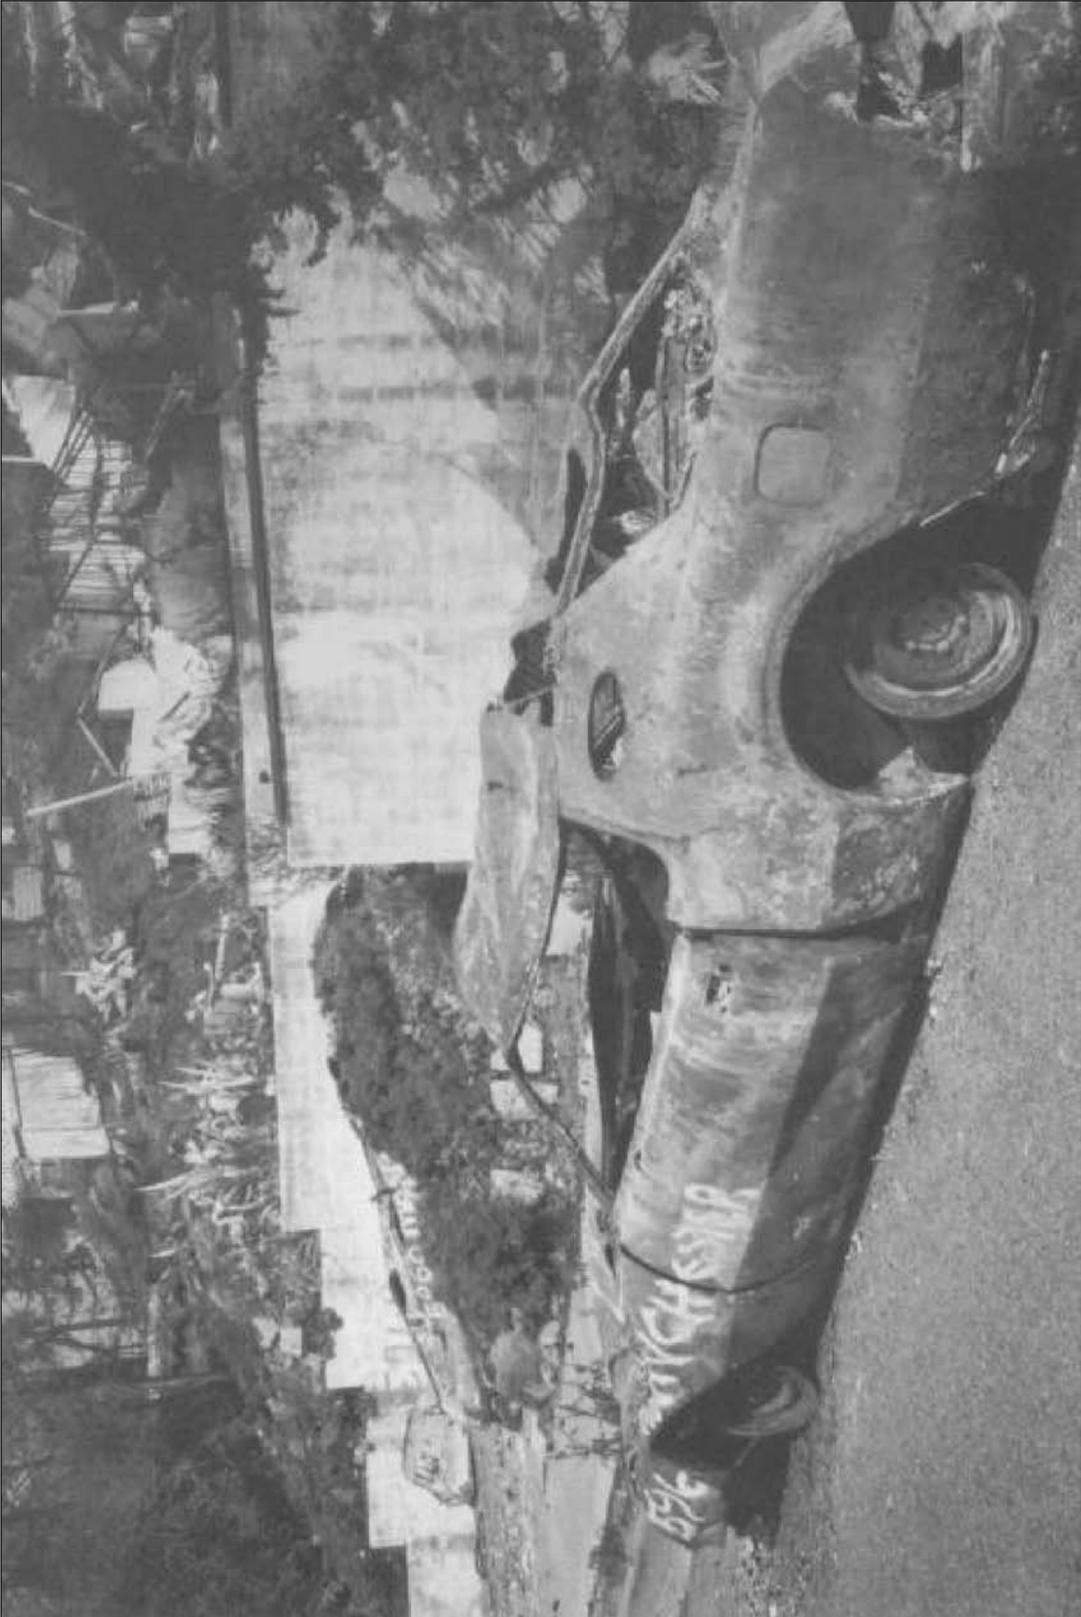
One of approximately 2,000 burned automobiles in the fire area.
