# Palmer Station Site Visit Report

May 2, 2008 to May 21, 2008

Robert Newsome

In May 2008, Robert Newsome visited Palmer Station, Antarctica for the Stanford University VLF Group's annual NSF grantee visit for contract A-306-P: Stanford University VLF Antenna. This report summarizes the objectives of the visit, the status of the equipment at the beginning of the visit, and the accomplishments made during the visit. Recommendations for future work are made.

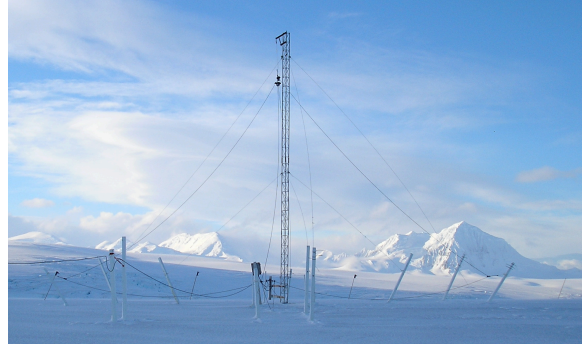
The Antenna mast was not tilted in any direction (due to melting of the ice foundation over summer). There was a moderate amount of slack on the Antenna cables, and the bottom part of both the east and west sides of the Antenna were frozen into the ground.

Figure 1 – The Antenna at the top of the Glacier.

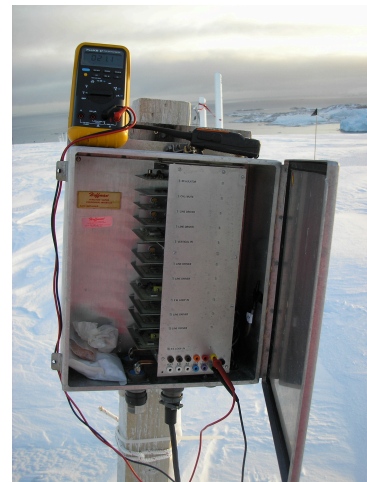
The antenna was recalibrated on May 19, 2008 between roughly 1800 UT and 2030 UT. The appendix contains the resulting calibration data tables and graphs. Broadband data was recorded during the calibration process and burned to DVD. However, it was found after the fact that the recording did not actually start until near 1830 UT despite the fact that the VLF DAQ software's recording schedule was set up to begin recording at 1730 UT. Thus, the lower frequencies of the calibration process were not captured in the recorded broadband data. Fortunately, the 30 second 50 Hz to 50 kHz frequency sweep at the end of the calibration process was captured. After the calibration process was finished, the injected calibration tone strength was set to 70.0 mV at 5 kHz, which corresponds to an injected calibration strength at the Preamp of 21.9 mV and a value of  $V_{CAL}$  of  $V_{CAL} = 10.9$  mV.

Figure 7 – Calibration at the Preamp.

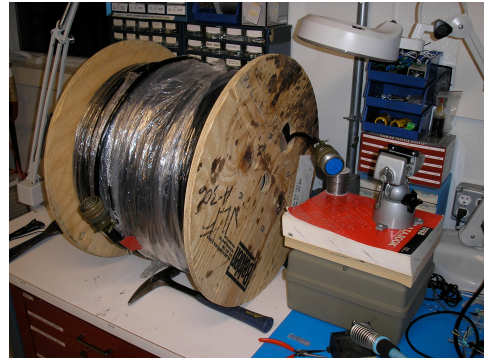
Figure 8 – Connectors attached to the new spool of 1000 feet of VLF cable, the night before installing it.

To address the problems with the JB2-JB3 cable, the entire cable was replaced with a brand new cable. The cable's downhill connector at the JB3 end was preserved (that is, the connector on the old cable was cut off and used in the same location on the new connector). The cable's uphill connector at the JB2 end (which had been damaged) was replaced with what appeared to be an old

connector no longer being used that I found in storage at TerraLab. The downhill connector at JB2 (also damaged) was replaced with a brand new connector. At JB1, two (2) of the three (3) wire-to-pin contacts damaged by the twisting motion of opening the connectors were repaired. These were the contacts associated with Pin C on the downhill connector and with Pin H on the uphill connector. The wire-to-pin contact associated with Pin P on the downhill connector was not repaired it was located in the middle of the 18 connections (very hard to get to with a soldering iron in the wind and snow/rain) and was only apart of the spare triplet (which is neither connected to the Preamp or to the Receiver).

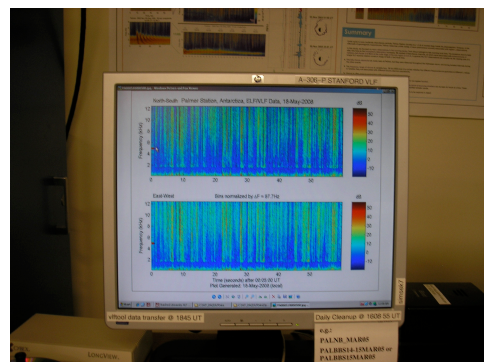
Figure 9 – The first spectrogram after the Antenna/Receiver system was working again.

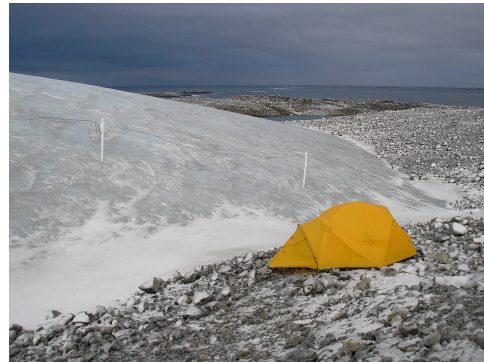
Figure 11 – The tent I pitched at the foot of the Glacier. Inside the tent I had a generator, a soldering iron, a heat gun, a can of gas, and lots of tools.
