Guidelines to Restoring Structural Integrity of Covered Bridge Members

Forest Service
Forest Products Laboratory
General Technical Report
FPL-GTR-252
January 2018

A FHWA-NHCBP (National Historic Covered Bridge Preservation) publication

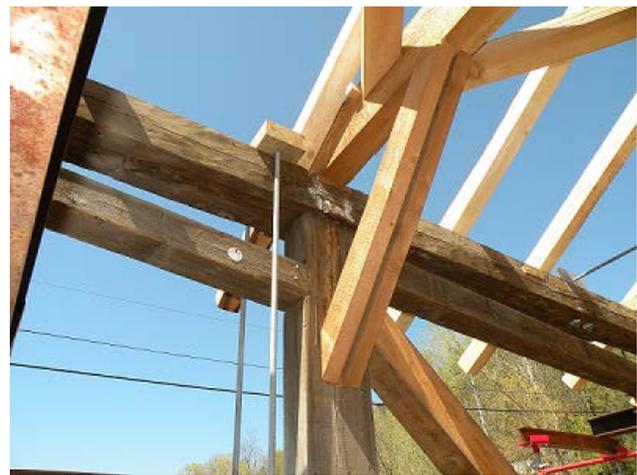
Figure 1.1—Replaced diagonal and knee brace that were deteriorated (Taftsville Covered Bridge, 1836, Windsor County, Vermont).

Covered bridge members are sometimes compromised by decay, insect attack, or a range of nonbiologic factors. Although publications are available describing methods of inspecting covered bridges for degradation, little information is available to guide decisions after a problem is detected. Additionally, assuming the cause of degradation is correctly identified, a decision still must be made as to whether the member can continue to function without corrective action or how it can be repaired, reinforced, or replaced while retaining the maximum amount of historic fabric. Proper repairs can extend the service life of a covered bridge for decades (Fig. 1.1).

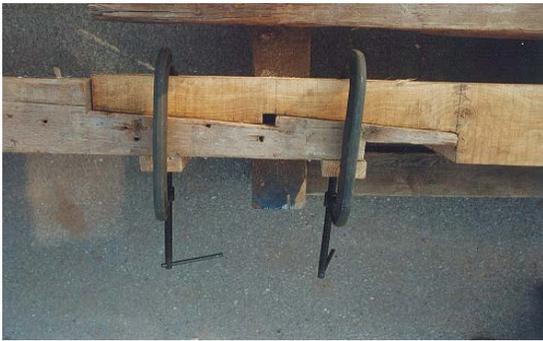
Figure 1.2—A tapered splice common to traditional timber framing ready to receive a wedge or shear key (Used with permission from DCF Engineering, Inc.).

There is a need to describe and evaluate repair techniques that are intended to extend the service life of bridge components. Rehabilitation techniques explored in this context include improved traditional timber framing or timber joinery (Fig. 1.2); use of fully threaded structural fasteners; post-tensioning of bottom chords (by adding steel cables or rods); epoxy injections or fiber-reinforced plastic (FRP) plates to reinforce top chords and floor beams; and replacement of members with glued-laminated timber (glulam), engineered wood products, or pressure-treated lumber. In some situations, the in-place application of preservative treatments may be used to decrease the likelihood of future decay or insect attack.

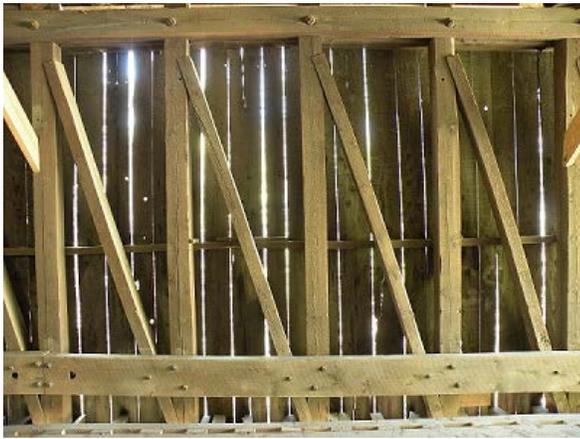
Figure 1.5—Example of a multiple kingpost truss (Blow-Me-Down Covered Bridge, 1877, Sullivan County, New Hampshire).

Some of the most common types of trusses used for covered bridges in the United States are the multiple kingpost, Town lattice, Burr arch, and Howe types (Figs. 1.5 to 1.8).

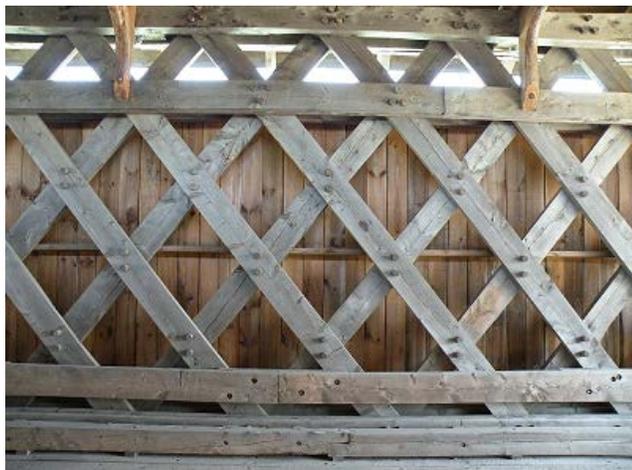
Figure 1.6—Example of a Town lattice truss (North Hartland Twin Bridge, 2001, Windsor County, Vermont). There is a twin bridge at this river crossing (the Willard Covered Bridge) that dates from 1871.

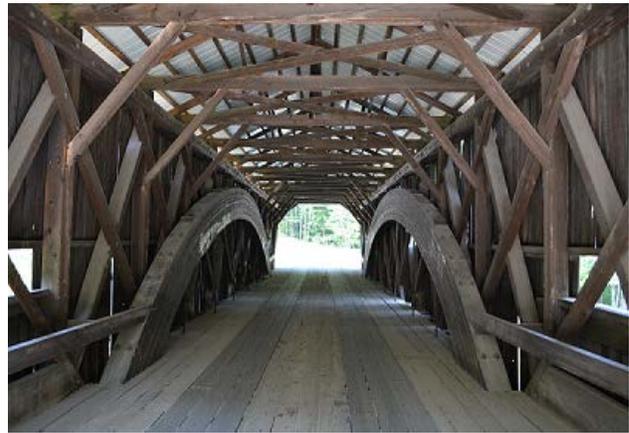
Figure 1.7—Example of a Burr arch truss (Durgin Covered Bridge, 1869, Carroll County, New Hampshire).

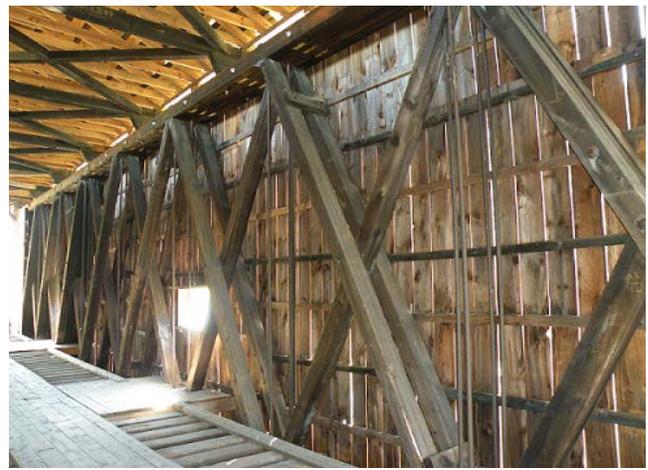
Figure 1.8—Example of a Howe truss (Shoreham Bridge, 1897, Addison County, Vermont).

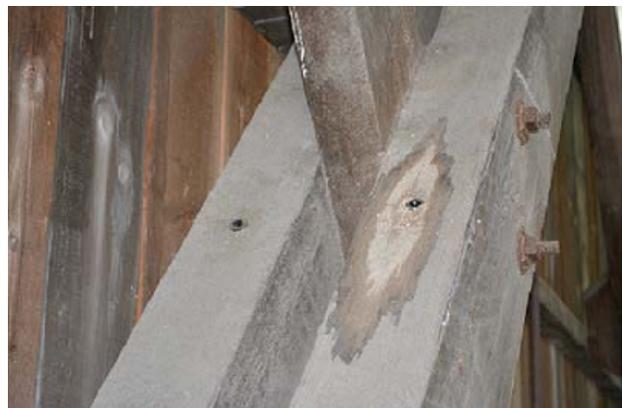
Figure 2.1—Moisture stain with no wood decay present (Unity Bridge, 1936, Lane County, Oregon).

- Moisture stains (Fig. 2.1)
- Presence of wood decay (Fig. 2.4)
- Insect activity (Fig. 2.5)
- Fuzzy wood (Fig. 2.6)
- Crushing of timbers (Fig. 2.7)
- Moss or lichens growing on wood components
- Peeling or flaking paint
- Fire damage (Fig. 2.8)
- Mechanical damage from vehicle impact (Figs. 2.9 and 2.10)
- Failed or damaged members (Fig. 2.11)
- Missing, loose, or displaced members (Fig. 2.12)
- Loose, missing, corroded, or broken connections (Figs. 2.13 to 2.17)
- Reverse camber (sagging) of the bridge (Fig. 2.18)

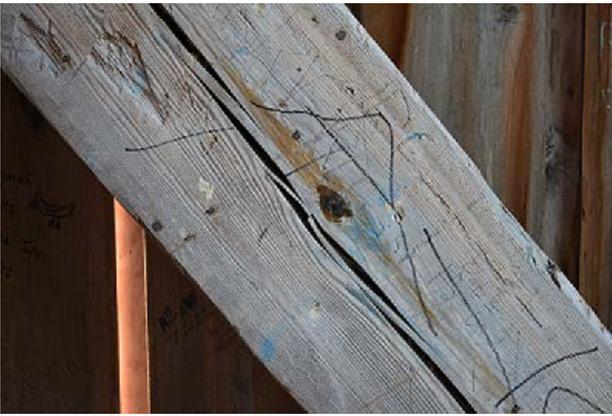
Figure 2.2—Drying check in a truss diagonal (Cataract Falls Covered Bridge, 1876, Owen County, Indiana).

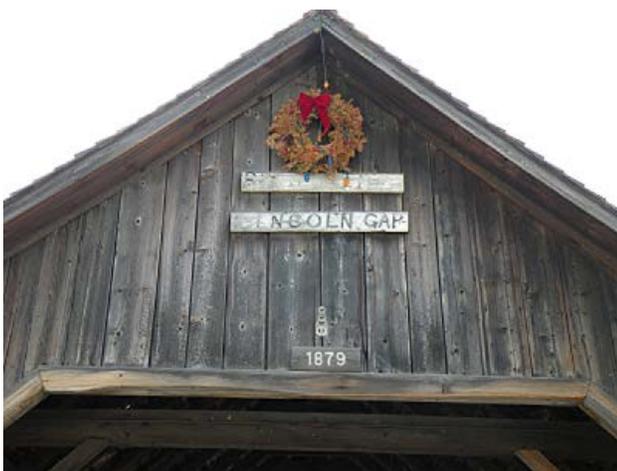
Figure 2.3—Weathered wood resulting in a desirable aesthetic effect. The siding does not require repair or replacement because of weathering (Lincoln Gap Covered Bridge, 1879, Washington County, Vermont).

Weathering of wood results from cyclic wetting and drying of the wood, exposure to ultraviolet light, and erosion by wind-blown debris, a process similar to sandblasting. Unlike decay or insect attack, weathering is typically not a significant factor in the failure of wood components and the collapse of a structure. Weathering will change the appearance of wood, but the process is so slow that failure of components caused by decay generally occurs long before weathering becomes a major factor in the failure. Weathering seldom damages the wood enough to require replacement, with the exception of shingles and cladding. Weathered wood is often considered aesthetically pleasing (Fig. 2.3).

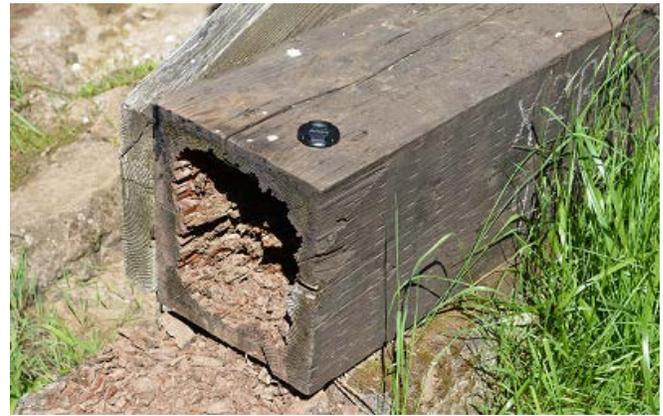
Figure 2.4—Decay of a timber sill in a bridge pier (Stewart Bridge, 1930, Lane County, Oregon).

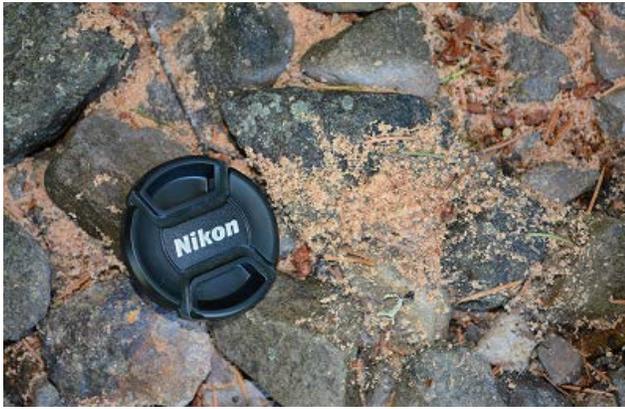
Figure 2.5—Evidence of insect attack found below bridge timbers (Belknap Covered Bridge, 1966, Lane County, Oregon).

often found in piles of wood substance below affected timbers or on the ground (Fig. 2.5).

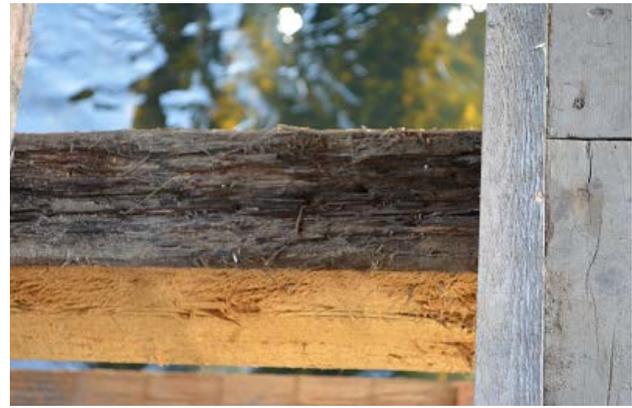
Figure 2.6—A joist showing fuzzy wood. This joist probably does not need to be replaced. An engineering analysis determined that it should be able to carry the original loads because only the very perimeter of the member was deteriorated (Blair Bridge, 1829, 1869, Grafton County, New Hampshire).

An additional type of wood deterioration that can occur with covered bridges members is called fuzzy wood and is caused by the chemical and physical action of salt breaking down wood fibers (Fig. 2.6). The crystallization of salt in between wood fibers can produce strands of fibers or, if severe enough, a mat of fibers on the surface. Salt damage is typically caused by the de-icing salts used on roadways. In salt environments, fuzzy wood is typically limited to the surface of the timber.

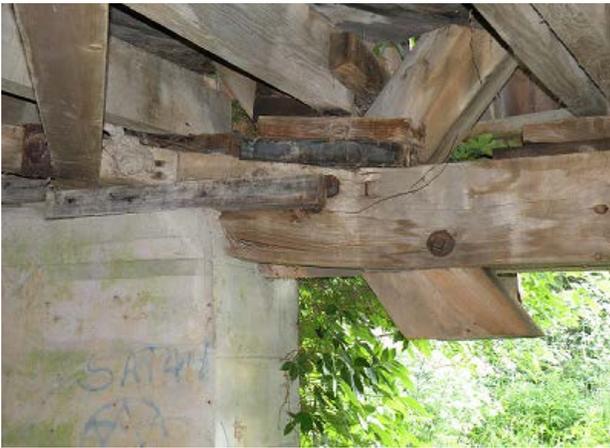
Figure 2.7—Crushed timbers at lower chord (West Engle Mill Road Covered Bridge, 1877, Greene County, Ohio).

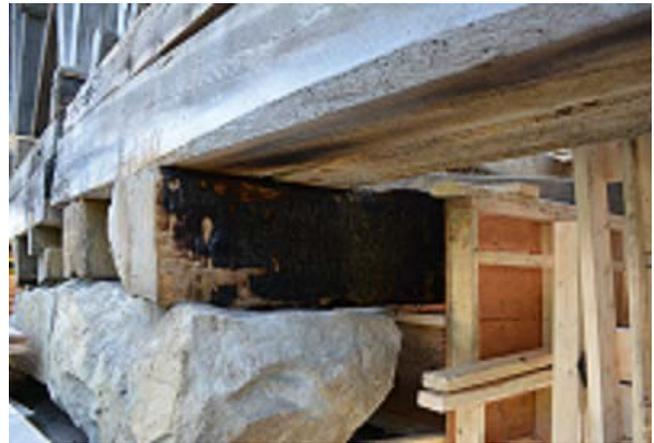
Figure 2.8—Fire damage of a floor beam (Blair Bridge, 1829, 1869, Grafton County, New Hampshire).

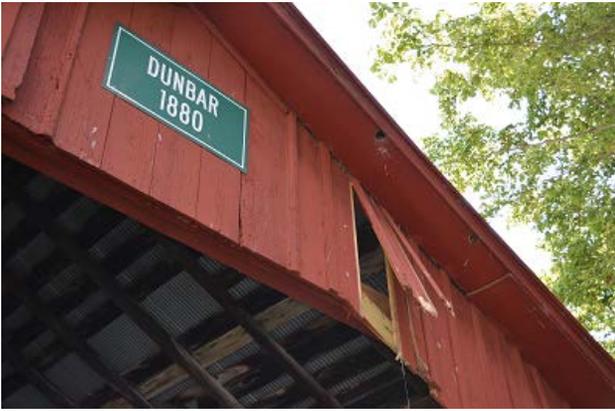
Figure 2.9—Damage at portal from vehicular impact (Dunbar Bridge, 1880, Putnam County, Indiana).

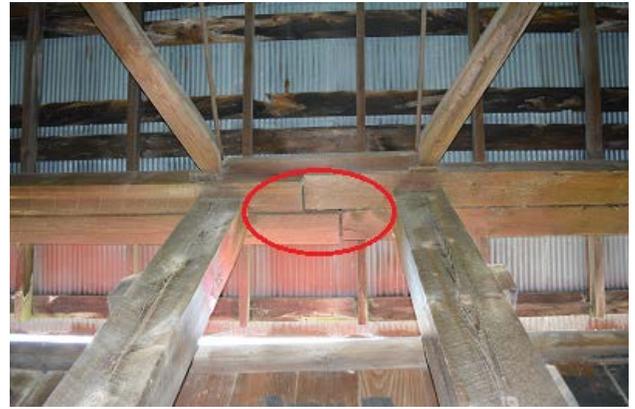
Figure 2.12—Displaced top chord members (Dunbar Bridge, 1880, Putnam County, Indiana).

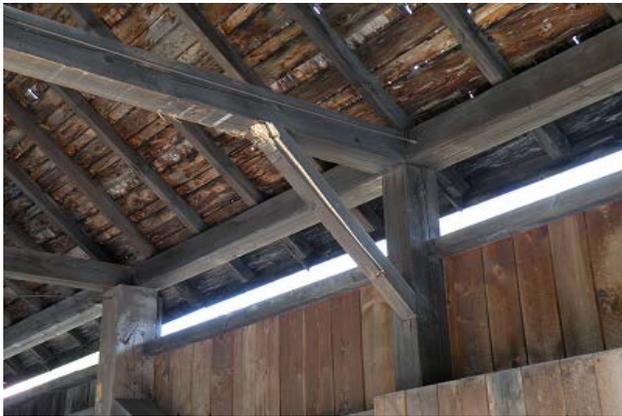
Figure 2.10—Damaged knee brace caused by vehicular impact (Lincoln Gap Covered Bridge, 1879, Washington County, Vermont).

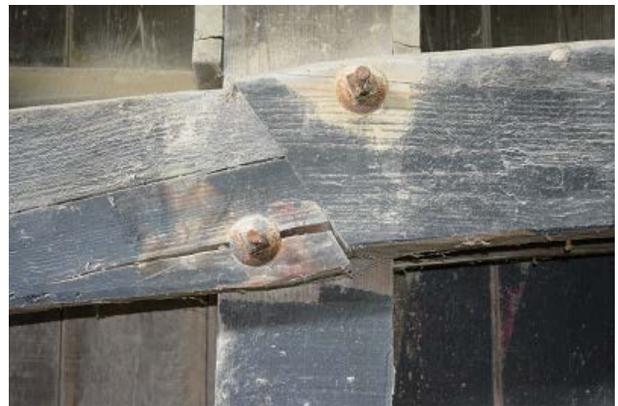
Figure 2.13—Split at bolted connection in a Burr arch truss (Cornstalk Covered Bridge, 1917, Putnam County, Indiana).

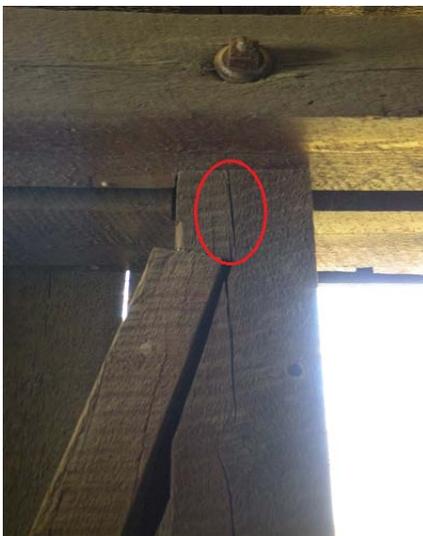
Figure 2.11—Compression diagonal notch in timber sheared off in a multiple kingpost truss (Blow-Me-Down Covered Bridge, 1877, Sullivan County, New Hampshire).

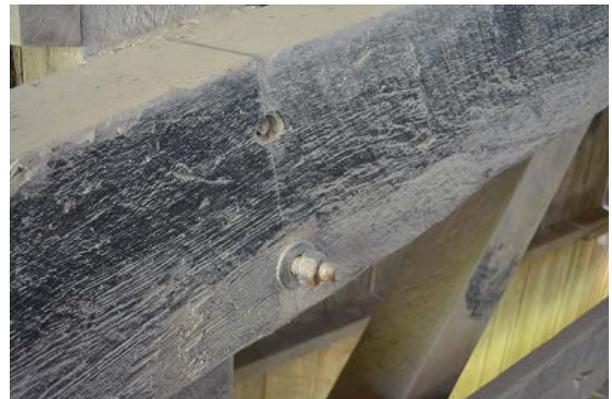
Figure 2.14—Loose and missing connections in the arch of a Burr arch truss (Oakalla Covered Bridge, 1898, Putnam County, Indiana).

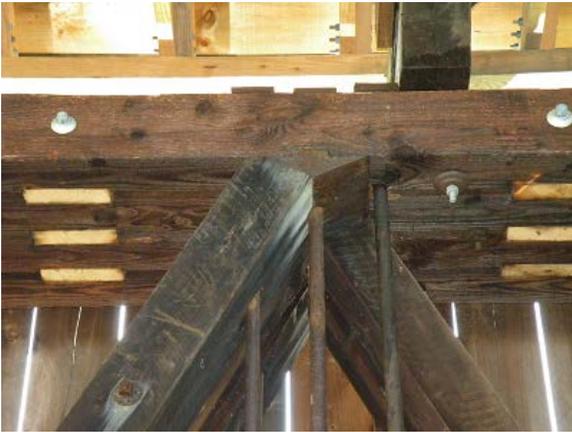
Figure 2.15—The steel rods, washers, and nuts have surface rust in this Howe truss. This is typically not problematic, but if the connections are loose, that may indicate more serious problems with the bridge (Shoreham Bridge, 1897, Addison County, Vermont).

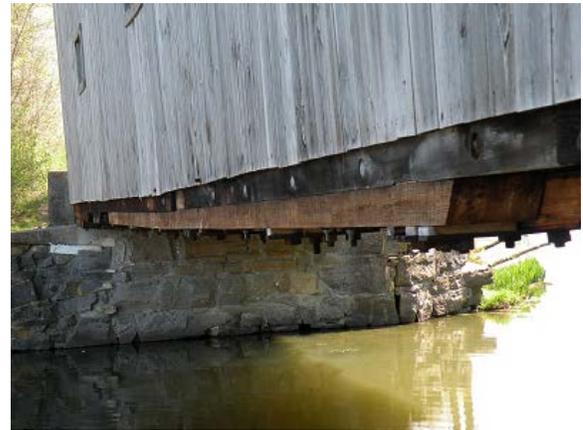
Figure 2.18—Sagging (reverse camber) (Shoreham Bridge, 1897, Addison County, Vermont).

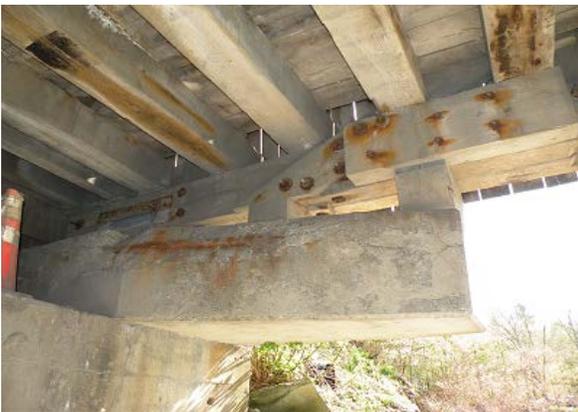
Figure 2.16—The bolts on the bottom chord of this Burr arch truss have extensive corrosion. This may be superficial, but the efflorescence of salt on the concrete bolster beam below the bottom chord indicates an environment where de-icing salts are used and where corrosion of the fasteners may be a significant problem (Waitsfield Village Bridge (or Big Eddy Bridge), 1833, Washington County, Vermont).

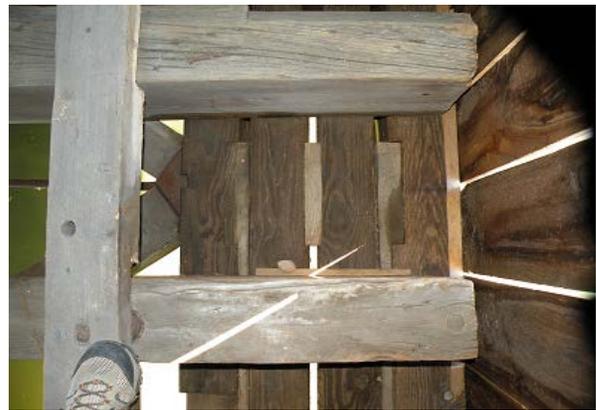
Figure 2.19—Bottom chord of the truss with deck joists above. Gaps can develop in the splices, weakening the bottom chord, especially towards midspan (Shoreham Bridge, 1897, Addison County, Vermont).

- Wood with moisture stains, visible decay, or insect damage
- Wood in contact with the ground
- Notched or drilled timber connections where moisture can accumulate
- Truss members
- Deck joists, stringers, and girders (Fig. 2.19)
- Openings (for example, portals, frames, and windows; Fig. 2.20)
- Material interfaces (for example, bolster beams on masonry; Figs. 2.21 and 2.22)
- Exterior woodwork, including cladding and shingles (Fig. 2.23)
- Areas where debris can build up (for example, guardrails and bridge approaches; Figs. 2.24 and 2.25)
- Areas of the bridge that have been altered (for example, previous repairs; Fig. 2.26)

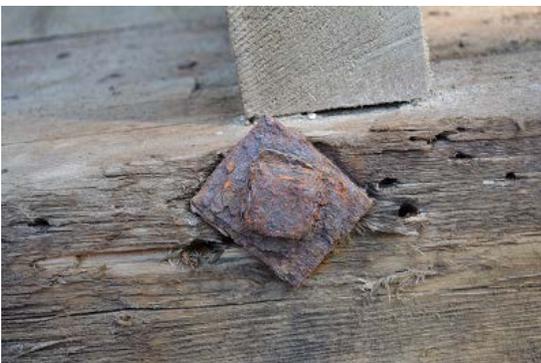
Figure 2.17—Close up of a severely corroded bolt (Blair Bridge, 1829, 1869, Grafton County, New Hampshire).

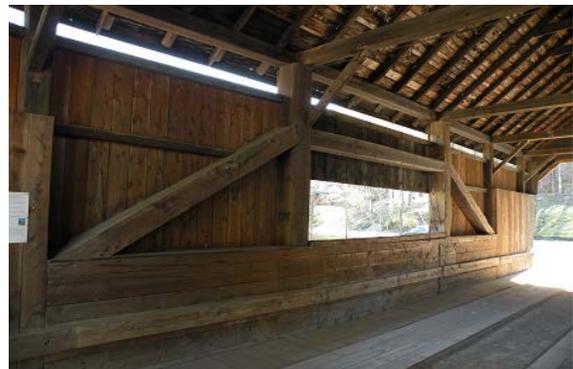
Figure 2.20—Portal opening and window (Lincoln Gap Covered Bridge, 1879, Washington County, Vermont).

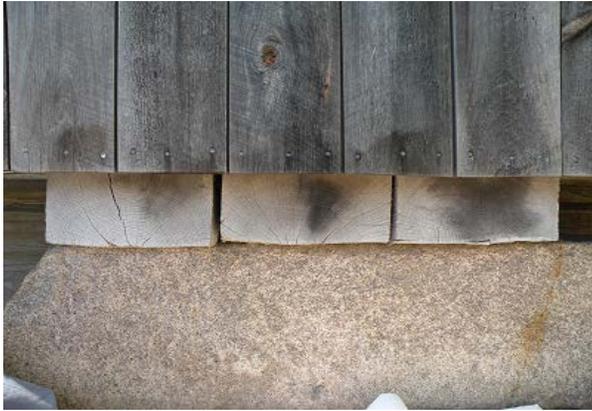
Figure 2.21—Material interface at the abutment (Cornish-Windsor Covered Bridge, 1866, Sullivan County, New Hampshire, and Windsor County, Vermont).

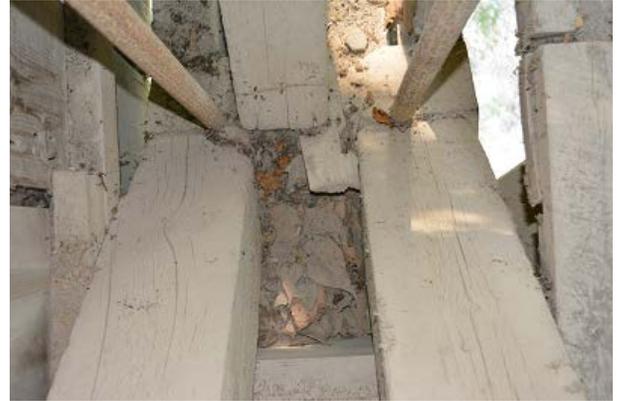
Figure 2.24—Location along a bottom chord where debris can build up between the diagonals and the vertical post (Pine Bluff Covered Bridge, 1915, Putnam County, Indiana).

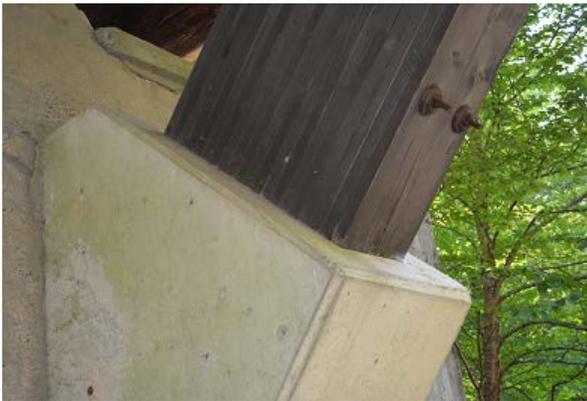
Figure 2.22—Material interface between an arch and abutment (Durgin Covered Bridge, 1869, Carrol County, New Hampshire).

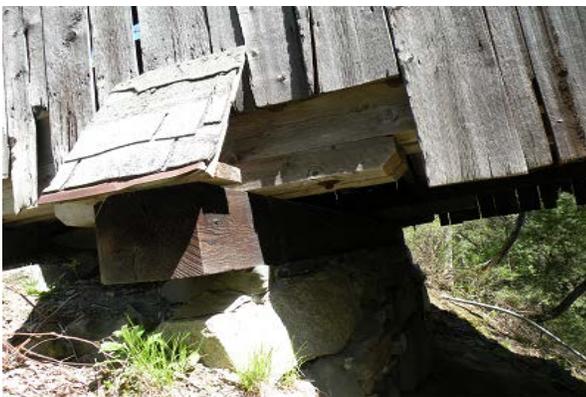
Figure 2.23—Exterior cladding and roof over bearing beam (Blow-Me-Down Covered Bridge, 1877, Sullivan County, New Hampshire).

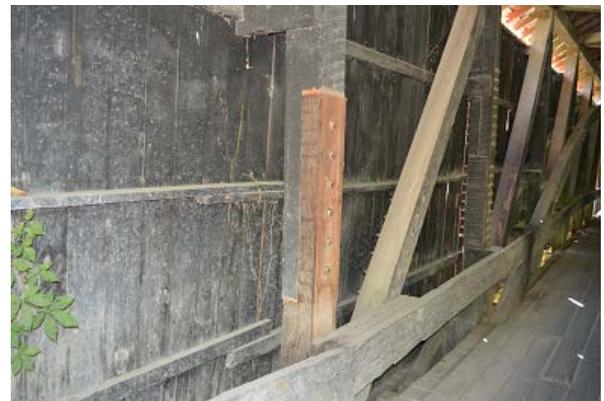
Figure 2.26—Previous repair to a truss post (Baker's Camp Covered Bridge, 1901, Putnam County, Indiana).

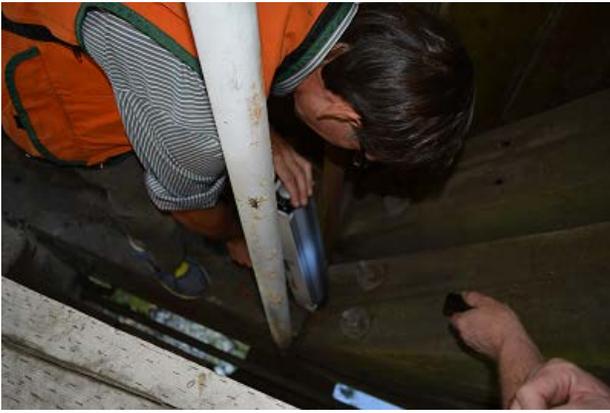
Figure 2.27—Resistance drilling of a Howe truss diagonal (Belknap Covered Bridge, 1966, Lane County, Oregon).

Resistance drilling using a calibrated electronic drill provides quantified information about the internal, hidden condition of the wood members in a covered bridge (Fig. 2.27). The term resistance drilling has been used to describe any drilling technique intended to measure the ease of drill penetration into wood. Portable drills with standard bits have been used not only to test the relative difficulty of drilling into wood (resistance) but also to observe the color and integrity of the wood chips extracted by the drill bit. However, this type of drilling cannot quantify the loss of material.

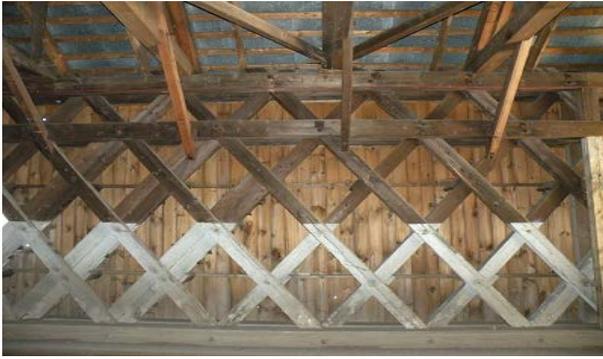
Figure 2.28—The siding makes inspection of the treenail connections located on the outside of this Town lattice truss difficult (Cornish-Windsor Covered Bridge, 1866, Sullivan County, New Hampshire, and Windsor County, Vermont).

One of the most common issues when assessing a covered bridge is difficult access. Some members may have easy access on only one side (Figs. 2.28 and 2.29), some

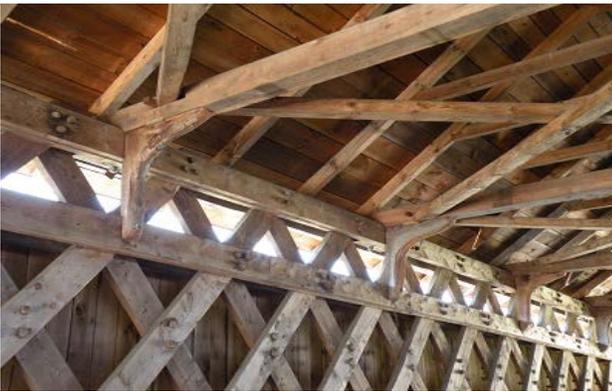
Figure 2.29—Top chord of a Town lattice truss that is difficult to inspect on the top and outside surfaces because of the roof pitch (North Hartland Twin Bridge, 2001, Windsor County, Vermont). There is a twin bridge at this river crossing (the Willard Covered Bridge) that dates from 1871.

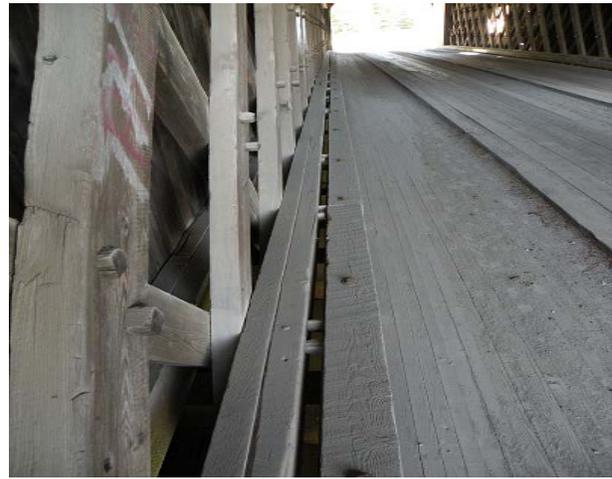
Figure 2.30—Limited access to bottom chord of the truss for conducting a condition assessment (Willard Covered Bridge, 1871, Windsor County, Vermont).

members may be wholly or partially covered by other members (Fig. 2.30), and some members have excellent accessibility (Fig. 2.31). Other members may have no easy access although they are visible from a distance (Fig. 2.32). The assessment may be limited to visual inspection, perhaps using a mirror or videoscope, or limited to touch to sense loose or missing connections or pockets of deterioration.

On the bridge shown in Figure 2.30, the guardrail is on shims to allow debris to flow underneath the guard rail and off of the deck. The bottom chord of the truss is only accessible from below. However, because of the elevated guardrail, this bridge is more conducive to “natural” cleaning that decreases maintenance requirements.

Contrasted with the hidden bottom chord shown in Figure 2.30, the bottom chord of the truss shown in Figure 2.31 provides nearly ideal access for inspecting the timber. The timbers are visible, and accessible for probing or conducting resistance drilling. It is easy to see if debris is trapped.

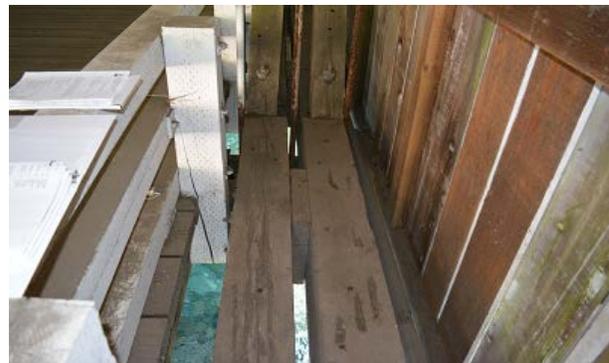
Figure 2.31—Excellent access to bottom chord of the truss for conducting a condition assessment (Belknap Covered Bridge, 1966, Lane County, Oregon).

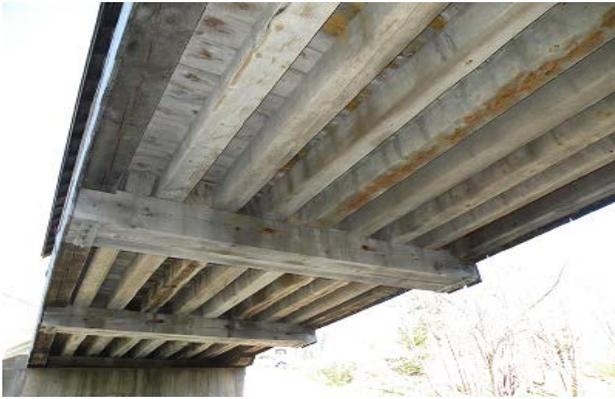
Figure 2.32—Girders and stringers that are visible from below but are difficult to access because of the height above the river (Lincoln Gap Bridge, 1879, Washington County, Vermont).

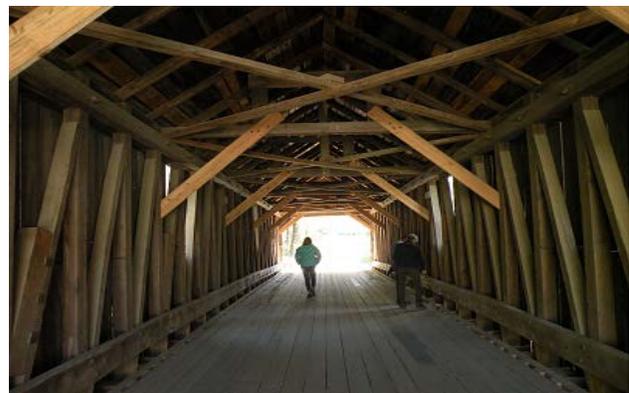
Figure 3.1—Multiple kingpost truss (Blow-Me-Down Covered Bridge, 1877, Sullivan County, New Hampshire).

Even for a relatively simple structure, such as a multiple kingpost truss bridge (Fig. 3.1), the results from most commercially available computer modeling software typically show that the bridge is structurally inadequate, when in fact, it has been performing quite well for some time. There is a certain irony in watching a 30-ton truck cross a bridge with a posted 3-ton limit without producing a visible deflection. The bridge is performing well. What is

Figure 3.1 shows that how and where the truss members are connected can dramatically impact the structural performance of the truss and bridge, and accurately modeling that performance in a computer model is often very difficult to do. To illustrate some of the peculiarities of covered bridge structural behavior, examples of issues to consider when analyzing simple joints or the composite action of a Burr arch truss are presented later in this chapter.

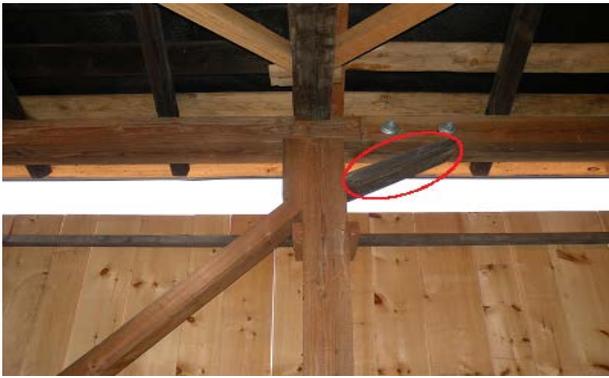
Figure 3.2—Check brace (Pulp Mill Covered Bridge, 1820, Addison County, Vermont).

It is important to understand that there are very few unnecessary components in a covered bridge. If there is something inserted into the structure, no matter how small, there is probably a reason it is there. An example of this is the small check brace shown in Figure 3.2. The truss was constructed with the diagonal web member connecting to the vertical below the panel point. The intent of the design was that the vertical post be axially loaded and the diagonal web member connects to the post below the top chord to simplify the joinery where the vertical post meets the top chord. The diagonal web member induces a bending moment in the vertical post at the connection (remember that the post is designed to carry axial loads, not bending loads). To resist the bending moment and keep it from pushing the vertical post out of plane, the bridge builders inserted a short check brace. Some contractors or structural engineers may not realize the importance of this small detail. If the check brace is removed during repairs, a bending moment is introduced in the vertical post that it was never intended to carry, possibly resulting in unintended consequences.

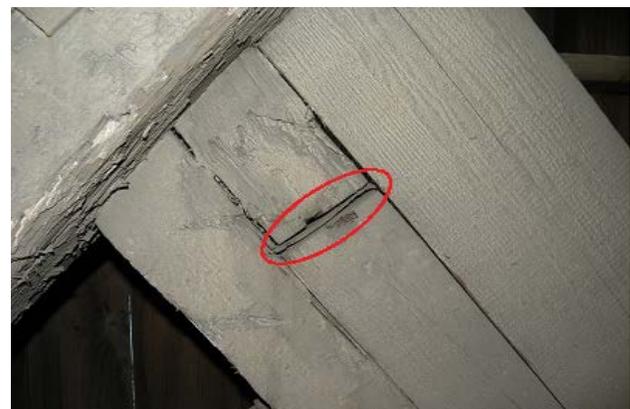
Figure 3.4—Shim in a compression diagonal of a Town lattice truss (Cornish-Windsor Covered Bridge, 1866, Sullivan County, New Hampshire, and Windsor County, Vermont). The shim should not be removed.

The repair detail shown in Figure 3.3a and b is a round shear pin, designed to transfer shear loads between adjacent members of a Town lattice truss. To the untrained individual, it may look like a plug with no structural role. The shim in Figure 3.4 was inserted during previous repairs

to ensure that the compression load in the diagonal was transferred adequately. Sometimes these small construction details seem like an afterthought, and people want to pull them out (sometimes as a souvenir). If a shim needs to be removed during repairs because of deterioration or damage, a new one should be installed using one made of the same wood species. If it is not replaced, leaving a gap, the

diagonal will no longer have full contact in bearing and the compression load will not be transferred as originally intended.

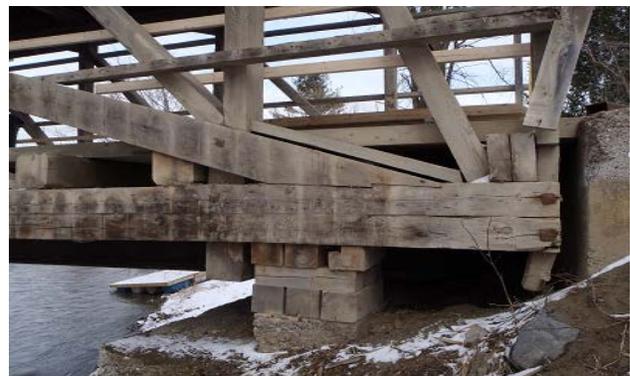
Figure 3.9—A Burr arch using a tied-arch detail (Quinlan Covered Bridge, 1849, Chittendon County, Vermont. Used with permission from Katherine Hill PE, The Structures Studio – Structural Engineers).

Some Burr arches use a tied-arch detail instead (Fig. 3.9). In this case, the bottom end of the arch is notched directly into the truss bottom chord near the end of the chord. This has the advantage of better protecting the end of the arch from the elements and eliminating the possibility of differential settlement between arch and truss supports. However, the thrusting force of the arch is now resisted by the truss bottom chord rather than the abutments, significantly increasing the tension force on the bottom chord splices — the connection that typically limits the overall load capacity of the bridge. The arch-to-bottom-chord connection is prone to shear failure because the notch is close to the end of the chord; failure of this connection can produce distress in the truss as it results in complete loss of the arch action.

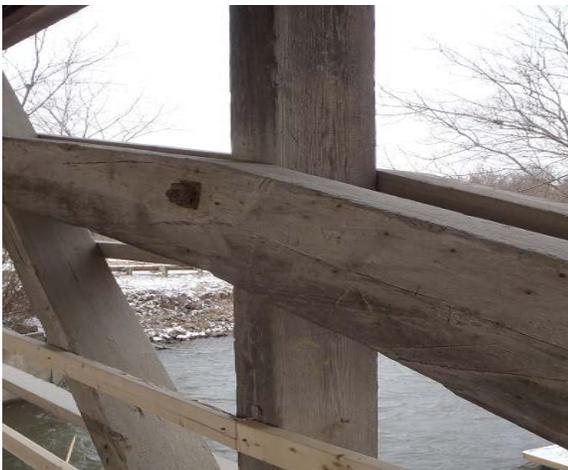
Figure 3.10—A Burr arch bolted to the truss vertical (Quinlan Covered Bridge, 1849, Chittendon County, Vermont). The bolt is a 1- by 1-in. wrought-iron bolt penetrating 19 in. of wood, turned down to a 1-in. diameter at the threads (Used with permission from Katherine Hill PE, The Structures Studio – Structural Engineers).

Details vary for those cases in which the arch is connected to the trusses. A single iron through-bolt is a common detail, typically grossly undersized by today's design standards and often decreased in cross section because of corrosion (Fig. 3.10). If the bolt is undersized, does the engineer want to rely on that existing bolted connection as a load-transfer

mechanism? Some of these bolts show visible signs of distress when removed, including bending of the bolt and crushing of the surrounding wood; such a bolt cannot be assumed to provide a rigid connection from arch to truss. In theory, one could treat the bolt as a spring and continue on with the computer analysis; in reality, it is difficult to estimate the spring stiffness of the bolt with sufficient accuracy to justify the increased time and complexity to include this spring behavior in the computer model.

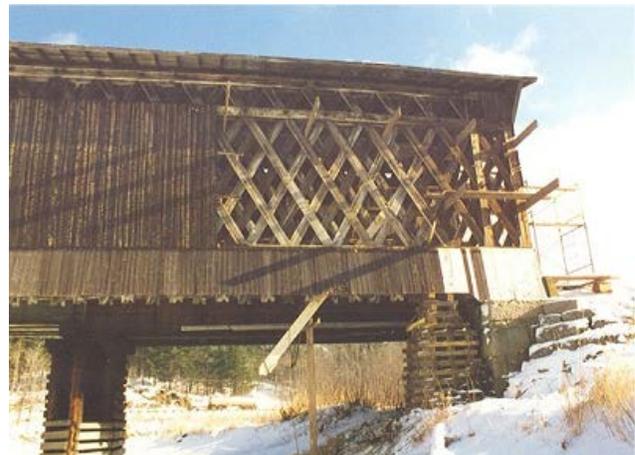
Figure 4.3—Cribbing under the Fisher Railroad Bridge (1908, Lamoille County, Vermont. Used with permission from Jan Lewandoski).

the bridge shown in Figure 4.2, the support was needed at the abutment to repair the bedding timbers. Additionally, cribbing and shoring were installed further from the abutment to support the heavy-timber lattice truss railroad bridge because of the need to repair the damaged timber that extends further from the abutment (Fig. 4.3). The cribbing and shoring allowed for replacing failed lattice members and adding supplementary braces to address displacement of the bottom chords just beyond the abutments (Fig. 4.4).

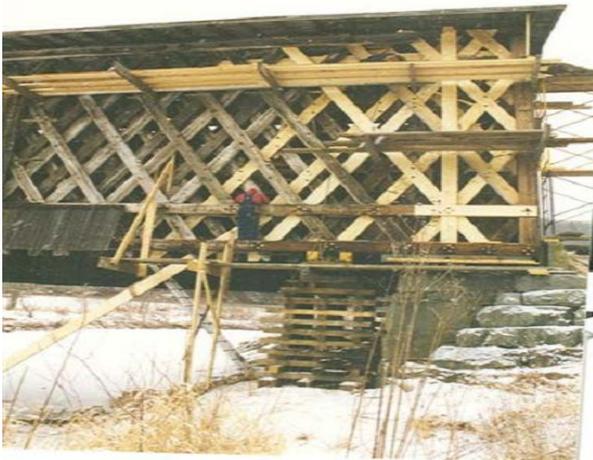
Figure 4.4—Repairs being made to the failed lattice members and bottom chords after placement of cribbing and shoring (Fisher Railroad Bridge, 1908, Lamoille County, Vermont. Used with permission from Jan Lewandoski).

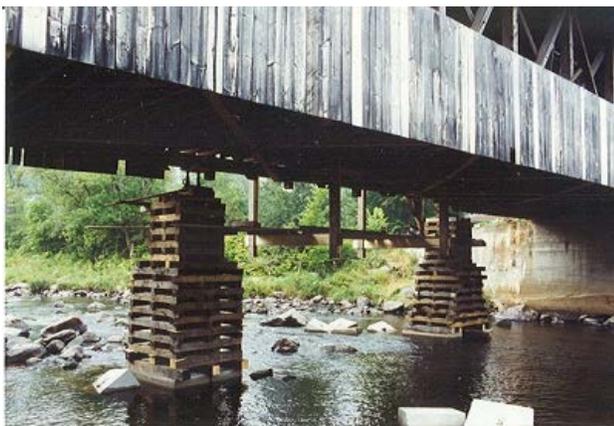
Figure 4.5—Shoring of the Israel River Bridge in progress. Note the staging hung from the cribs (Israel River Bridge, 1862, Coos County, New Hampshire. Used with permission from Jan Lewandoski).

Shoring to support the bridge may require supports placed in the river. Although careful planning is critical, it is possible to place staging on a frozen river provided that the loads are not too heavy and the work can be completed before a thaw. More frequently, temporary foundations of large concrete blocks or sandbags can be leveled on the riverbed to support timber cribs (Fig. 4.5). Structural staging can be used for

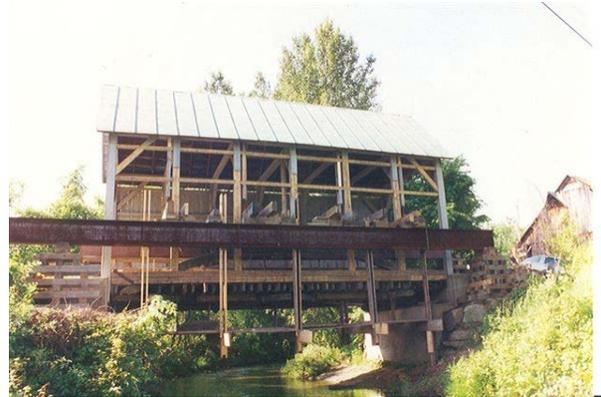
Figure 4.6—Steel I-beams supported on timber cribs laid on the abutments. Timber shores were placed across the steel beams at each column, and the top chord was jacked. Note the suspended staging for accessing the bottom chords and deck frame (Best's Covered Bridge, 1899, Windsor County, Vermont. Used with permission from Jan Lewandoski).

For shoring truss chords and decks, timbers, steel beams, or wood I joists suspended below the bridge deck often make up part of the shoring (Figs. 4.6 to 4.10). The shoring provides a walkway beside the bridge deck and can be used to support members that are to be repaired. Jacks can be placed on the shores when it is necessary to remove loads from members that require repair. As with cribbing, setting the staging is an art. Although the repairs are the final product, the logistics of repair implementation — setting the cribbing, shoring, and staging — are essential to

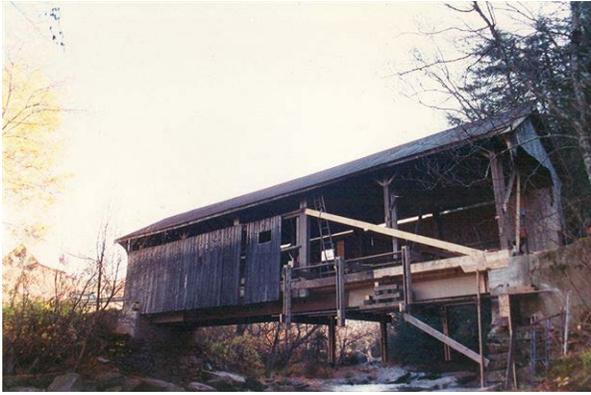
Figure 4.8—Supplementary beams installed to support the roadway in an earlier repair were used to shore one of the queenpost trusses for repair. Note the repair at the bottom chord and replacement bed timber and arch brace (Lumber Mill Covered Bridge, ca. 1890, Lamoille County, Vermont. Used with permission from Jan Lewandoski).

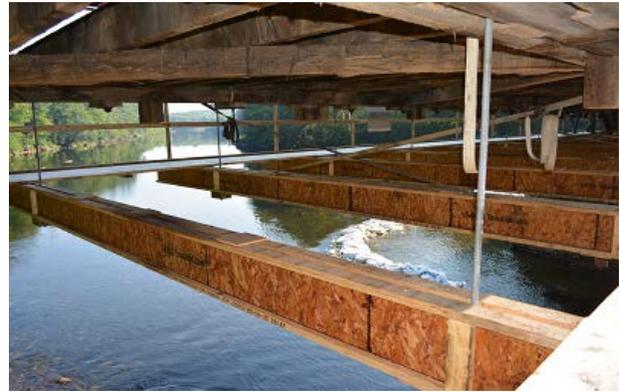
Figure 4.10—Structural wood I-joists used as shoring beneath the truss chords and deck (Blair Bridge, 1829, 1969, Grafton County, New Hampshire).

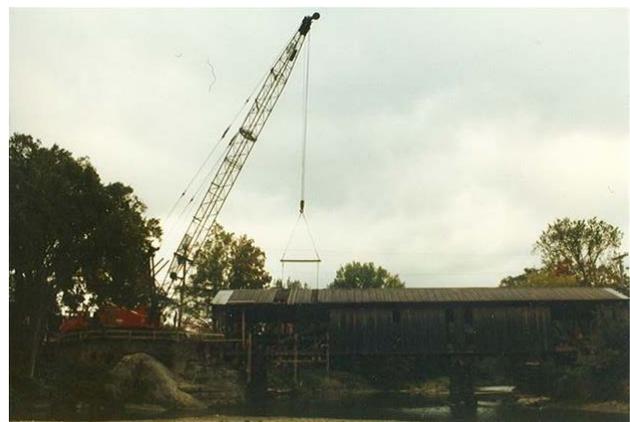
Figure 4.11—Rigging using a crane, equipped with slings and spreaders to lift and support the portion at the abutment. Additional shoring of the Big Eddy included a timber crib near the middle of the river to decrease the effective span by approximately 40% (Waitsfield Village Bridge (or Big Eddy Bridge), 1833, Washington County, Vermont. Used with permission from Jan Lewandoski).

Rigging makes use of cables, chains, or other means to lift or support heavy timbers, staging, shoring, assemblies (for example, trusses), or the entire bridge. In the context of covered bridges, rigging typically involves the use of cables for lifting or providing temporary support (Figs. 4.11 and 4.12).

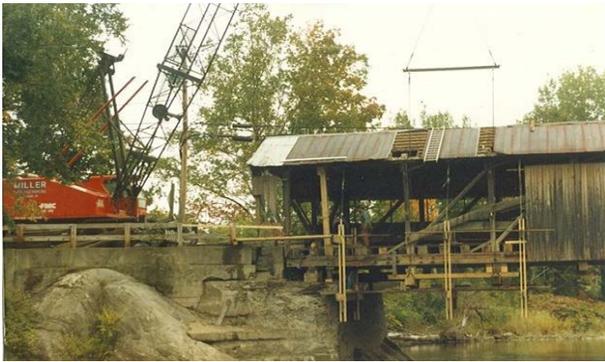
Figure 4.12—Using a crane to rig cable stays for supporting a small section of the bridge while repairs were made (Waitsfield Village Bridge (or Big Eddy Bridge), 1833, Washington County, Vermont. Used with permission from Jan Lewandoski).

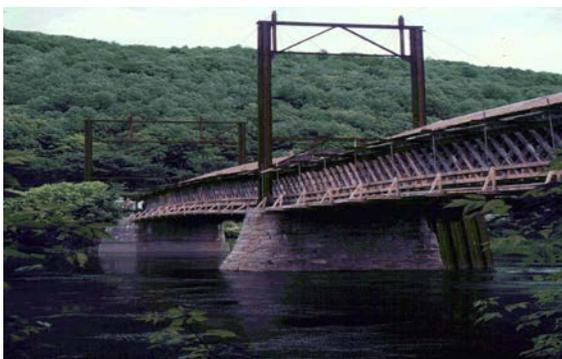
Figure 4.13—Rigging (Cornish-Windsor Covered Bridge, 1866, Sullivan County, New Hampshire, and Windsor County, Vermont. Used with permission from Jan Lewandoski and D. Huston).

The Cornish–Windsor Bridge is the longest two-span covered bridge in North America. The main support structures are Town lattice trusses, visible after the siding was removed (Fig. 4.13). A proprietary cable-stay system (Dywidag Systems International USA, Inc.) was used to shore the bridge for repairs. Primary cables were rigged on temporary steel frames, with cable stays supporting steel needle beams inserted below the top chords at regular intervals. With this system, it was possible to restore camber to the spans.

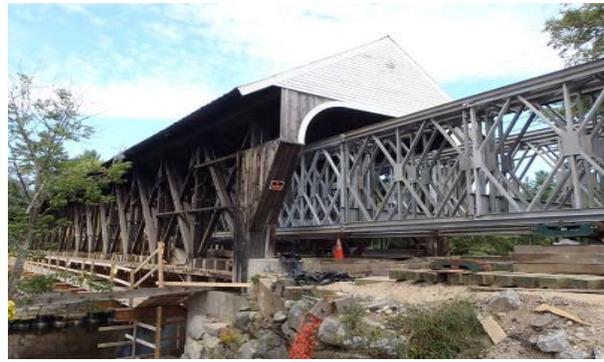
Figure 4.14—Acrow multispan panel truss being inserted (Blair Bridge, 1829, 1869, Grafton County, New Hampshire. Used with permission from Katherine Hill).

Modular support trusses are available to slide into the opening of a covered bridge, connect to the timber trusses, and remove loads from the wood trusses so that repairs can be made. These modular trusses essentially provide jacking points along the entire length of the bridge, so that the

bridge can be fully supported to recover camber and make repairs. In this way, modular support trusses can expedite repairs and decrease the need for other means of structural support. The trusses are typically panel systems that are extended through the bridge from abutment to abutment. The weight of the multispan truss is not insignificant and requires care in installation to prevent damage to the timber bridge that may already be in fragile condition (Figs. 4.14 and 4.15). Monitoring movement at key locations, such as piers, may be desirable. Although accelerometers, lasers, or other sensors can be used to monitor movement or vibration, sometimes watching for vibrations in a cup of water strategically placed can be as useful as more sophisticated sensors (Fig. 4.16).

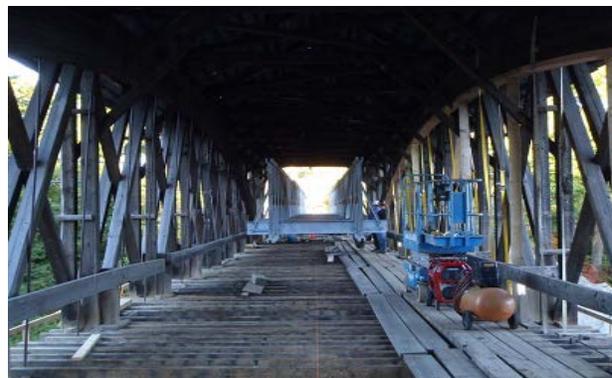
Figure 4.15—View from inside the bridge of the Acrow multispan panel truss as it is being inserted into the bridge (Blair Bridge, 1829, 1869, Grafton County, New Hampshire. Used with permission from Katherine Hill).

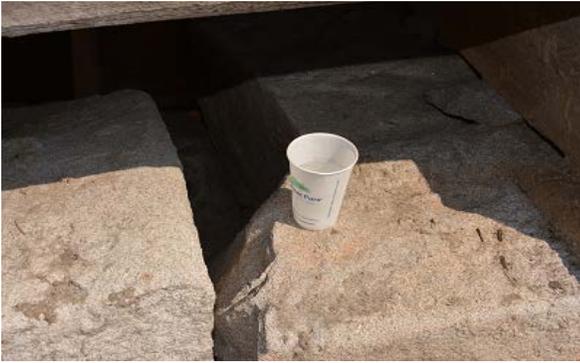
Figure 4.16—Monitoring pier movement using a paper cup filled with water to watch for vibrations (Blair Bridge, 1829, 1869, Grafton County, New Hampshire).

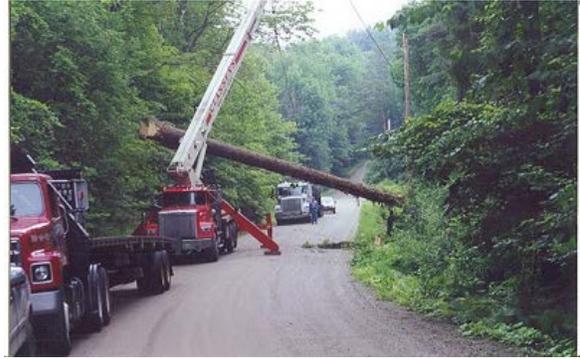
Figure 4.19—Felling a locally available tree to meet size requirements and transportation limitations (Lincoln Gap Covered Bridge, 1879, Washington County, Vermont. Used with permission from Jan Lewandoski).

Repairing timber bridges can require custom sawmilling to obtain timbers in lengths not readily available or when transportation logistics may be prohibitive. The spruce log shown in Figure 4.19 was sawn into a 60-ft-long,

12- by 12-in. timber for replacing the decayed bottom chord of a small queenpost truss bridge.

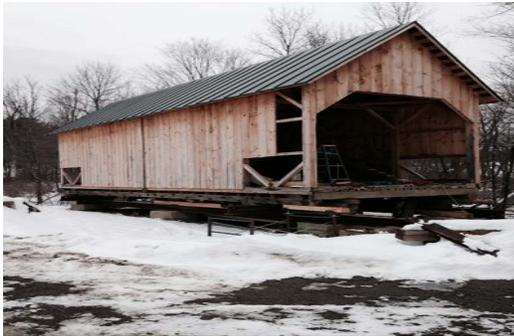
Figure 4.17—Bridge removed from the river for repairs. This small Burr arch truss bridge has been removed from the river (by crane) and temporarily shored on I-beams for repair. Because repairs included the addition of lamina to the arch and replacement of decayed bottom chord members to increase cross section of the chords, it was more efficient and cost-effective to move the bridge to implement the repairs (Bowers Covered Bridge, 1919, Windsor County, Vermont. Used with permission from Jan Lewandoski).

supports, or lifting it with a crane. In the temporary location, it can be repaired without working over the river (Fig. 4.17). If it is deemed necessary to remove the bridge from the river to most effectively achieve the needed repairs, the crane operator must coordinate with the structural engineer to identify locations for attaching cables and rigging. The structural engineer will need to provide a rigging plan specifying the lifting points, cable sizes, and connection details. This information, much of which can be derived from the engineer’s structural model, is critical to avoid damage to the bridge during lifting.

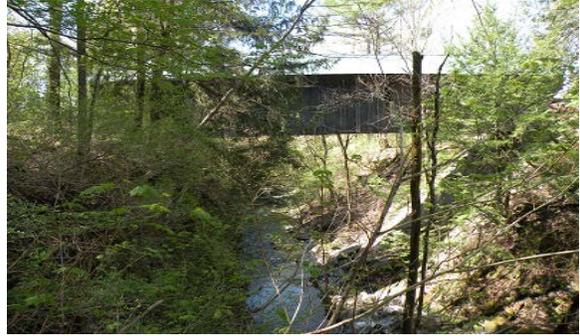
Figure 4.20—A deep ravine that limits access to the bridge from below (Blow-Me-Down Covered Bridge, 1877, Sullivan County, New Hampshire).

When a bridge is over a deep ravine, moving the bridge or installing shoring may be challenging or infeasible because of logistics, cost, or environmental concerns. In these situations, it may be possible to install additional structure and avoid disassembly and repair procedures that require shoring. For example, on the bridge in Figure 4.20, many of the connections on the lower ends of the kingposts and diagonals had failed because of inadequate end distance in the connections. Shear blocks were installed to help transfer load between the diagonal and the vertical posts (Fig. 4.21) in areas of the timbers unaffected by deterioration.

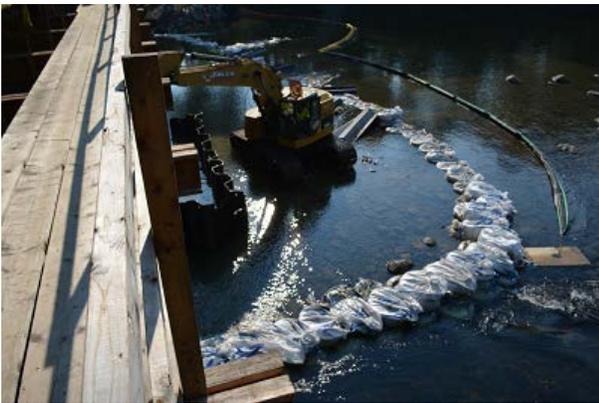
Figure 4.18—Constructing a cofferdam to allow for work on the pier (Blair Bridge, 1829, 1869, Grafton County, New Hampshire).

Cofferdams are useful when repairs to piers and abutments are necessary. The cofferdam serves as a temporary enclosure around a pier or adjacent to an abutment to allow for the water at the base of the pier to be drained (Fig. 4.18). Once watertight, the enclosure creates a dry area for the repair work to proceed.

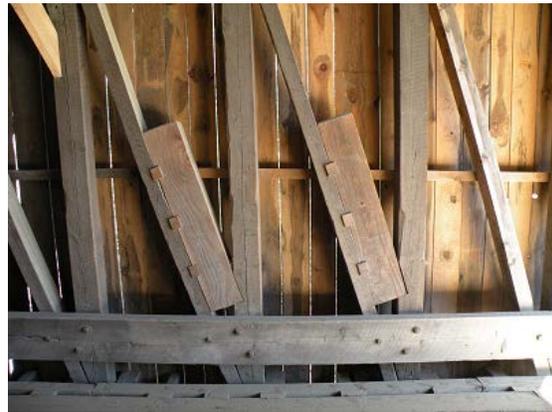
Figure 4.21—Shear blocks to transfer load between diagonal and vertical members that have deteriorated connections that could not practically be repaired from below (Blow-Me-Down Covered Bridge, 1877, Sullivan County, New Hampshire).

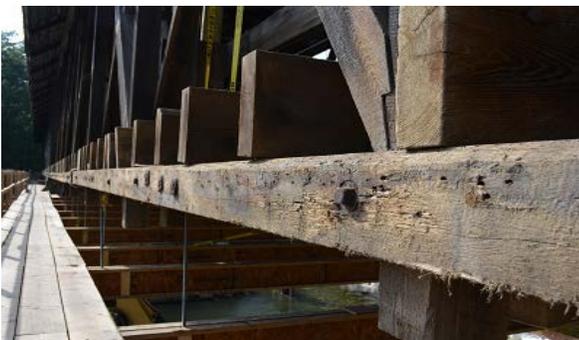
Figure 5.1—Weathered bottom chord in good condition (Blair Bridge, 1829, 1869, Grafton County, New Hampshire).

Figure 5.1 shows the exposed bottom chord of a truss. It looks a bit weathered, and there are small seasoning checks on the outer face. Seasoning checks are a natural characteristic of wood that develop as the wood dries and shrinks until it comes into equilibrium with environmental conditions of humidity and temperature. The short seasoning checks on this timber are approximately parallel to the long edge of the timber. That indicates that the timber has very little slope of grain and is a high-grade timber for structural purposes, at least based on the outer face. Looking for checks or large knots on the other faces is the means of assessing the grade, which is discussed later in this chapter. For this timber, no repairs are needed.
