Guidelines to Restoring Structural Integrity of Covered Bridge Members

Forest Service
Forest Products Laboratory
General Technical Report
FPL-GTR-252
January 2018

A FHWA-NHCBP (National Historic Covered Bridge Preservation) publication

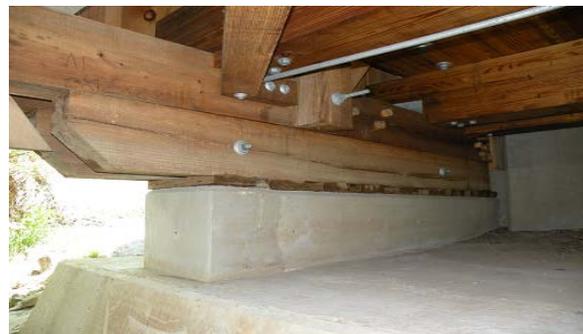
Figure 5.2—Bedding timber supporting the bottom chord of the truss. Note spacer blocks to provide separation that limits moisture absorption from the concrete into the bedding timber, thereby extending the service life of the bedding timber (Cornwall-Salisbury Covered Bridge, 1865, Addison County, Vermont).

If deterioration caused by wood decay or insect attack has decreased the cross section of the timber to the point at which it is no longer able to perform its intended function, replacement is warranted. Figure 5.2 shows a bedding timber, also called a bolster beam. The bedding timber distributes the load of the bottom chord at the abutment to prevent overstress that could result in crushing. For timber that is in direct contact with other materials, such as

concrete or masonry, moisture can migrate from the concrete or masonry into the bottom face of the timber. After prolonged contact with moisture, the timber can provide a favorable environment for wood decay. The bottom chord of a truss is a difficult member to replace because of numerous connections. The bedding timber carries the load from a quarter of the bridge into the abutment (because there is one at the end of each bottom chord). If a bedding timber deteriorates, replacing it is easier and less costly than repairing the bottom chord. The bedding timber is there to protect the bottom chord of the truss from deterioration. In essence, it can be considered sacrificial. The bedding timber in Figure 5.2 has wood spacer blocks under it to create a barrier between it and the concrete.

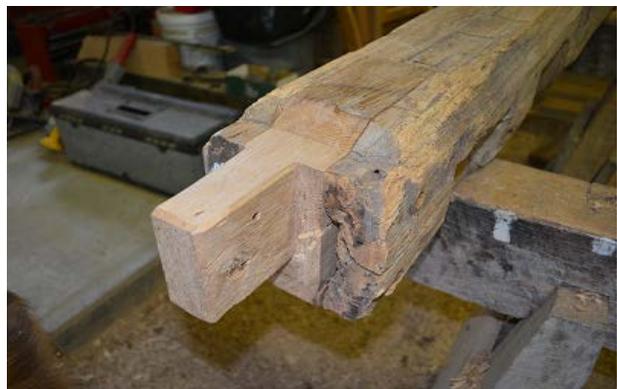
Figure 5.5—Tenon repair on the bottom of a post. The tenon was spliced into the deteriorated area, saving the rest of the post.

Although many repairs can be done in situ, damaged timbers are often temporarily removed from the bridge for repair. The tenon in the post shown in Figure 5.5 had deteriorated, but the rest of the post was intact. Splicing in a new tenon allows for restoring the strength of the joint while keeping much of the historic fabric.

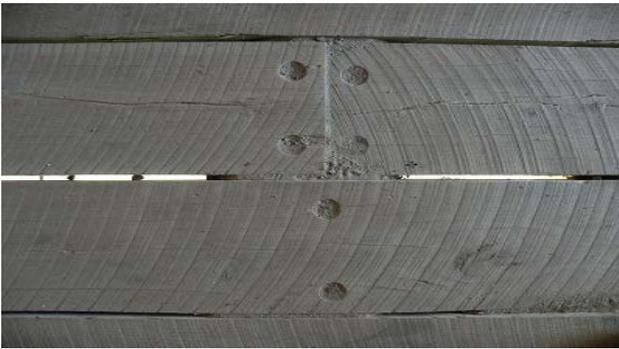
Figure 5.6—Circular-saw marks of decking boards (North Hartland Twin Bridge, 2001, Windsor County, Vermont).

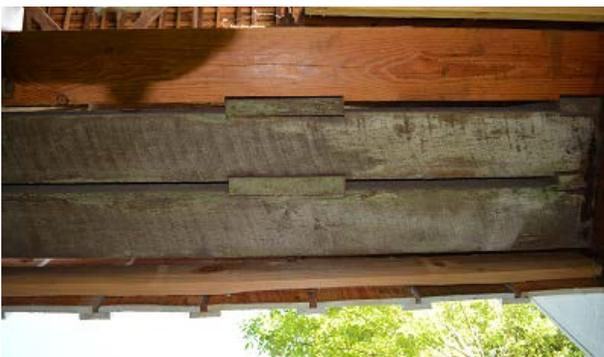
Figure 5.7—Replacement of a bottom chord timber (Parvin Bridge, 1921, Lane County, Oregon).

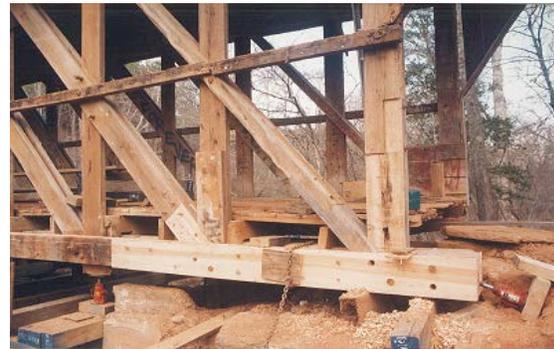
Figure 5.8—Bottom chord and post repaired using spliced timber (Bunker Hill Covered Bridge, 1895, Catawba County, North Carolina. Used with permission from DCF Engineering).

Figure 5.8 shows a post and bottom chord that have been repaired using the same wood species and timber joinery. The damaged portions of the post and bottom chord, including the connections, were cut away and the replacement timber was spliced to the sound wood of the original members. When the same wood species, grade, and quality are used at the same moisture content, an effective in-kind repair is likely to be a long-term repair.

An experienced craftsperson that understands timber joinery can produce tight structural joints that will work and last for decades. That is what is needed with a spliced repair. A loose joint will not only fail to correctly transfer the loads across the joint but will allow for moisture intrusion into the joint that can lead to early failure caused by wood decay, thereby requiring another repair well before it should be needed. The splices in Figure 5.8 in the bottom chord of the truss eliminated the need to replace the entire bottom chord. A number of other splices are visible in the post and the diagonal, all using traditional timber joinery.

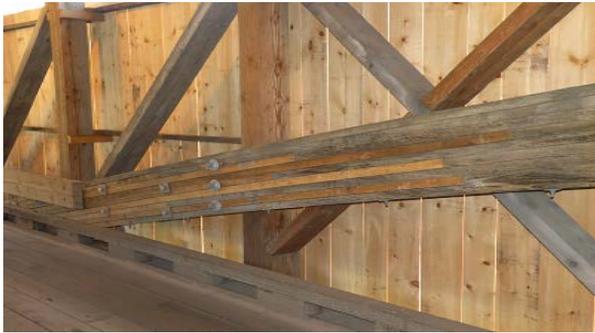
Figure 5.9—Replaced laminations in a double Burr arch truss (Pulp Mill Covered Bridge, 1820, Addison County, Vermont).

Figure 5.9 is an example of an arch that had some deterioration in laminae that made up the arch, probably caused by decay that developed with time. Rather than replacing the entire arch, it was possible to open the arch

and replace the individual laminations. That is usually the best means of doing an arch repair. It is typically not necessary to replace the entire end of the arch unless it is in poor condition (Fig. 5.10). If not properly integrated with the rest of the arch, replacing a segment of the entire cross section of an arch can introduce stresses into the connections between the original and replacement segments that alter the behavior of the arch. As was discussed in Chapter 3, the distribution of loads between the arch and the associated truss is complicated and any effort to repair the arch should strive to maintain the balance of load distribution. If individual laminations are in need of replacement or repair, replacing the individual laminations is possible using an experienced craftsperson.

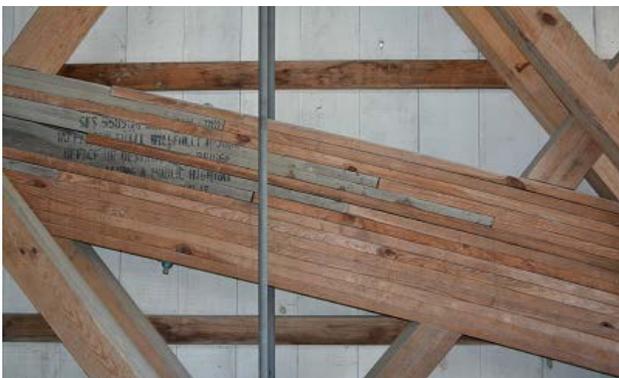
Figure 5.10—Blending of replacement laminations near the end of an arch with original laminations that are still in good condition (Mechanicsville Covered Bridge, 1867, Ashtabula County, Ohio).

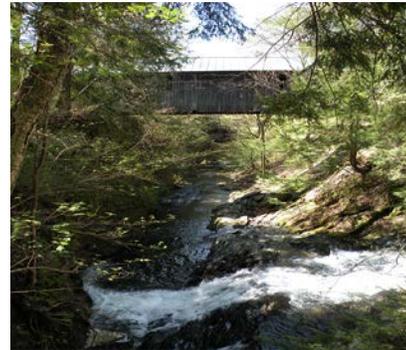
Figure 5.11—Deep ravine, which made use of shoring cost-prohibitive (Blow-Me-Down Covered Bridge, 1877, Sullivan County, New Hampshire).

Understanding the structural behavior of a bridge, in part through proper engineering analysis, is key to implementing effective repairs. When a repair is not as simple as a partial or full replacement, innovative solutions to challenging repair situations may be necessary. The bridge shown in Figure 5.11 had failed corbels at the bottom of the truss posts. The wood joinery that connected the vertical posts to the diagonals and the bottom chord of the truss had decayed and needed to be repaired. The bridge crosses a deep ravine,

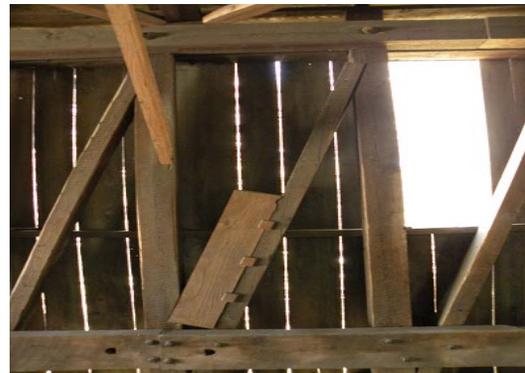
Figure 5.12—Sistered diagonal repair, using shear keys to transfer load (Blow-Me-Down Covered Bridge, 1877, Sullivan County, New Hampshire).

making the use of cribbing and shoring to support the bridge during repairs costly and challenging. The craftsperson used a sistered diagonal in which the short replacement timber bears in a new notch in the post (Fig. 5.12). The repaired diagonal has a shear key between the members to adequately transfer the loads. Although not the most elegant or aesthetic treatment, the repair is functional, it leaves the historic structural system in place, and it addresses site conditions, which are beyond the control of the engineer and the bridgewright or contractor.

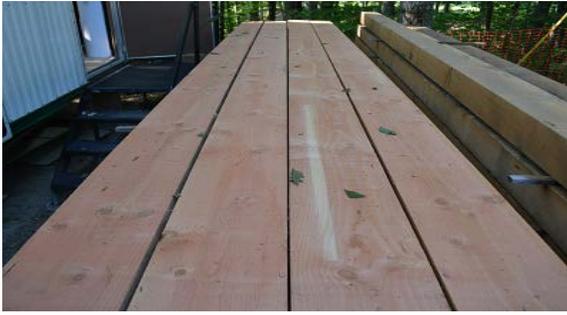
Figure 5.13—High-quality lumber procured for bridge repairs (Blair Bridge, 1829, 1869, Grafton County, New Hampshire).

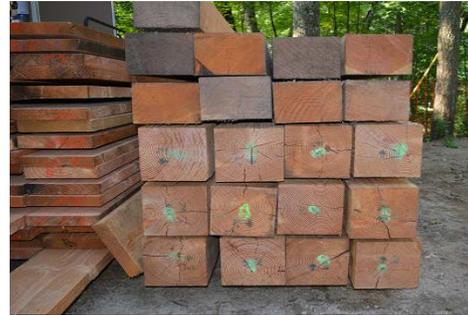
Figure 5.14—High-quality timber procured for bridge repairs (Blair Bridge, 1829, 1869, Grafton County, New Hampshire). Note the end checks (which are the result of the timbers drying) and proper storage with spacers to allow for air circulation.

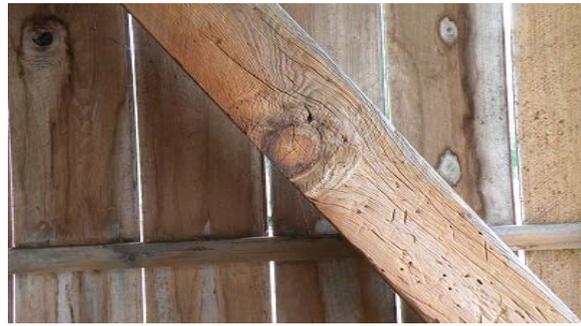
Figure 5.15—Large edge knot in a diagonal brace (Eldean Covered Bridge, 1860, Miami County, Ohio). Note how the grain deviates around the knot and “runs out” at the edge of the member. This creates a weak location in the member.

The location of the knot has an impact on member strength. Therefore, within industry-developed grading rules, there are knot size limitations based on the location of the knot. Centerline knots on the wide face of a member have the least impact on grade and therefore have the largest allowable knot size. Edge knots generally increase localized tensile stresses and therefore have smaller knot size limitations. This information can be useful to the structural engineer. Not only is the position of a knot known in a

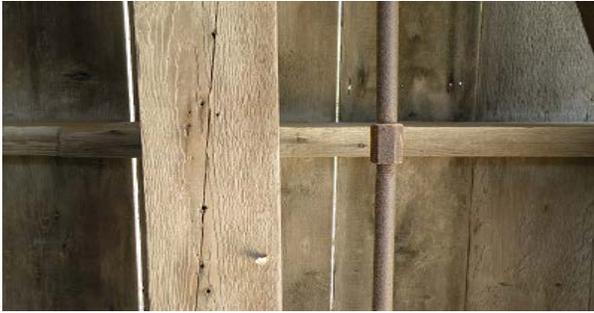
Figure 5.16—Slope of grain as evidenced by the presence of seasoning checks (Seguin Covered Bridge, 1850, Chittenden County, Vermont).

Slope of grain is generally measured as a ratio of rise to run, that is, the number of inches the grain slopes upward or downward within a given distance (generally 8, 10, 12, or 15 in.) that is parallel to the long axis of the member (Fig. 5.16). Because seasoning (drying) checks in timber generally follow the slope of grain, determining the slope of grain on painted timbers can be achieved relatively easily by examining drying checks. All visible faces of the timber should be examined for slope of grain because not all faces will exhibit the same extent of slope of grain. Twist in a

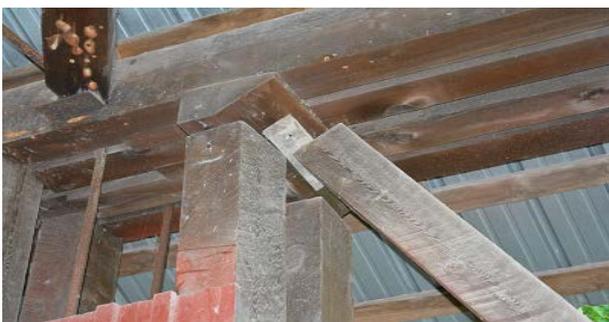
Figure 5.17—Slope of grain in a vertical post as indicated by slight twisting at the top of the post (Pine Bluff Covered Bridge, 1915, Putnam County, Indiana).

member is also indicative of slope of grain when seasoning checks are absent (Fig. 5.17). Although not always conclusive, this approach closely correlates with results achieved using laboratory methods for measuring slope of grain, which are not practical for field use.

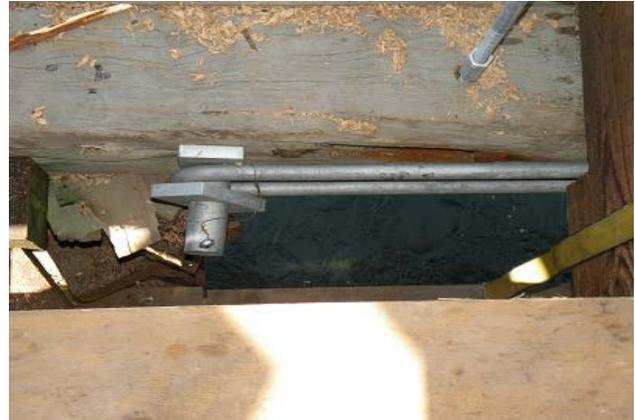
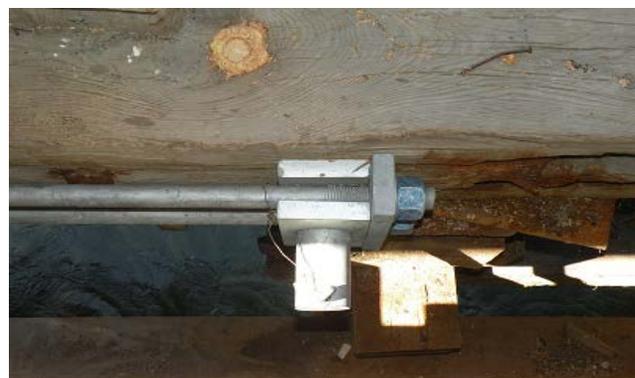
Figure 5.18—U-bolt tying together a scarf joint in the bottom chord (Taftsville Covered Bridge, 1836, Windsor County, Vermont).

Figure 5.19—U-bolt tying together a scarf joint in the bottom chord (Taftsville Covered Bridge, 1836, Windsor County, Vermont).

Steel U-bolts placed on opposite sides of the timbers can be used to augment the connection capacity between the timbers. The goal is to tie the chord together when minor damage or deterioration is present in or near the connection, but this does not warrant a full repair. The timber shown in Figures 5.18 and 5.19 is a bottom chord with a splice between two timbers. The steel U-bolts allow for increasing the strength of the poor connection by maintaining tightness between the timbers. Because the bottom chord is in tension, the connection wants to open under load; the U-bolt helps to keep the bottom chord timbers together and decreases sag in the bridge. Rather than steel U-bolts being used, connections in the original timbers are often joined with timber joints

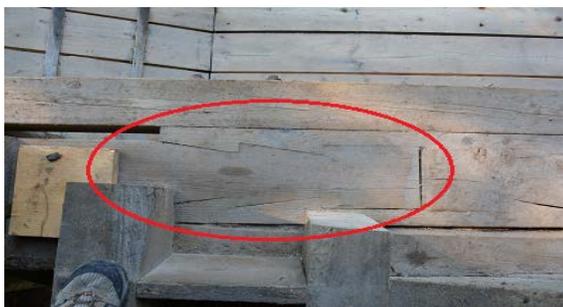
Figure 5.20—Lightning bolt splice used to join two timbers in a bottom chord (Blair Bridge, 1829, 1869, Grafton County, New Hampshire).

using shear blocks, such as the lightning bolt splice shown in Figure 5.20.

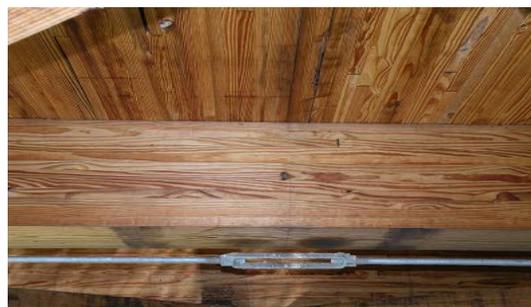
Figure 5.21—Glued-laminated timber joists for increasing the load-carrying capacity of the deck (Cornwall-Salisbury Covered Bridge, 1865, Addison County, Vermont).

Often somewhat hidden from public view, glulam truss chords and floor beams are unobtrusive and can be installed using many of the same methods used for solid timbers (Fig. 5.21). Glulam connections often consist of steel angles and plated connectors, rather than traditional timber joinery, to take advantage of the higher design properties (Fig. 5.22). Glulam can also be used for bedding timbers (Figs. 5.23 and 5.24).

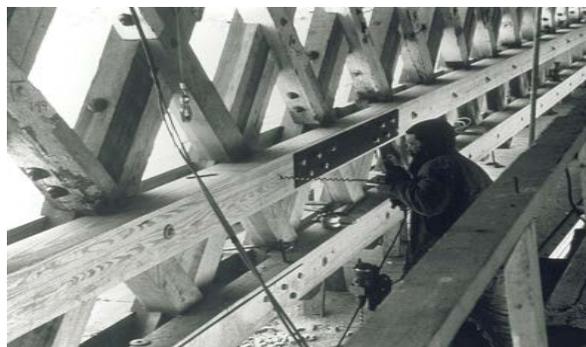
Figure 5.22—Installing a glulam bottom chord in a Town lattice truss ca. 1988 (Cornish-Windsor Covered Bridge, 1866, Sullivan County, New Hampshire, and Windsor County, Vermont. Used with permission from DCF Engineering).

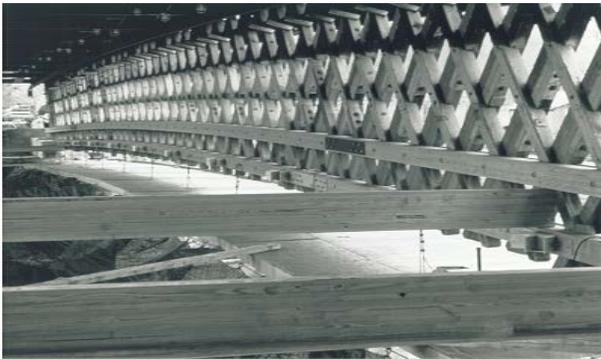
Figure 5.23—Glulam bottom chord and floor beams being installed ca. 1988 (Cornish-Windsor Covered Bridge, 1866, Sullivan County, New Hampshire, and Windsor County, Vermont. Used with permission from DCF Engineering.)

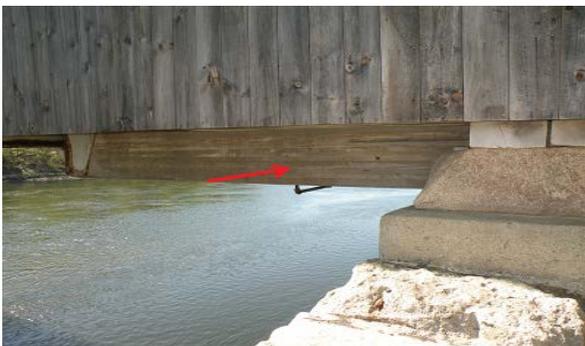
Figure 5.24—Glulam used as a bedding timber (Cornish-Windsor Covered Bridge, 1866, Sullivan County, New Hampshire, and Windsor County, Vermont).

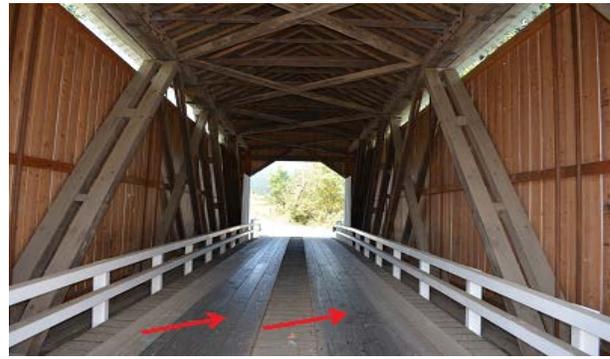
Figure 5.25—Running planks (Parvin Bridge, 1921, Lane County, Oregon).

Solid lumber planks were traditionally used for decking, occasionally with two lines of running planks parallel to the long axis of the bridge for wheels (Fig. 5.25). The running

planks could more easily be replaced than deck boards after physical abrasion from traffic decreased their thickness. Running planks were considered sacrificial; that is, maintenance of the deck included periodic replacement of these planks. Decking designed to carry greater loads relied on the composite action of the decking rather than on each deck plank carrying the load.

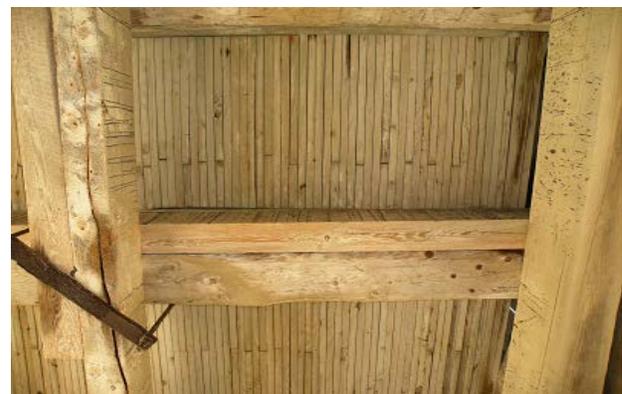
Figure 5.26—Stress-laminated deck viewed from below (Seguin Covered Bridge, 1850, Chittenden County, Vermont).

Mechanically laminated decking places the deck boards on edge, then secures them to one another with nails, and in later versions screws, to provide a stiffer and stronger deck than simple plank decks. The same construction technique is used to construct the arches in covered bridges to give them composite action so they act as a unit rather than several loose boards. Mechanically laminated decks have been used for several decades. The composite action can increase the capacity of the decks considerably. Since the early 1990s, stress-laminated decks have been in use (Figs. 5.26 and 5.27). The difference between the traditional mechanically laminated deck connected with nails or screws and a stress-laminated deck is that, with stress-laminated decks, the deck boards are joined with steel rods that extend across the entire width of the deck. The threaded rods are stressed in

tension and clamped along the edges of the deck to squeeze the deck boards together. The resulting increase in friction between the boards improves the composite action compared with the use of many nails or screws. Glulam panels that are fabricated off site can also be used as replacement decking to increase the capacity of the bridge.

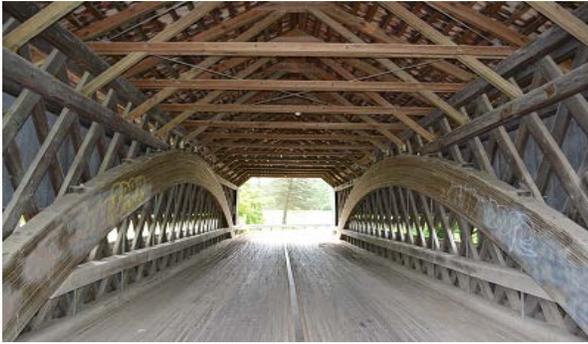
Figure 5.27—Stress-laminated deck as the wearing surface (Doyle Road Covered Bridge over Mill Creek, 1868, Ashtabula County, Ohio).

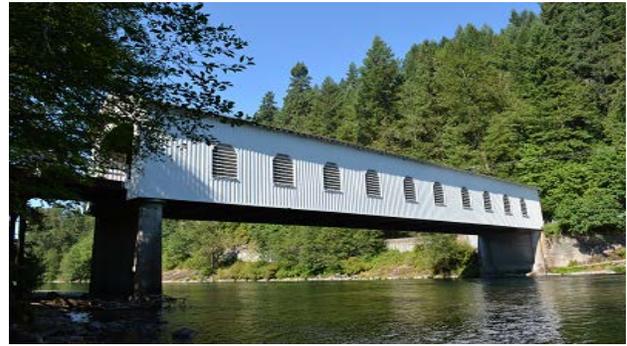
Figure 5.28—Overview (Goodpasture Covered Bridge, 1938, Lane County, Oregon).

The capacity of a covered bridge can be increased, or at least restored to its original capacity, by post-tensioning. Post-tensioning involves adding steel cables or rods to carry some of the load that the bottom (tension) chord may not be able to carry because of its species, size, or grade. The Goodpasture Covered Bridge in Oregon (Fig. 5.28) carries very significant highway loads, including logging trucks. One option that allowed for maintaining the historic integrity and aesthetics of the bridge while increasing load capacity was to insert post-tensioning cables (strands). Steel rods could also have been used; using rods would have simplified the anchorage details and made it much easier to retension should it be necessary to make adjustments. In either case, as with any significant repair, proper shoring and staging was required to prevent damage to the bridge

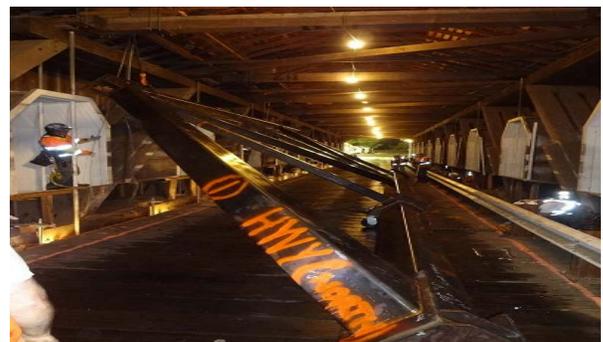
Figure 5.29—First steel truss being inserted into a bridge (Goodpasture Covered Bridge, 1938, Lane County, Oregon. Used with permission from OBEC Consulting Engineers).

during repairs. Steel trusses were erected inside the bridge to provide temporary support (Figs. 5.29 and 5.30).

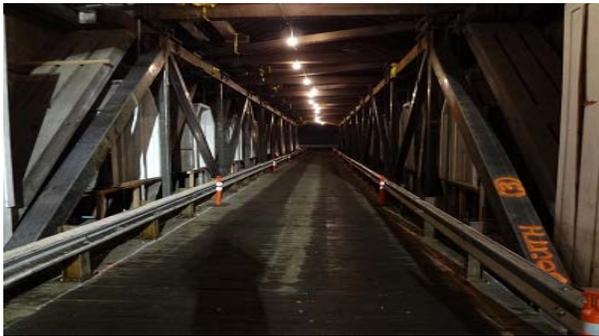
Figure 5.30—Steel support trusses erected in a bridge prior to installing post-tensioning hardware (Goodpasture Covered Bridge, 1938, Lane County, Oregon. Used with permission from OBEC Consulting Engineers).

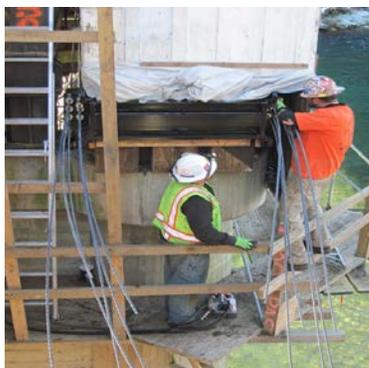
Figure 5.31—Steel end plate at the end of the bottom chord serving as the anchor for the steel strands (Goodpasture Covered Bridge, 1938, Lane County, Oregon. Used with permission from OBEC Consulting Engineers).

The ends of the bottom chords had steel plates attached to them to serve as the anchors for the cables (Figs. 5.31 and 5.32). The cables, each made up of several strands, were threaded through steel guides along the length of the bridge to prevent abrasion that could damage the cables or bottom chord timbers (Fig. 5.33). The contractor did not have access under the bridge and could not replace the floor beams. Therefore, the strand guides were attached to the bottom chords about midway between each pair of floor beams. After the strands were installed, hydraulic jacks were used to apply 20,000 lb of tension to the strands. The tensioning process transferred some of the tension that was carried by the timber bottom chord, which was highly stressed in tension, into the cables (Fig. 5.34). As a result, the bottom chord was no longer the controlling member in the bridge and the rated capacity increased from 15 to 44 tons to support loads associated with heavy trucks.

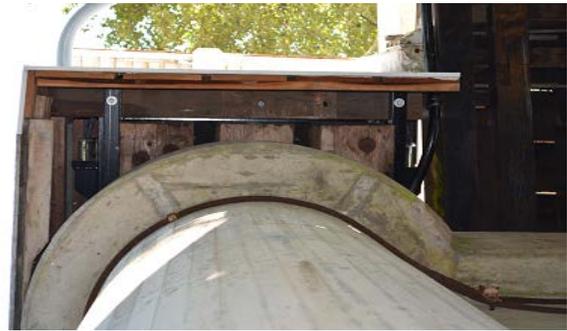
Figure 5.32—Steel end plate that serves as the anchor for the steel strands, viewed from below (Goodpasture Covered Bridge, 1938, Lane County, Oregon).

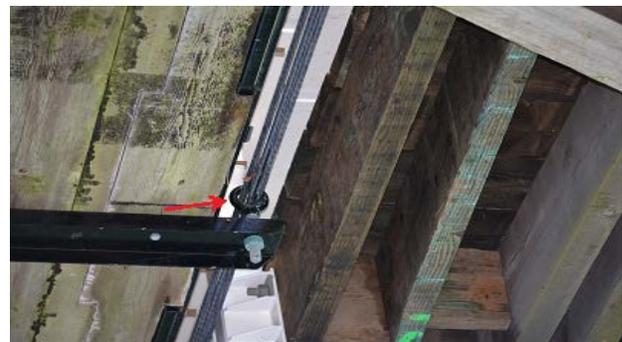
Figure 5.33. Steel strands threaded through a guide to prevent abrasion of either the cables or the bottom chord timbers (Goodpasture Covered Bridge, 1938, Lane County, Oregon).

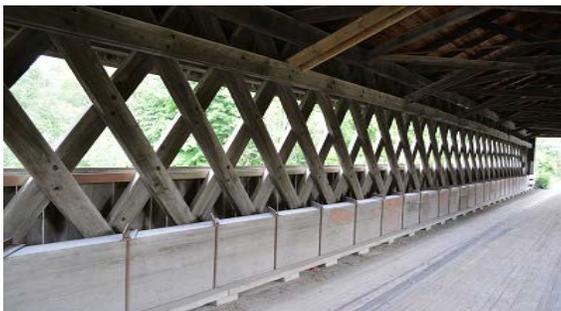
Figure 5.35—Root Road Covered Bridge, 1868, Ashtabula County, Ohio.

Lack of adequate clearance, either within the bridge or above the waterway, has resulted in damage to bridge members from oversized vehicles and loss of several bridges from flooding. Glulam beams have been used to essentially lower the deck from its original position, thereby increasing the height of vehicles that can pass through the bridge. Clearance is increased because the floor beams are attached to the bottom of the glulam, thus lowering the deck. This repair also offers the advantage of increasing the capacity of the bridge. Although effective, inserting the glulam dramatically alters the interior bridge aesthetics (Fig. 5.35).

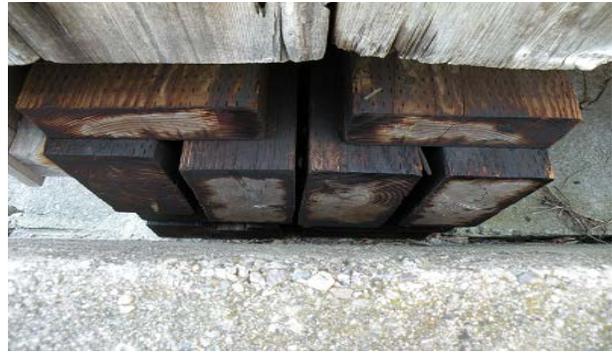
Figure 5.36—Pressure-treated bedding timbers used for increased durability (Shoreham Bridge, 1897, Addison County, Vermont).

durability (Fig. 5.36). Pressure treating timber is discussed in numerous publications that give the benefits and drawbacks of using chemically treated wood. Some wood species can be treated quite easily, such as southern yellow pine, whereas others are difficult to treat and rely on mechanical means, such as incising Douglas-fir to improve penetration of treatment into the wood (Fig. 5.37).

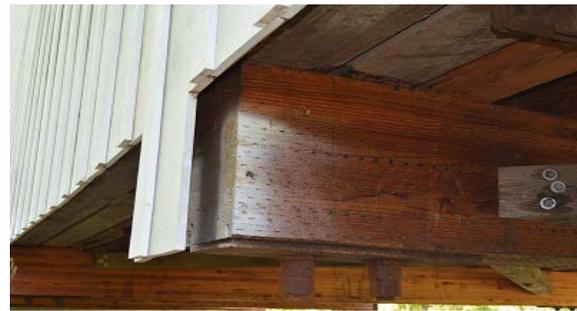
Figure 5.37—Pressure-treated glulam repair (Parvin Bridge, 1921, Lane County, Oregon).

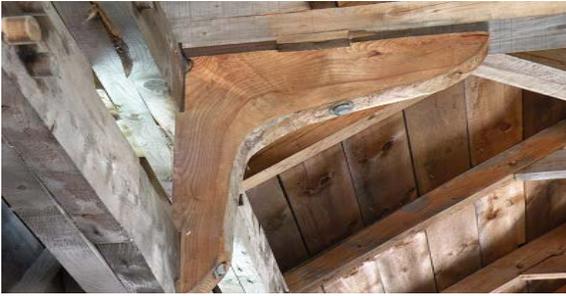
Figure 5.38—Natural knee brace; the curvature of the brace follows the grain (North Hartland Twin Bridge, 2001, Windsor County, Vermont).

An option for increasing internal clearance is the use of natural knee braces (Figs. 5.38 and 5.39). A natural knee brace comes from the base of a tree where the roots extend or from the juncture of a branch with the trunk. It forms a very strong brace that increases clearance for over-sized vehicles.

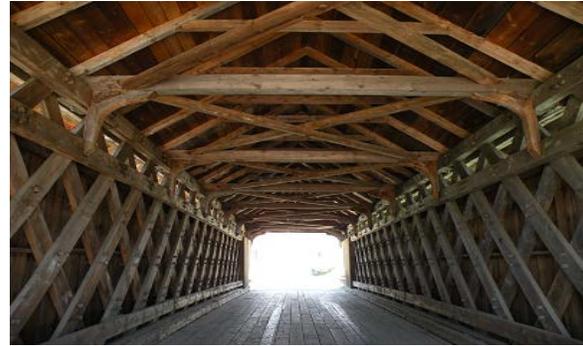
Figure 5.39—Natural knee braces (North Hartland Twin Bridge, 2001, Windsor County, Vermont).

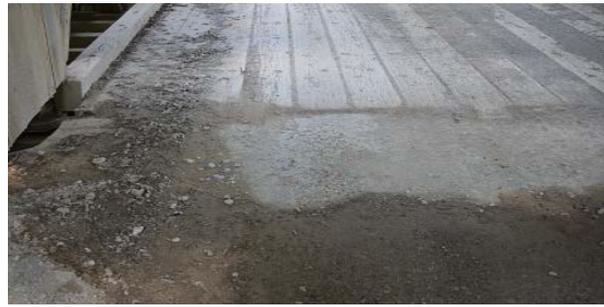
Figure 6.1—Debris build-up on bridge wearing surface and at the approach (Century Bridge, 1868, Ashtabula County, Ohio).

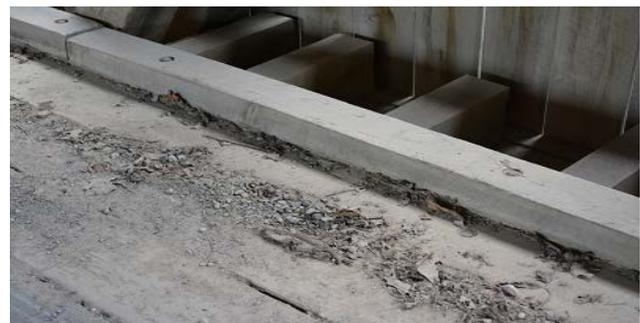
Figure 6.2—Debris build-up on wearing surface (Century Bridge, 1868, Ashtabula County, Ohio).

Figure 6.6—Gap under guardrail allows debris to be washed away. Compare with guardrail in Figure 6.2 that rests directly on the wearing surface (Willard Covered Bridge, 1871, Windsor County, Vermont).

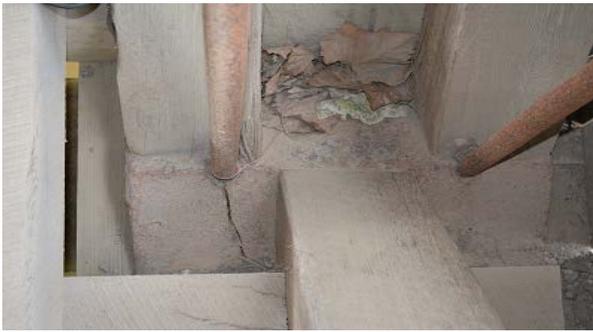
Figure 6.3—Vegetation debris build-up (Century Bridge, 1868, Ashtabula County, Ohio).

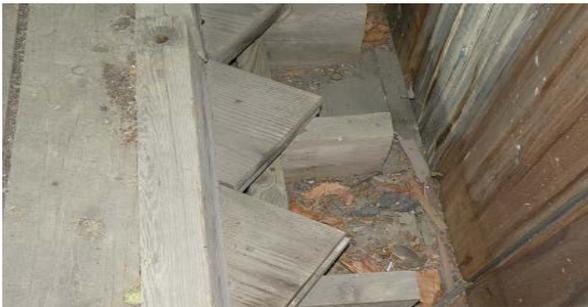
Figure 6.4—Debris build-up between boards and adjacent to siding (Ballard Road Covered Bridge, 1883, Greene County, Ohio).

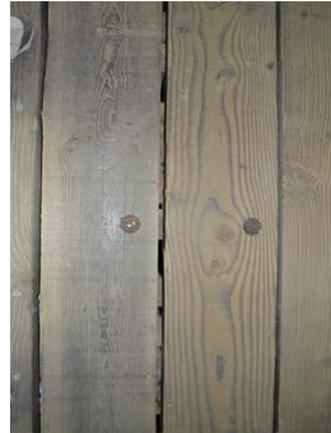
Figure 6.7—Gaps between the decking that allow for drainage of water and fine debris (Goodpasture Covered Bridge, 1938, Lane County, Oregon).

Some bridges have features that limit the accumulation of debris by providing natural drainage below the guardrail (Fig. 6.6), between the wearing surface decking (Fig. 6.7), or other areas. It is important to maintain the historic character of the bridge, but if opportunities are available to improve drainage and limit accumulation of debris that do not change the historic character of the bridge, they should be considered to decrease maintenance demands. Installing a grate or a cattle guard at an approach will significantly decrease the quantity of gravel and loose vegetation that accumulates on the bridge by providing a drainage

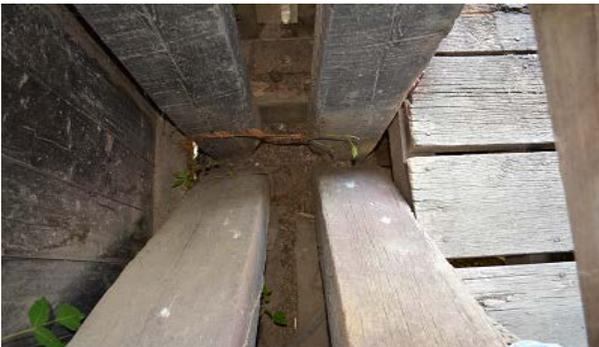
Figure 6.5—Debris accumulation and incipient vegetation colonization (Houck Covered Bridge, 1880, Putnam County, Indiana).

Many covered bridges are not on paved roads or at least may not have paved approaches. Gravel, dirt, and grit accumulate on the approach, and then foot and vehicular traffic aid in moving some of the debris onto the bridge. Precipitation further moves the debris onto the wearing surface, running boards, supporting timbers, and trusses (Figs. 6.1 and 6.2). Wind blows loose vegetation (leaves, pine needles, grass, etc.) into areas of the trusses that are not well drained for this larger debris (Figs. 6.3 and 6.4). With time, it is trapped and allows for moisture to accumulate and be absorbed into the wood at that spot. Left in place long enough, the trapped, moist material can allow the growth of grass, shrubs, and even trees. Identifying and removing vegetation and trapped debris is easy and highly effective in protecting the bridge (Fig. 6.5).

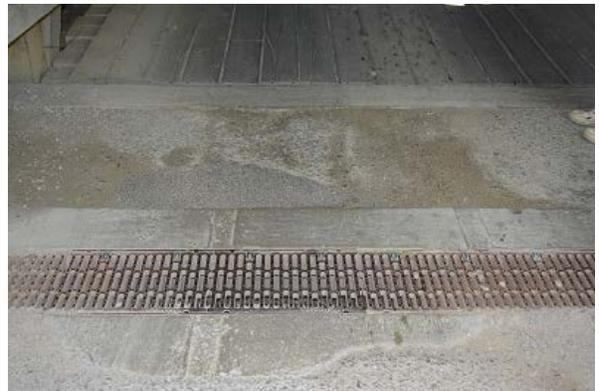
Figure 6.8—Steel grate on approach to bridge to intercept debris before it reaches the wearing surface of the bridge (Baker's Camp Covered Bridge, 1901, Putnam County, Indiana).

mechanism that intercepts debris before it reaches the bridge (Fig. 6.8).

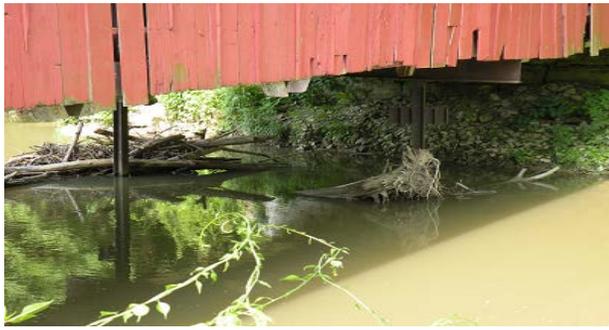
Figure 6.9—Debris build-up under bridge (Stevenson Road Bridge, 1877, Greene County, Ohio).

Cleaning under the bridge is equally important. Debris flowing downstream can collect on piers, abutments, rocks, and low-flow areas (Fig. 6.9). With sufficient build-up, the debris may contact the bedding timbers, lower chords of the trusses, or siding. As with accumulated debris on the bridge, debris and vegetation that is in contact with the wood can result in active wood decay. Potentially more serious, sufficient build-up of debris can restrict flow of the waterway during periods of high rainfall, run-off, or flooding that can erode the material around the piers and abutments. The loss of material, or scour, can result in destabilization of the bridge supports and has resulted in collapse of bridges. Bridge siding and lower chord members are frequently loosened, damaged, or lost as the result of impacts by brush and other debris carried down waterways by high water.

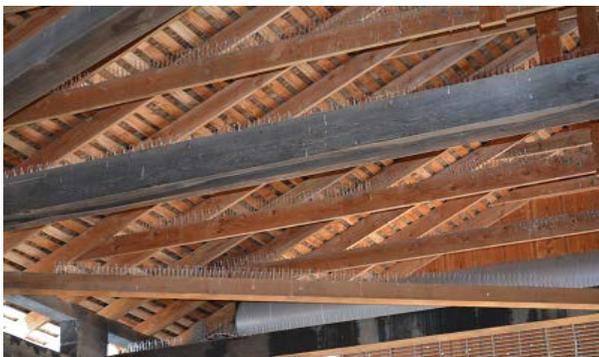
Figure 6.10—Nails used to discourage birds and rodents (Lowell Covered Bridge, 1945, Lane County, Oregon).

inhibitors can be installed in some locations to discourage bird and rodent access to the bridge. Nail strips and other devices have been used successfully to prevent birds and rodents from building nests on the upper surfaces of exposed roof framing members and top chords of trusses (Fig. 6.10).

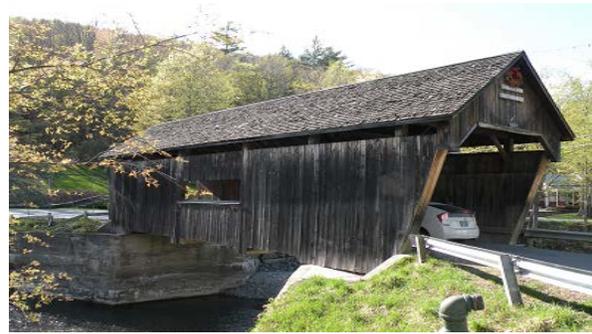
Figure 6.11—Overhangs on the roof and portals protect the truss members and decking from moisture damage and decay (Lincoln Gap Covered Bridge, 1879, Washington County, Vermont).

After cleaning, the two most cost-effective measures for extending the life of covered bridges are controlling water and vegetation management. These measures can greatly improve the environment around the bridge. If organic debris and vegetation are cleared from around the perimeter of covered bridges, debris build-up within the interior is removed and maintained, and the interior of the bridge has minimal exposure to moisture, the occurrence of and rate of deterioration caused by decay fungi will typically be slowed. Moisture management is often incorporated into the construction of the bridge. That is the purpose of the roof and siding. Additionally, the roof eaves and the portals may extend several feet beyond the trusses to add more protection from wind-blown precipitation (Fig. 6.11).

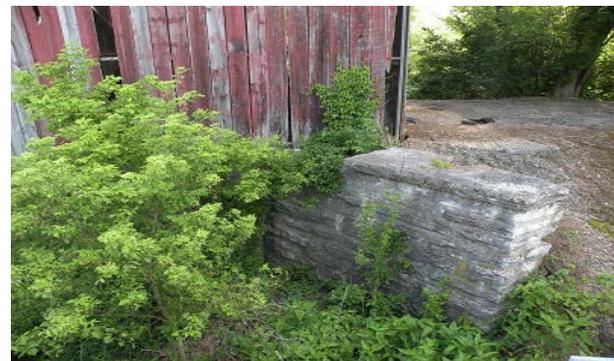
Figure 6.12—Vegetation (West Engle Mill Road Covered Bridge, 1877, Greene County, Ohio).

Without vegetation management, covered bridges can be engulfed in the invasive trees, shrubs, and grasses that spring up without periodic maintenance (Fig. 6.12). This overgrowth creates a moist microclimate conducive to decay

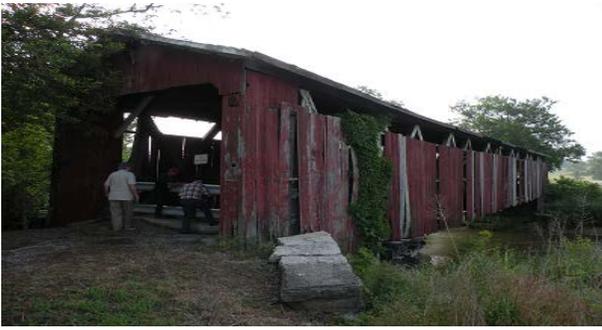
Figure 6.13—Vegetation removal as part of bridge maintenance (West Engle Mill Road Covered Bridge, 1877, Greene County, Ohio).

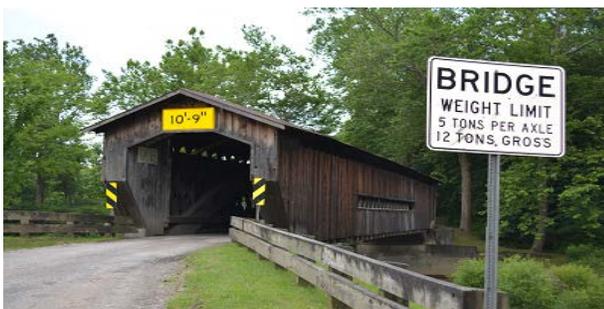
Figure 6.14—This bridge may never have been painted, or the paint has weathered away (Benetka Road Covered Bridge, ca 1900, Ashtabula County, Ohio).

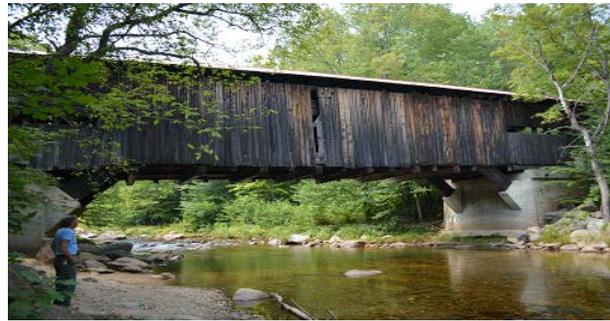
Figure 6.15—It is possible that this bridge was never painted (Durgin Covered Bridge, 1869, Carroll County, New Hampshire).

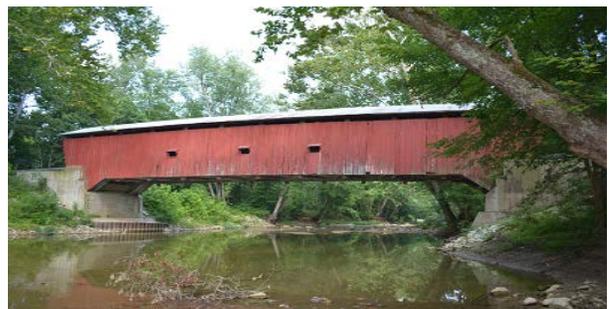
Figure 6.16—Paint failure on the siding (Rolling Stone Covered Bridge, 1915, Putnam County, Indiana).

Extending the service life of the protective roofing and siding may require periodic painting (of wood that was originally painted) to prevent the wood from cracking or splitting caused by excessive weathering. Peeling paint and failed coatings offer insufficient protection to the wood substrate, resulting in shorter service periods and more frequent maintenance (Figs. 6.16 and 6.17).

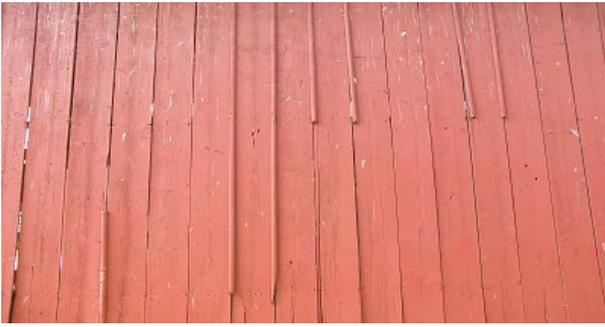
Figure 6.17—Paint failure on the siding (Stevenson Road Bridge, 1877, Greene County, Ohio).

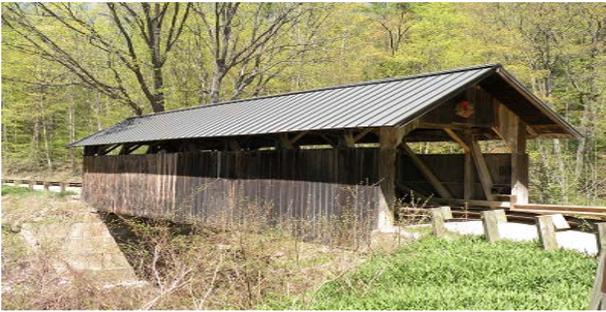
Figure 6.18—Replacement of original roof with metal roof, perhaps to limit maintenance costs (Seguin Covered Bridge, 1850, Chittenden County, Vermont).

Regarding the siding and roofing, although the intent should be to maintain the historic character of the bridge in accordance with The Secretary of the Interior's Standards for the Treatment of Historic Properties, there may be valid reasons for using alternate materials. The most common area of historic bridges to warrant material substitutions is the roof. In some climates, wood shingles may not be readily available that equal the quality of the historic shingles. The maintenance and replacement costs may warrant consideration of a material with a longer service life. Additionally, concerns about fire may warrant consideration of fire-retardant shingles or a composite or metal roof covering. Such substitutions can be made successfully without jeopardizing the visitor experience of the bridge (Fig. 6.18).

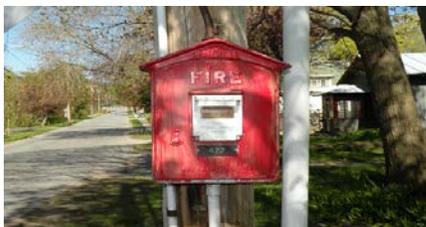
Figure 6.19—Fire Box (Cornish-Windsor Covered Bridge, 1866, Sullivan County, New Hampshire, and Windsor County, Vermont).

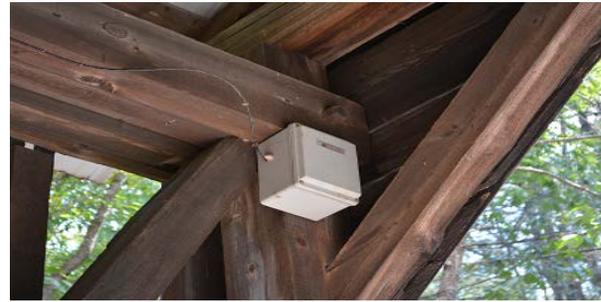
Figure 6.20—Fire alarm system (Durgin Covered Bridge, 1869, Carroll County, New Hampshire).

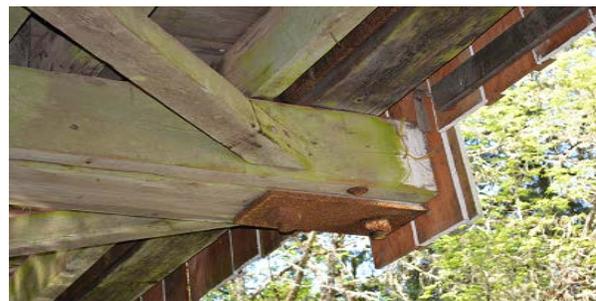
Figure 6.21—Biological growth found on this floor beam indicates favorable conditions that could lead to decay (Stewart Bridge, 1930, Lane County, Oregon).

Biological growth is an indication of a favorable environment for wood decay (Fig. 6.21). It does not mean

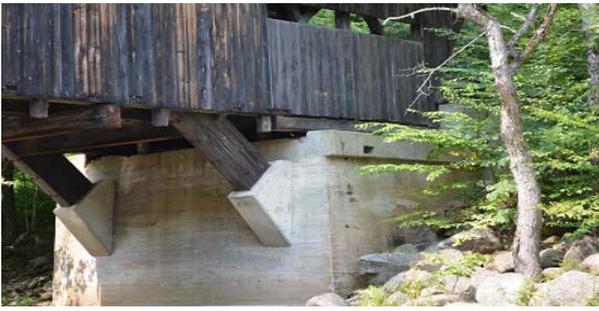
Figure 6.22—Material interface between the base of the arch and the concrete abutment where remedial treatments, such as borates, can extend the service life of the timber (Durgin Covered Bridge, 1869, Carroll County, New Hampshire).

Used as a common remedial chemical treatment, borate rods can be inserted into holes drilled in the wood where deterioration is likely (Fig. 6.22). Borates are low-level toxicity preservatives that are used to improve the durability of both new and in-service wood products. Borates are not an alternative to pressure-treated wood that will be in ground contact. They require moisture to migrate through the wood; therefore, they are placed where the wood is likely to be frequently damp, such as near the exposed end grain, near the bottom face of members close to ground contact and at exposed, wood–wood connections where members meet, including repair splices.

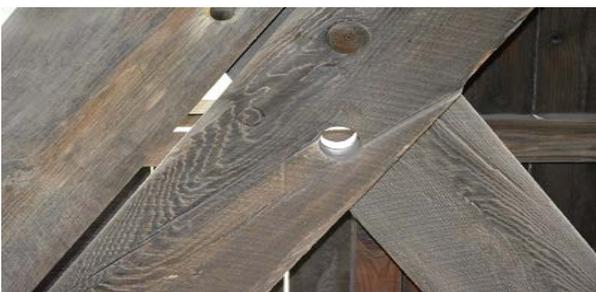
Figure 6.23—Missing treenail connection (Benetka Road Covered Bridge, ca 1900, Ashtabula County, Ohio).

The bridge should be visually inspected for missing or loose connections. In particular, treenails (pegs) used in the lattice-work of trusses and traditional timber joinery are often collected as souvenirs. The people who collect the pegs do not recognize that the pegs are essential to the structural performance of the bridge (Fig. 6.23).

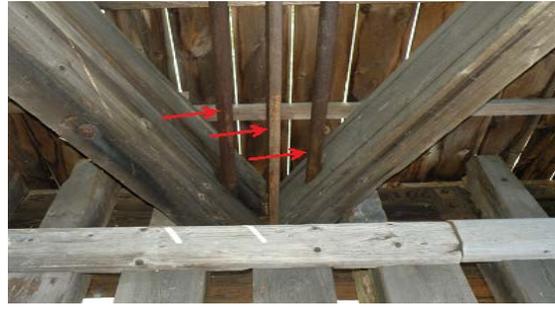
Figure 6.24—Minor surface corrosion (rust) (Shoreham Bridge, 1897, Addison County, Vermont).

As discussed in Chapter 2 on condition assessments, corroded metal fasteners can indicate moisture and salt issues. Light surface corrosion (rust) is generally not problematic and need only be monitored (Fig. 6.24). Severely corroded metal that has either a loss of material or a build-up of corroded metal may require cleaning or warrant replacement of the steel connectors to avoid potential failure of the connection (Fig. 6.25).

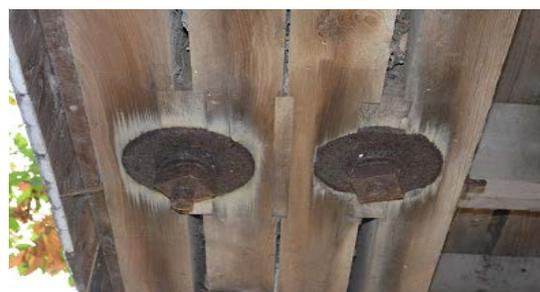
Figure 6.25—Severely corroded bolts (Potter's Covered Bridge, 1871, Hamilton County, Indiana).
