# **ADHESION TESTING OF EPOXY COATING**

**Research Report No. 1265-6**

*Structural Integrity of Epoxy-Coated Bars*

**TEXAS DEPARTMENT OF TRANSPORTATION**

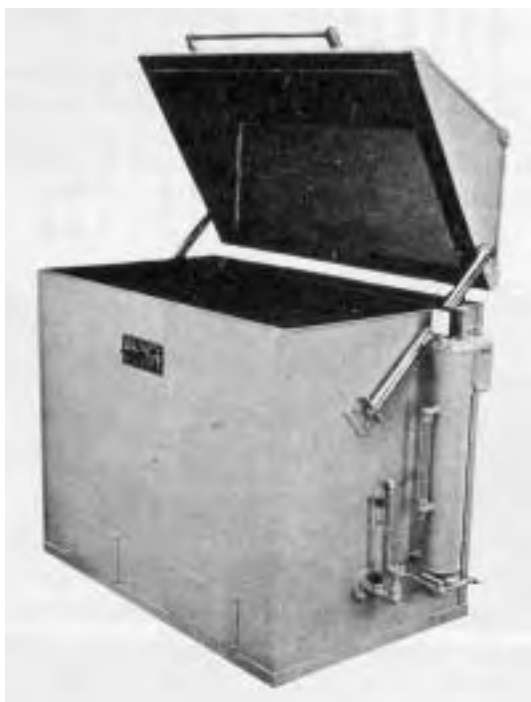
air saturator tower, a salt solution reservoir, atomizing nozzles, sample panel supports, and heat controls to maintain the conditions of test at the desired temperature, and a relative humidity of 95% to 98% (Figure 1.1).<sup>11</sup> At the end of the exposure, a knife adhesion test is usually performed to determine the extent of disbondment and underfilm corrosion. This test is described in several standards such as ASTM A775<sup>23</sup>, ASTM A934<sup>24</sup>, and MTO Draft 93-10-01.<sup>29</sup> Different test procedures vary in concentration of salt solution, temperature, time of exposure, sample preparation, and acceptance criteria. For instance, both ASTM A775<sup>23</sup> and A934<sup>24</sup> specify  $35^{\circ}\text{C} \pm 2^{\circ}\text{C}$  salt spray of 5% NaCl solution for  $800 \pm 20$  hours. Bars contain three intentional 3-mm diameter defects drilled through the coating evenly spaced along one side of the bar with the holes centered between deformations. The acceptance criterion is that the average coating disbondment radius should not exceed 3 mm from the edge of the intentional defect at 9 test sites.

**Figure 1.1 Salt fog cabinet.**<sup>11</sup>

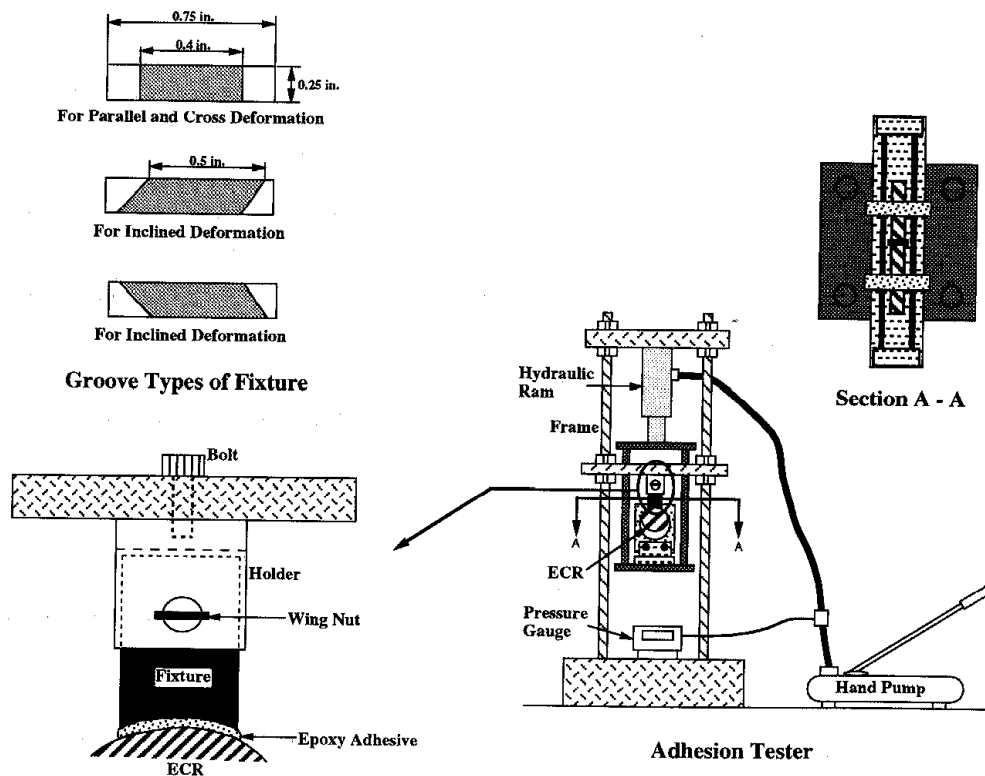
Coating is pulled off a steel substrate using a special adhesion test device. This procedure was developed and used in a NCHRP study.<sup>2</sup> In this study, the test procedure consisted of gluing the concave side of an aluminum pull-stub to the surface of the epoxy-coated bar using a two-part structural epoxy adhesive. To improve adhesion between the coating and the aluminum pull-stub, the coating surface was roughened with a rasp and subsequently cleaned with ethanol. Careful attention was given to properly aligning the pull-stub being placed on the bar using a specially designed alignment device. The adhesive was allowed to cure for 24 hours before testing. The coating was then scored around the pull-stub to expose bare metal to isolate the coating test area and eliminate the influence of cohesive forces that could be exerted by the surrounding coating. The bar/pull-stub assembly was mounted on a specially designed loading frame. The test set-up is schematically shown in Figure 1.2.

**Figure 1.2 Schematic of pull-off adhesion testing system used in the NCHRP 10-37 study.<sup>2</sup>**

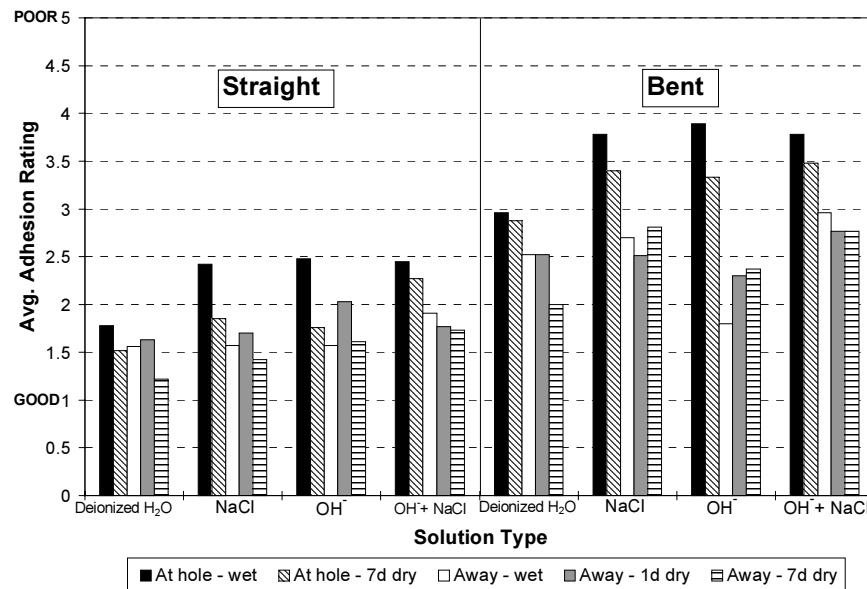
- Straight bars tested in hot deionized water can more easily pass the adhesion test than when tested in the other three hot solutions (NaCl, OH<sup>-</sup>, and OH<sup>-</sup> + NaCl). See Figure 1.3.

**Figure 1.3 Average overall adhesion ratings for all coatings under all test conditions [FHWA-RD-94-103].<sup>6</sup>**

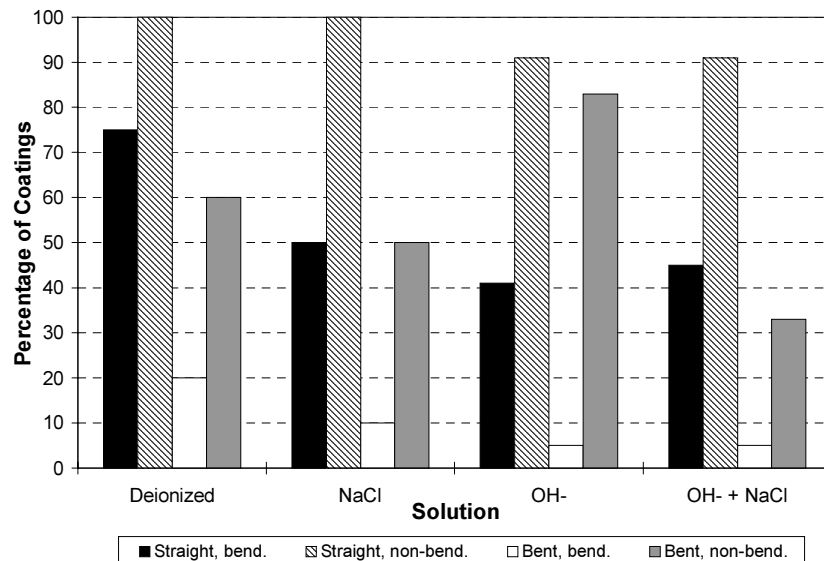
- Nonbendable coatings applied to straight bars exhibited the best overall performance, with more than 90% of nonbendable coatings on straight bars showing excellent adhesion ratings (Figure 1.5).

- When nonbendable coatings were applied to prebent bars, the overall adhesion performance was worse than when applied to straight bars (Figure 1.5). This implies that it may be more difficult to coat and/or clean a prebent bar than a straight bar when applying nonbendable coatings.
- The poorest overall adhesion performance was achieved with bent bars using bendable coatings. Only 5% to 20% of the 20 or 21 bendable coatings on bent bars had excellent adhesion ratings (Figure 1.5).

**Figure 1.5 Percentage of coatings with average adhesion rating of 1 to 1.5 in different solutions [FHWA-RD-94-103].<sup>6</sup>**

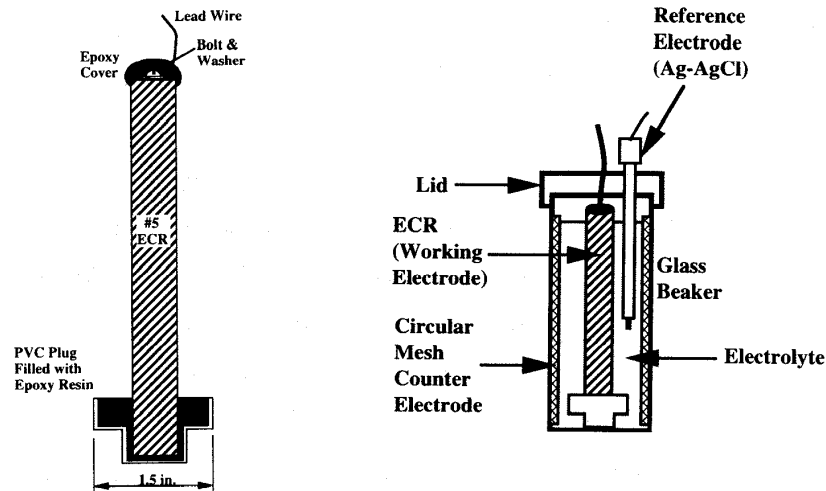
formation and rusting. At the end of immersion, adhesion testing was conducted using the special adhesion pull-off test device and procedure discussed earlier. Three test locations along the bar length were selected randomly per specimen. Adhesion tests were conducted after 1, 14, and 21 days of air drying.

Figure 1.8 Schematic of epoxy-coated bar specimen and of immersion test cell for hot water test of NCHRP 10-37 study.<sup>2</sup>

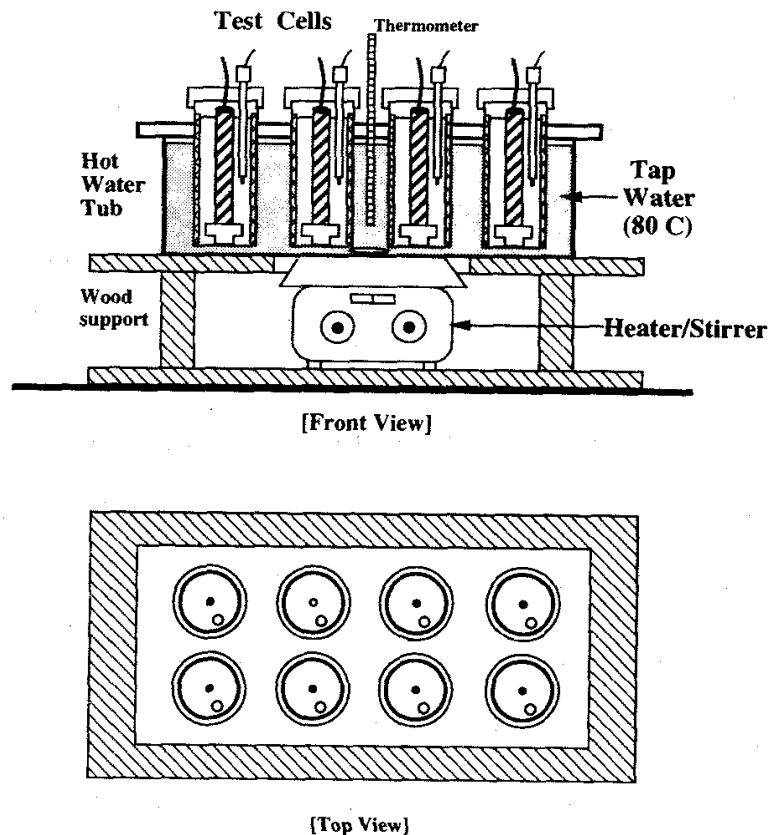
Figure 1.9 Schematic of hot water test apparatus for NCHRP 10-37 study.<sup>2</sup>

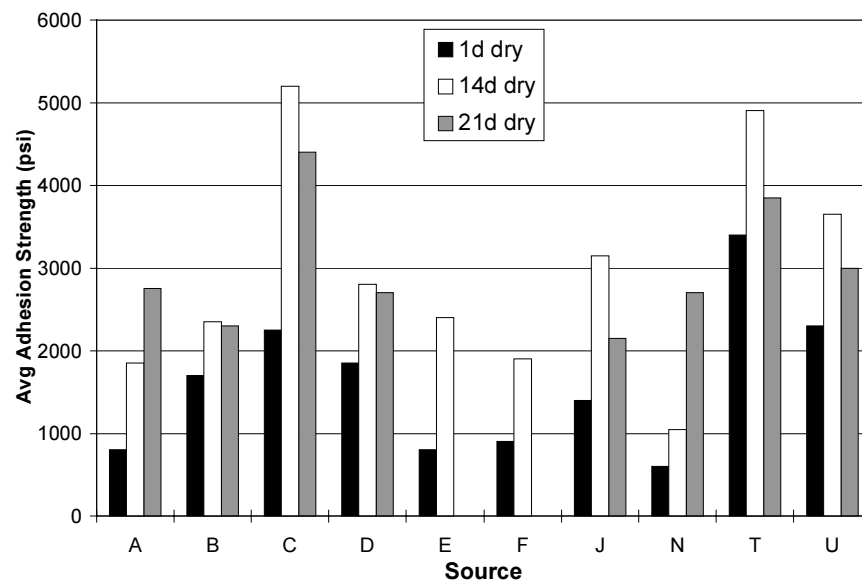
- The amount of underfilm corrosion and the post-immersion (drying) period affected coating adhesion strength. In general, adhesion strength increased with extended drying time (Figure 1.10).

**Figure 1.10 Average adhesion strength of coated bars from various sources after 14 days of immersion in 80°C distilled water [NCHRP 10-37].<sup>2</sup>**

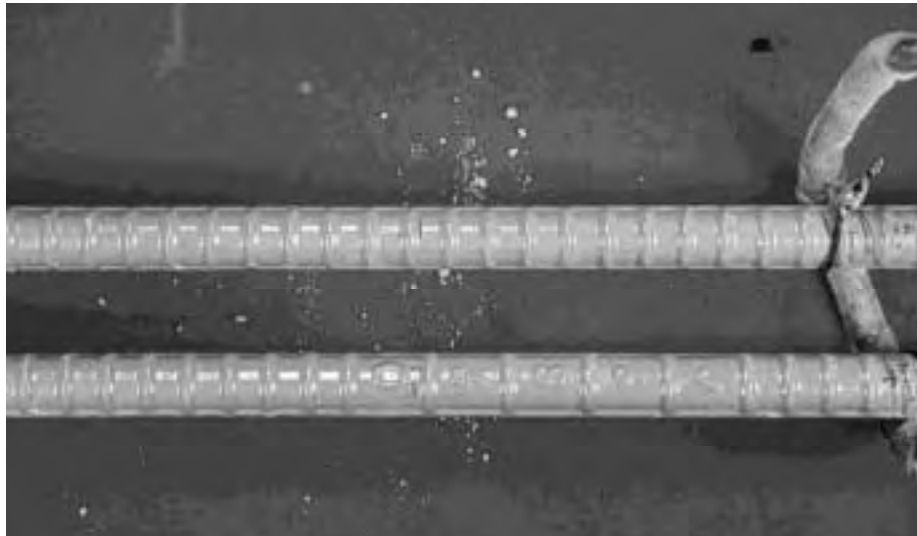
The degree of adhesion loss after chloride exposure seemed to be affected by differences in coating integrity. Straight bars from beam B1 were in excellent condition with no visible damage before chloride exposure. The bar condition was preserved without signs of corrosion or extensive adhesion loss after 4.3 years of chloride exposure (Figure 1.11). Longitudinal bars in the remaining autopsied specimens had intentional damage, patched or unpatched, and exhibited adhesion loss within the wetted region with varying degrees of underfilm corrosion (Figure 1.12). Since bars for all beams came from the same lot, it is reasonable to assume that all bars had similar coating adhesion before chloride exposure. Clearly, coating integrity was fundamental in the preservation of adhesion and its protective capabilities. In addition, it was found that adhesion loss always occurred around areas of damaged coating and was least affected at locations farthest from damaged coating. Similar observations have been made by Sagüés.<sup>1</sup> Visible holidays and coating defects were present on areas that experienced coating disbondment in coated bar segments extracted from four bridge decks in California.<sup>36</sup> This evidence suggests that the agents causing coating disbondment migrated to the coating-substrate interface through coating defects rather than through the bulk of the coating.

**Figure 1.11 Longitudinal coated bars of beam B1 remained in good condition after 4.3 years of chloride exposure (undamaged coating before exposure).<sup>34</sup>**

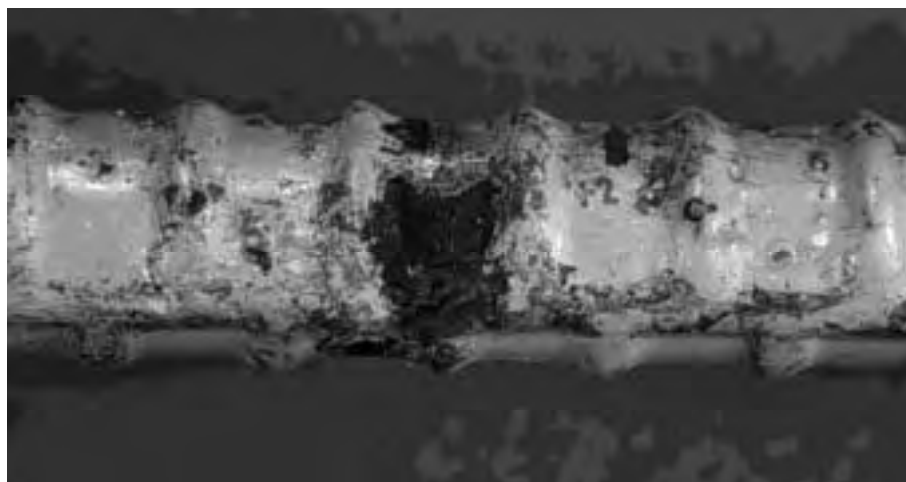
**Figure 1.12 Build up of rust products at damaged spot on bar from beam B10.<sup>34</sup>**

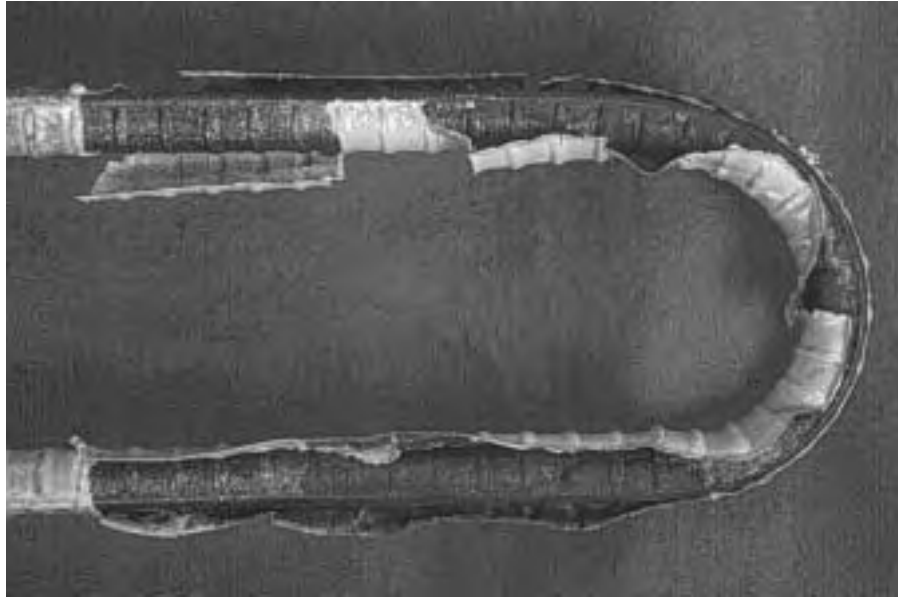
**Figure 1.13** Coating debonding on a 13 mm (#4) bar from the macrocell study after 4.5 years of exposure.<sup>33</sup>

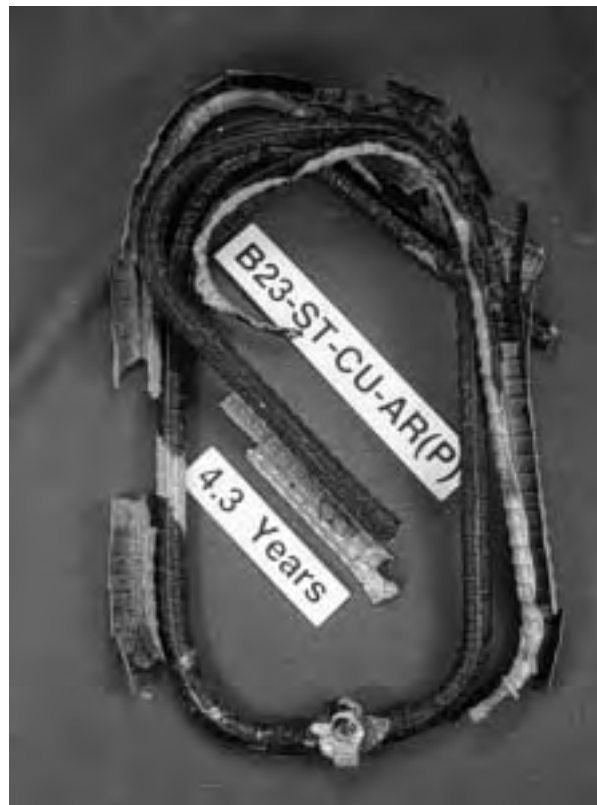
**Figure 1.14** Coating extensively debonded on stirrups from beam specimens.<sup>34</sup>

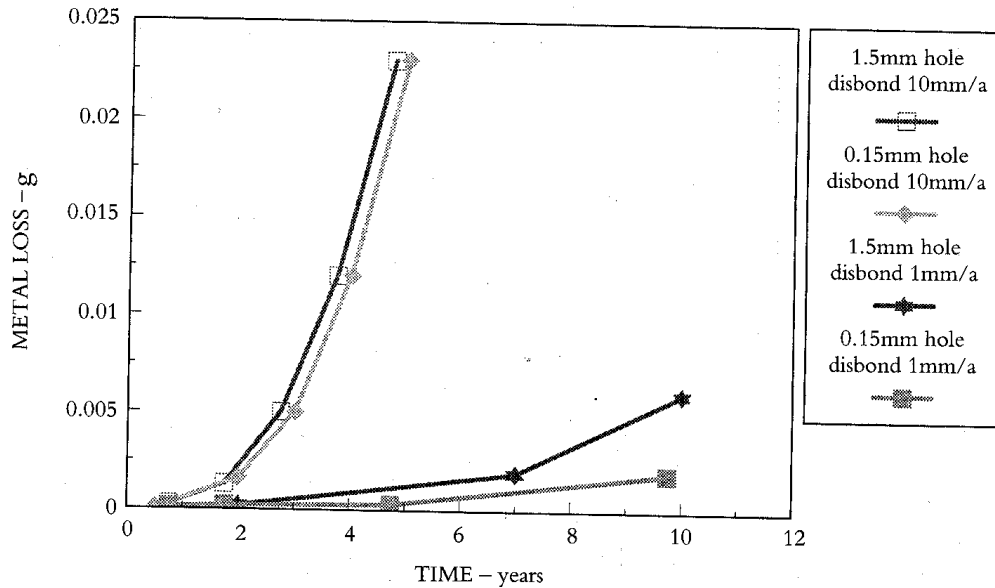
In an attempt to clarify the role of holes in the coating versus coating adhesion, a numerical model was developed at UMIST University.<sup>42</sup> The “Cottis Model” revealed that in the presence of holes in the coating in a low permeable concrete, the bar corrosion rate was governed primarily by the coating adhesion, and not by the relative size of the defects in the coating (Figure 1.15). However, there was no explanation of the validity of the model for coated bar specimens, particularly in a real concrete environment.

**Figure 1.15 Cumulative corrosion with time for epoxy-coated steel in low permeability concrete according to "Cottis Model" [UMIST].<sup>42</sup>**

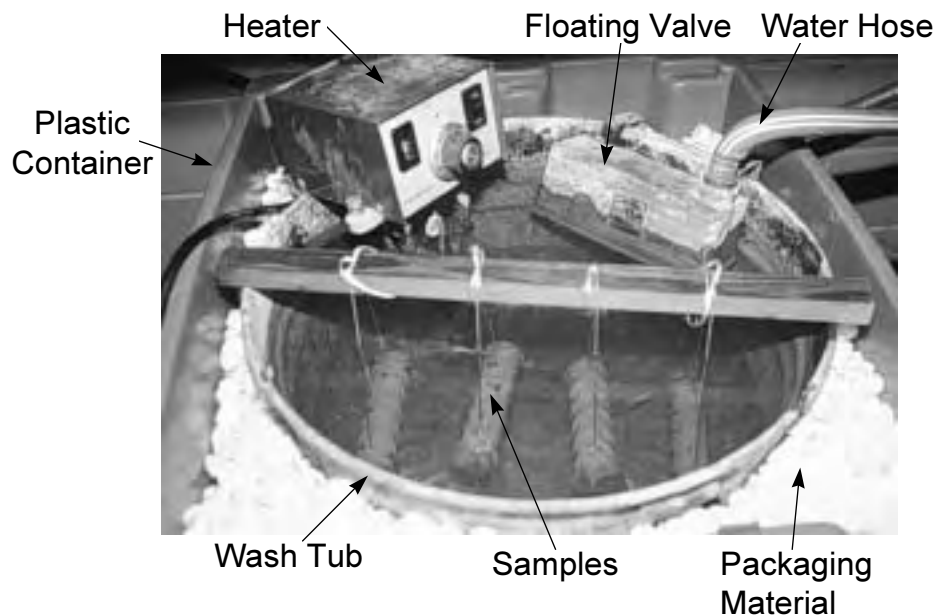
The Canadian draft specification requires submerging bar samples in a tap water bath at a temperature of  $73 \pm 2^{\circ}\text{C}$  for a period of  $48 \pm 2$  hr (Figure 2.1). Spacing of at least 25 mm between bar samples is required. The bars are removed from the water bath and stored in air at  $23 \pm 3^{\circ}\text{C}$  for  $24 \pm 2$  hr. Subsequently, samples are prepared for adhesion testing as follows: With the specimen securely clamped on a vise, an X-cut is made through the coating at six locations between bar deformations, as shown in Figure 2.2. Three test sites are located on each side of the bar. The cuts must extend through the coating so that the metal is visible. The cuts are made with a utility knife having a new, sharp blade for each specimen. The length of each cut should not be less than 10 mm or the distance between adjacent deformations. The two cuts forming the “X” should intersect at an angle as close to  $90^{\circ}$  as possible. The “X” cut defines 4 flaps of coating and each one is tested. All test sites should be located at least 25 mm from the bar ends.

**Figure 2.1** Hot water bath.

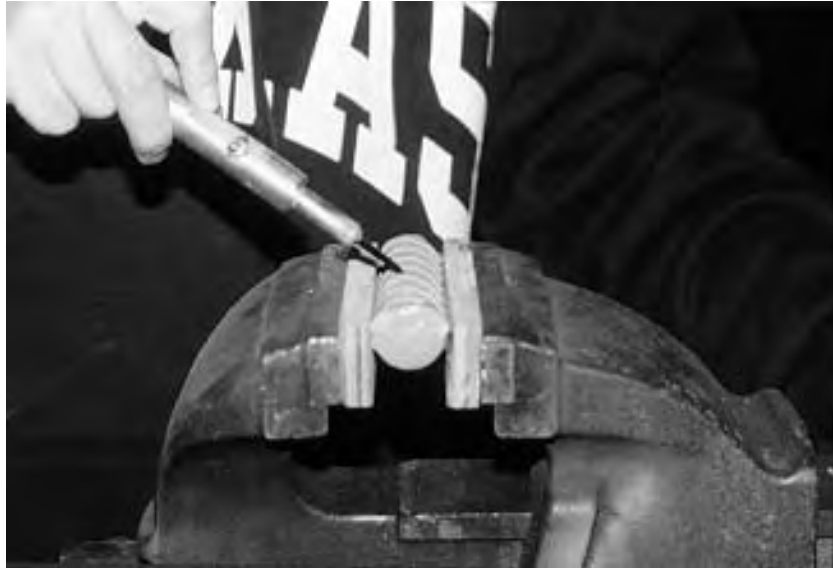
**Figure 2.4 Adhesion testing of epoxy-coated bar specimen.**

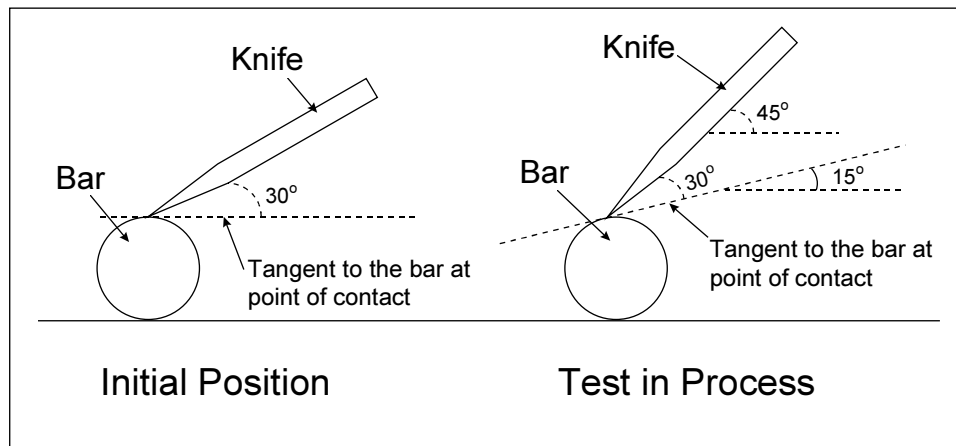
A utility knife with snap-off blades was used for adhesion testing. With such a knife, new blades could be easily used for every test and the test was economical. However, the knife blade design was not very suitable for adhesion testing on epoxy-coated bars. The problem was that the sharp edge of the blade was parallel to the knife axis. The blade was not symmetrical and did not have a very pointed sharp tip. During the test, the blade had to be held at an oblique angle with respect to the path that the blade had to follow (the line bisecting the flap of coating) so that the blade tip could be inserted under the coating. For the operator, this was an awkward and uncomfortable position.

Figure 2.5 Angle of knife during adhesion testing.

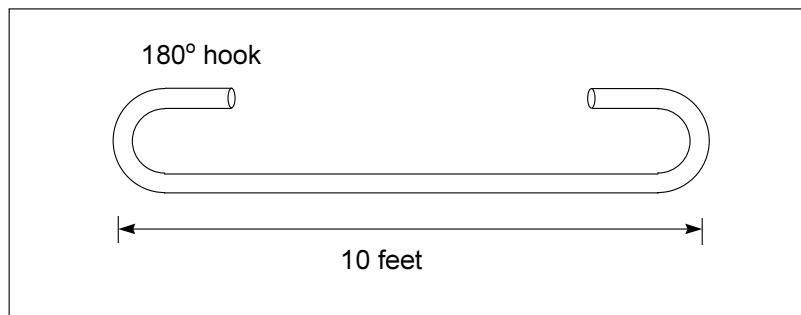
Shipped bars were 10 feet long and had a 180° hook at each end (Figure 2.6). Bars from coater *C* were individually wrapped in soft styrofoam sleeves to protect the coating from damage during shipment. Bars from coaters *A* and *B* were not as carefully handled during shipment. Bars from coater *A* had the most damage. Samples 12.5 cm long were cut from both the straight and bent portions of the bars. A total of 51 bar samples were cut, including at least two samples from each group. Samples were selected from locations with the least damage. Bar ends were sealed with silicone. Specimens were immersed in their “as-received” condition without repairing coating damage.

**Figure 2.6 Epoxy-coated bar dimensions as-received from coaters.**

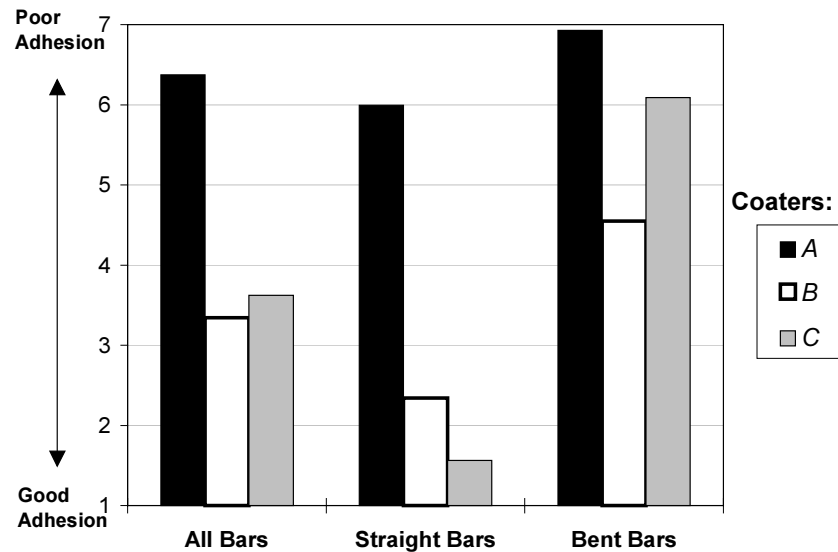
If bent bars are not considered, the difference in coating adhesion between the three coaters becomes even more pronounced. Straight samples from coater *A* showed poor coating adhesion while straight samples from coaters *B* and *C* showed very good to excellent performance, as evidenced in Figure 2.7.

Figure 2.7 Average adhesion ratings of specimens grouped by coating plant and type of specimen (bent or straight).

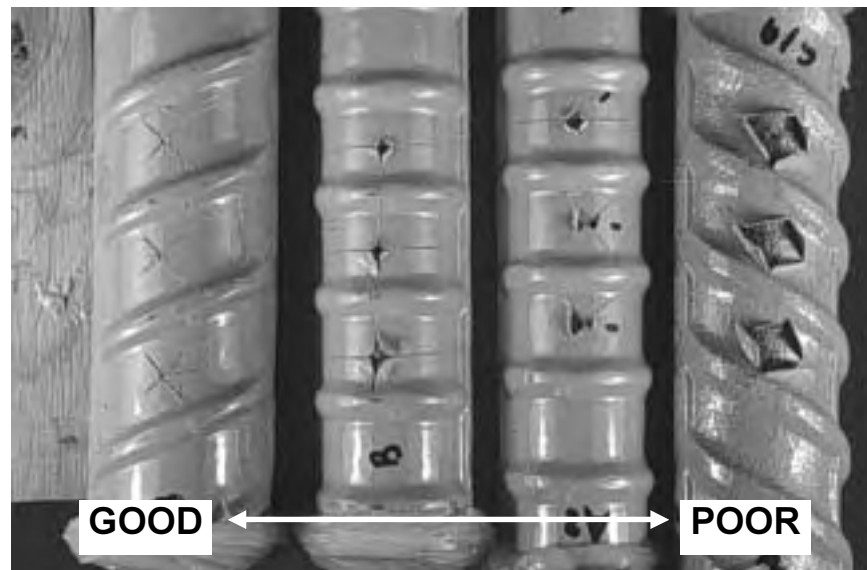
Figure 2.8 Typical adhesion test results of several specimens from all coaters.

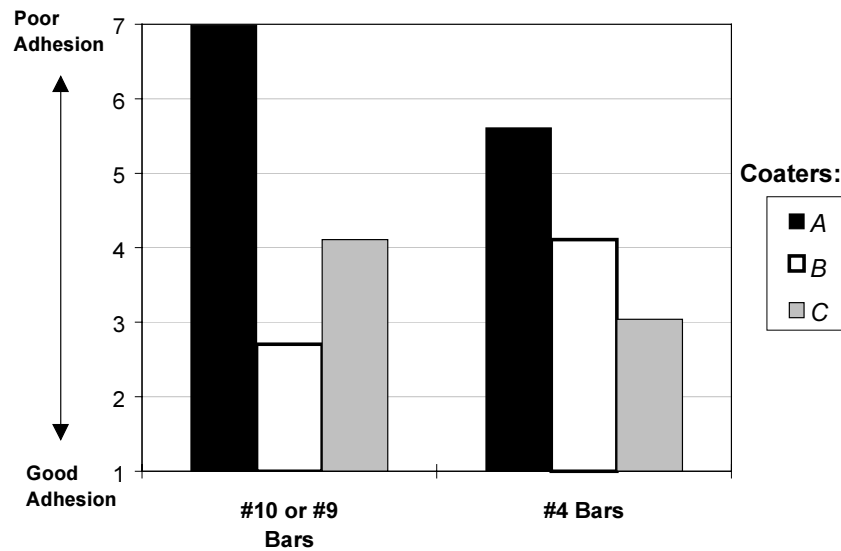
In Figure 2.9, average adhesion ratings are categorized by bar size and coater. There is not a clear relationship between bar size and coating adhesion. Bars of smaller diameter from coating plants *A* and *C* performed better than bars of larger diameter. However, in the case of bars from plant *B*, larger bars showed better coating adhesion than smaller bars. Considering specimens from all coaters, smaller bars, with average rating of 4.7, tended to have slightly better coating adhesion than larger bars, with average rating of 5.4 (Figure 2.10).

Figure 2.9 Average adhesion rating of specimens grouped by coater and bar size.

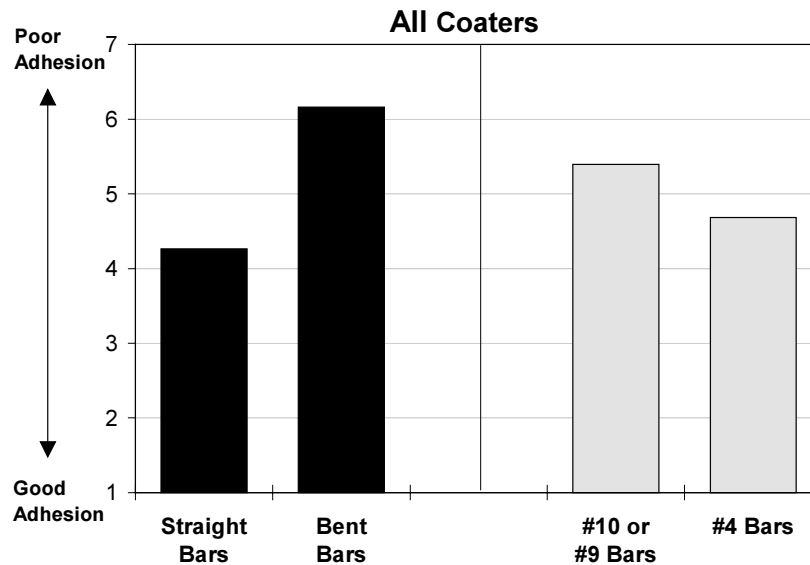
Figure 2.10 Average adhesion rating of specimens grouped by bar type and bar size.

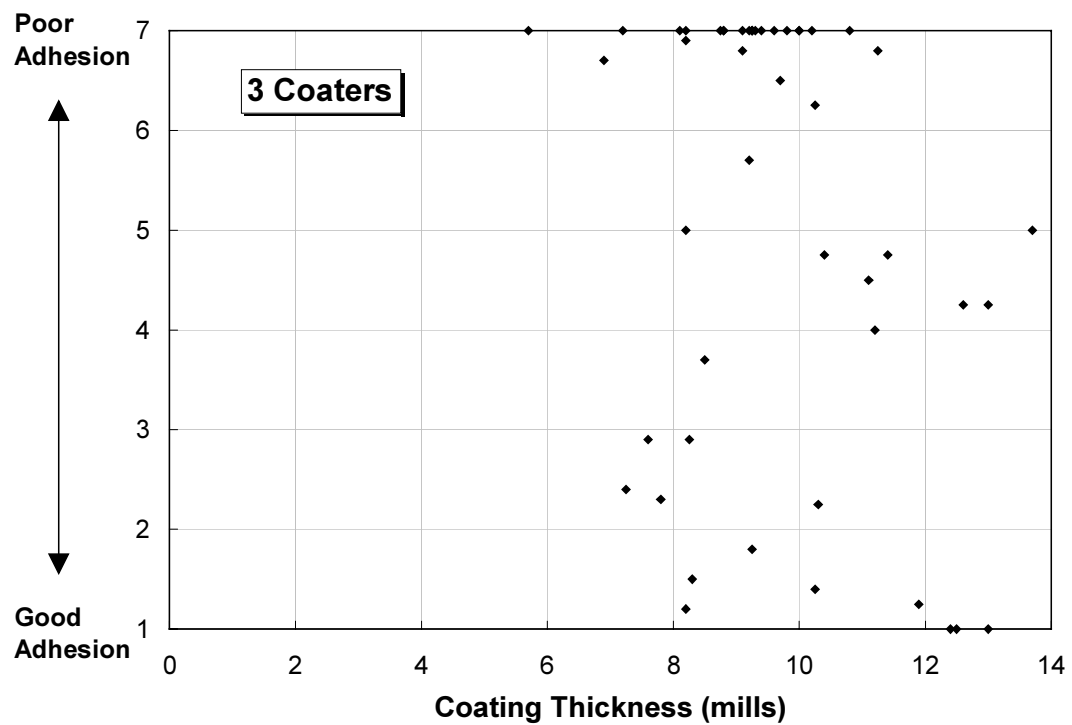
Figure 2.11 Adhesion rating vs. coating thickness of all specimens.

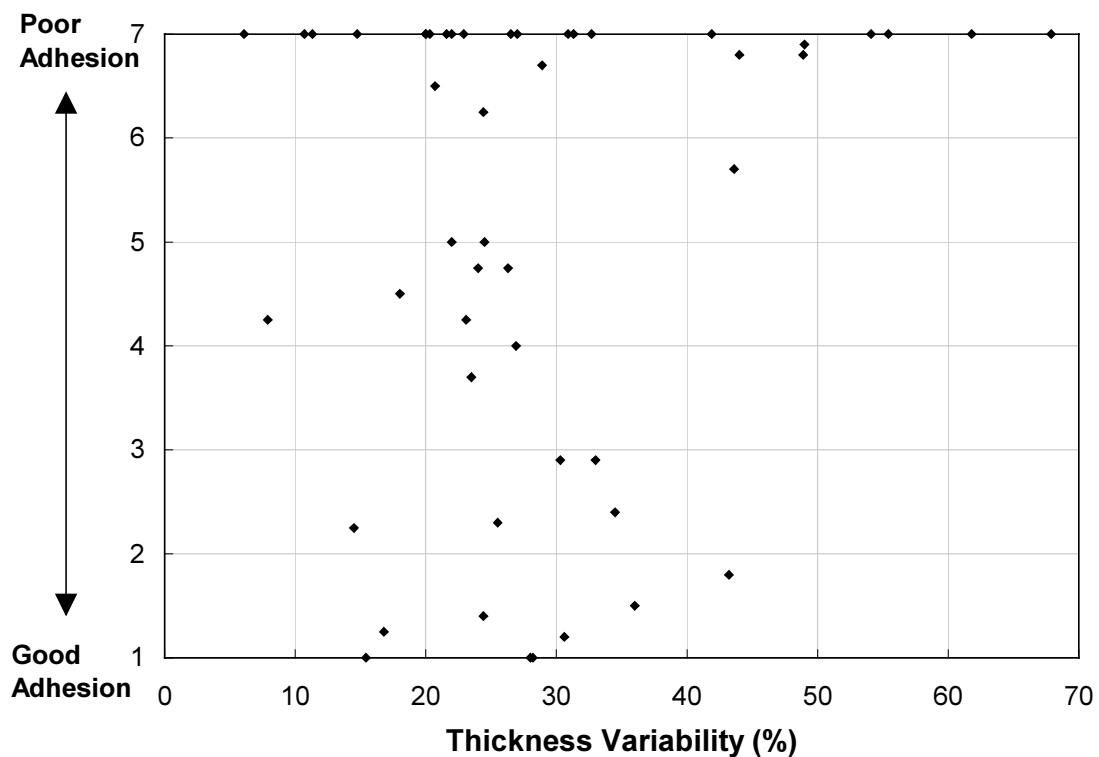
thickness variability, and adhesion rating of each specimen are plotted in Figure 2.12. Again, no clear relationship between these two coating characteristics was found.

Figure 2.12 Adhesion rating vs. variability of coating thickness.

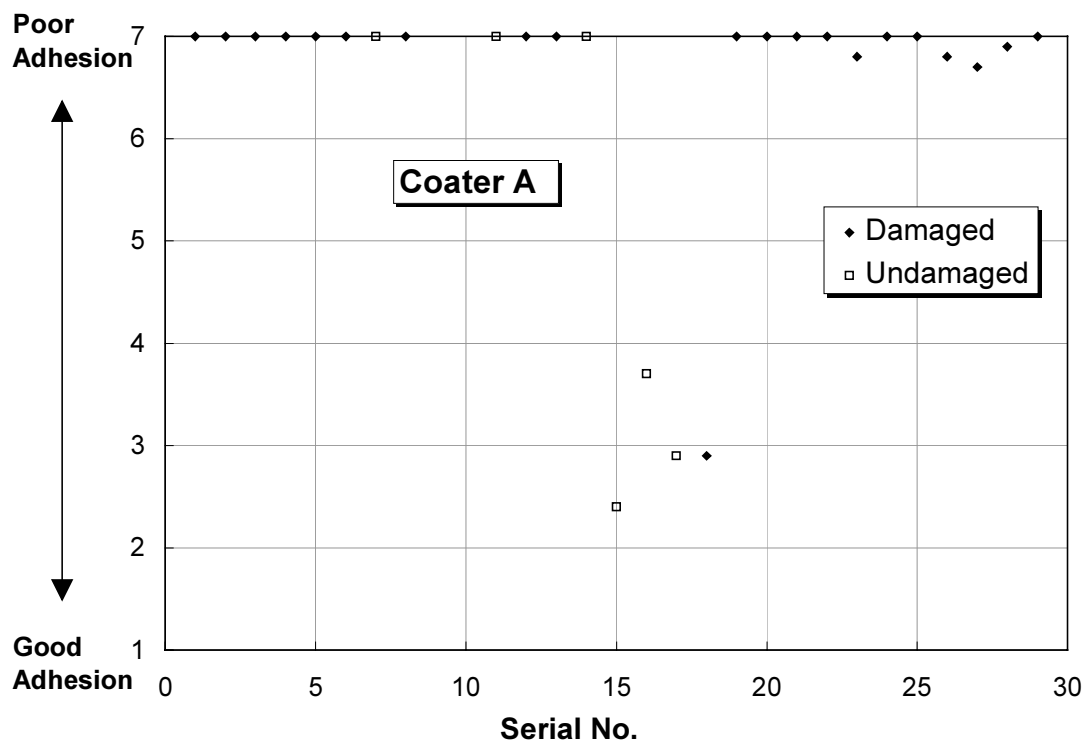
As mentioned previously, bars were immersed in hot water in their as-received condition. About one third of the specimens had some degree of coating damage and remaining specimens were undamaged. Both Swiss and MTO test procedures specify the use of bars free from holidays and bare areas. Therefore, it was of interest to observe the performance of bars that did not meet specifications. Some field studies reported in the literature showed that bars with damaged coating prior to exposure underwent worse adhesion loss than undamaged bars.<sup>36</sup> Loss of adhesion was observed at an intentional hole in the coating after hot solution immersion tests conducted by the FHWA.<sup>6</sup> Adhesion ratings of each individual specimen for coaters *A*, *B*, and *C* are plotted in Figures 2.13, 2.14, and 2.15. Data points are plotted in sequence and the horizontal axis only shows the sequence number of each sample. Black points represent specimens with coating damage and white points represent specimens with no damage in the coating. Figure 2.13 shows that most specimens from coater *A* were damaged and exhibited poor adhesion. One half of undamaged specimens showed poor adhesion and the other half showed better adhesion, with ratings between 2.4 and 3.7. Graphs for coaters *B* and *C* (Figures 2.14 and 2.15) showed more widespread scatter of data and no clear relationship between coating damage and coating adhesion. There were specimens with no coating damage and poor coating adhesion and specimens with damaged coating and excellent adhesion.

Figure 2.13 Effect of coating damage on coating adhesion (Coater *A*).

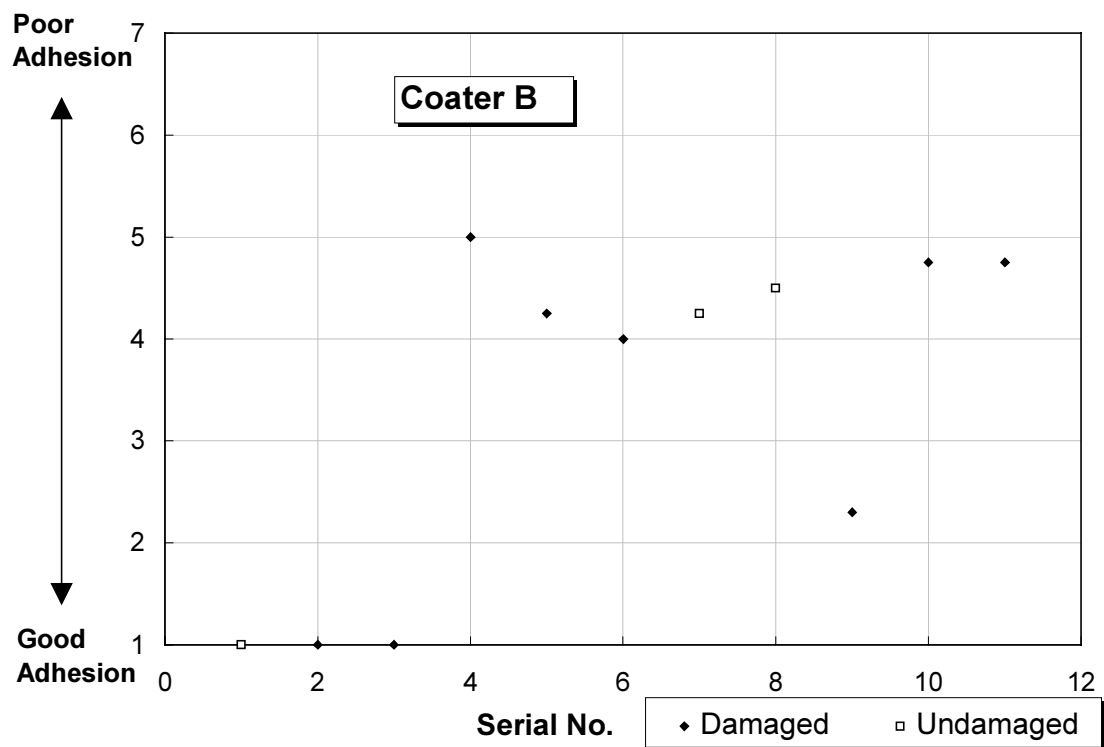
Figure 2.14 Effect of coating damage on coating adhesion (Coater B).

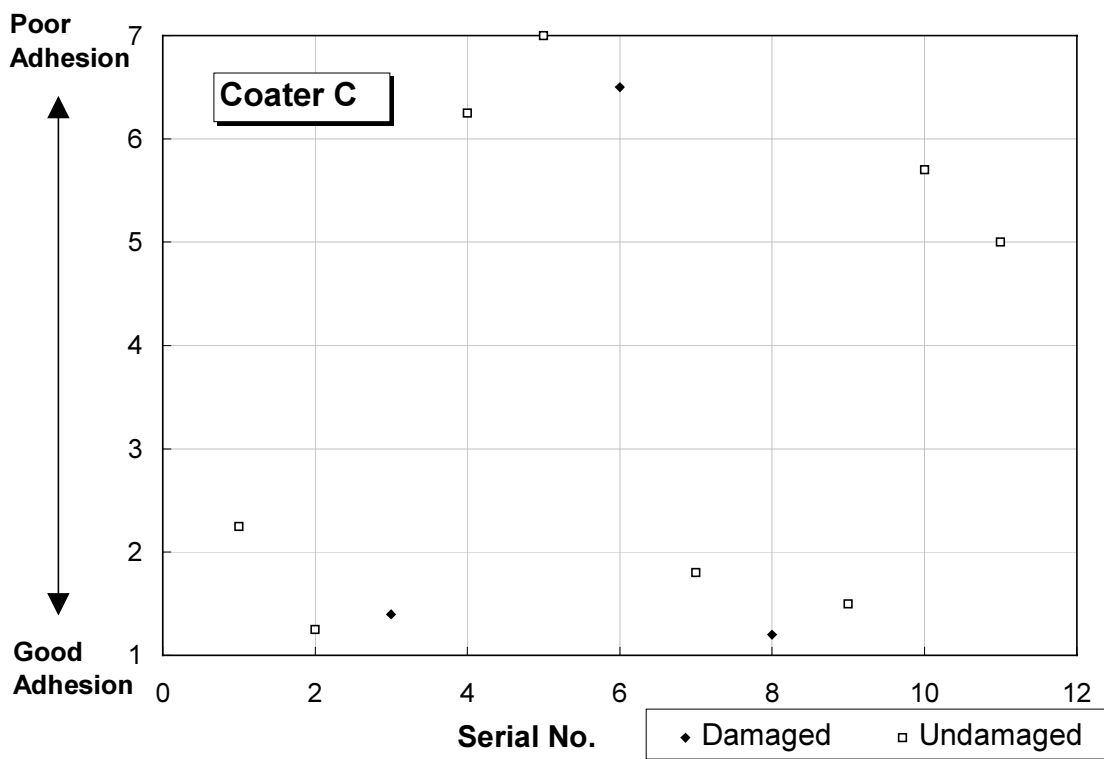
Figure 2.15 Effect of coating damage on coating adhesion (Coater C).

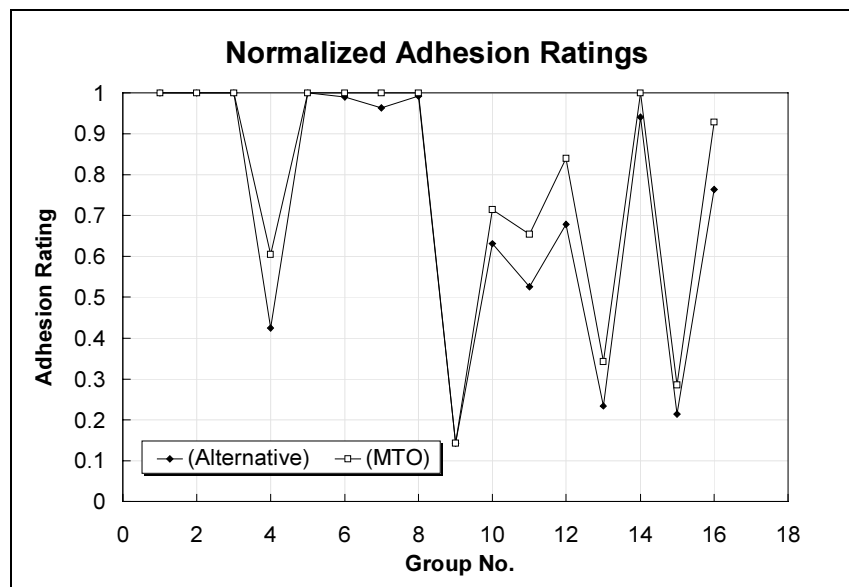
The alternative adhesion rating system is compared to the MTO rating system in Figure 2.16. The average adhesion rating of each representative group of specimens was calculated using both rating systems and plotted on the graph. Since each rating system has a different range, the values had to be normalized so they could be plotted on the same graph. Normalization was done by first dividing the readings of the alternative system by 7 (the largest value of that system) to produce a range from 0.14 to 1.0. Subsequently, the values of the MTO system were converted to the normalized system by interpolation. A normalized rating of 1.0 represents poor adhesion and a normalized rating of 0.14 indicates good adhesion. It can be seen that curves representing each system follow very similar trends. The largest difference between the two ratings was 0.18 and the average difference was 0.06. Consistently, the MTO rating system gave equal or worse adhesion ratings than the alternative system. This indicates that the MTO system tends to be more stringent in certain cases. As opposed to the system in the first MTO draft, the newer rating system was devised to be very simple and easy to use but, because of its simplicity, it would be expected to err on the safe side.

**Figure 2.16 Comparison of adhesion rating systems.**

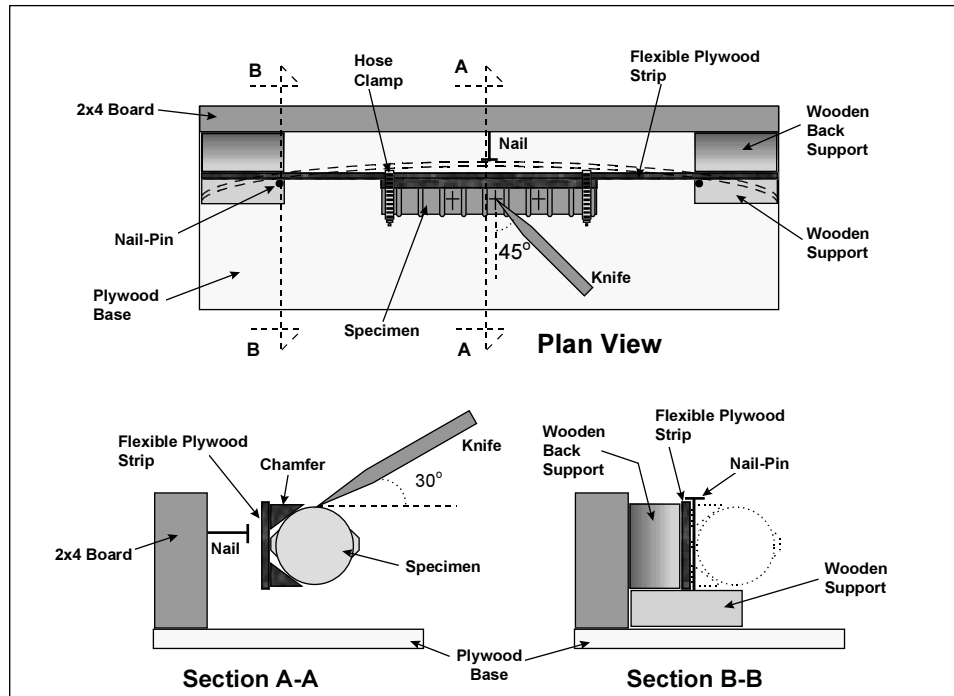
The weight selected for calibration was based on the following considerations: X cuts at each test site were oriented as illustrated in Figure 3.1. The knife was positioned approximately  $45^\circ$  with respect to the bar axis in a horizontal plane, and at approximately  $30^\circ$  with respect to a tangential plane at the point of contact with the bar. When the knife was pushed against the bar, one of the three orthogonal components of the knife force produced lateral deflection of the plywood strip. The horizontal component is  $F_{\text{knife}} \cos 30^\circ \cos 45^\circ$ . For  $F_{\text{knife}} = 3.5 \text{ kg}$ , the horizontal component is 2.14 kg.

Figure 3.1 Special device to calibrate knife force.

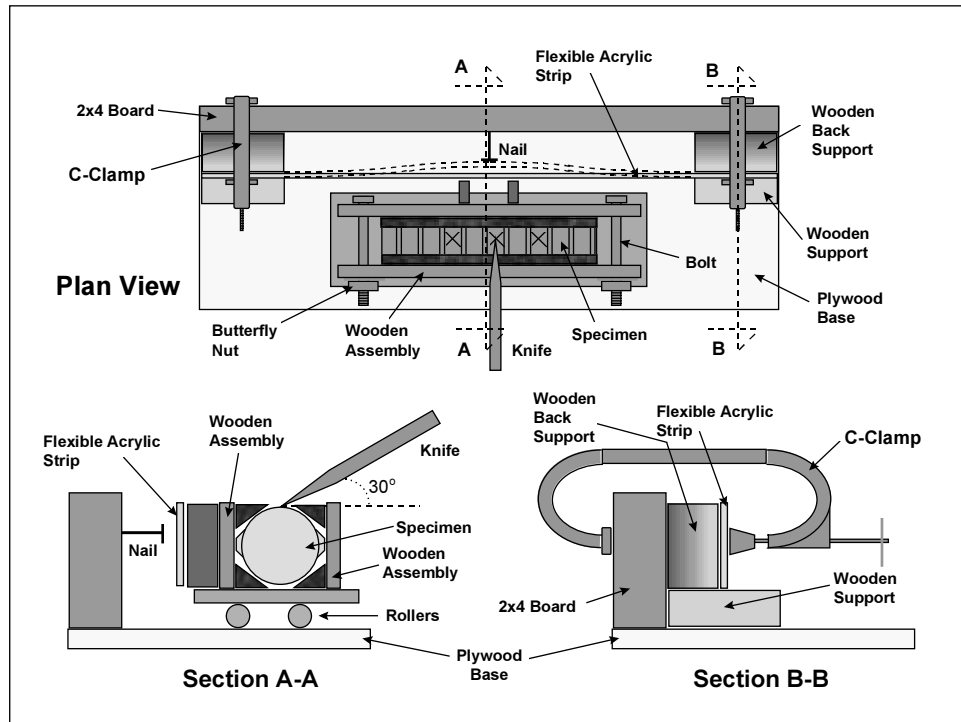
**Figure 3.3 Improved device to calibrate knife force.**

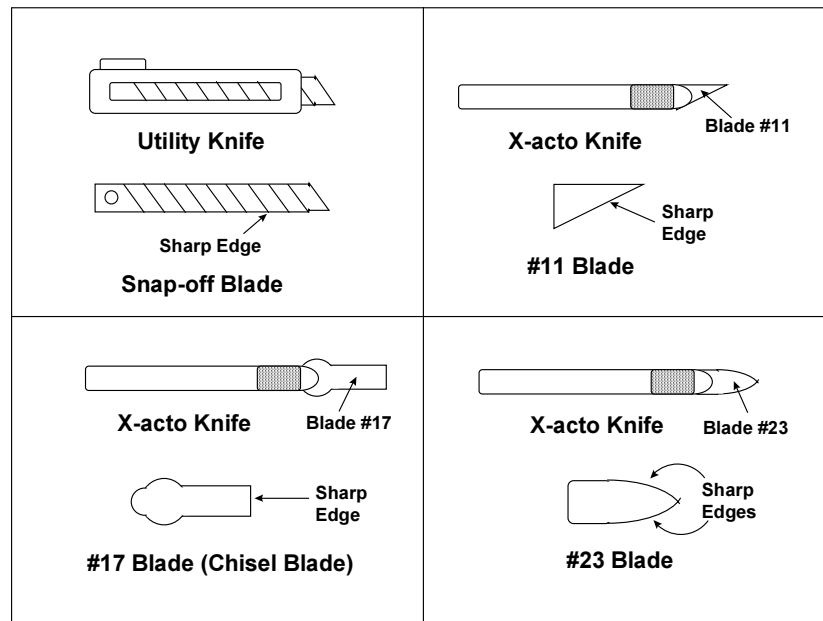
**Figure 3.6** Types of knife blades used for adhesion study.

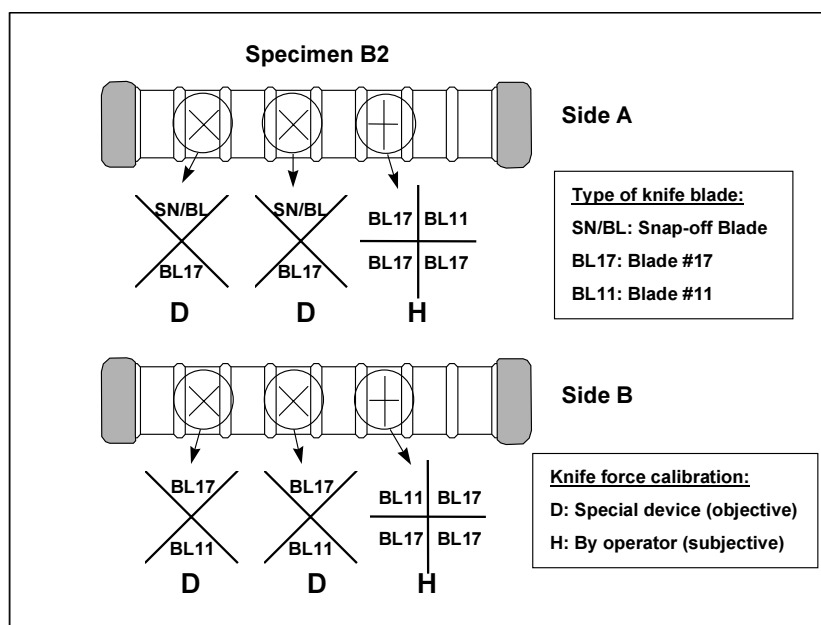
**Figure 3.7 Typical specimen for adhesion test using several types of knife blades and force calibration procedures.**

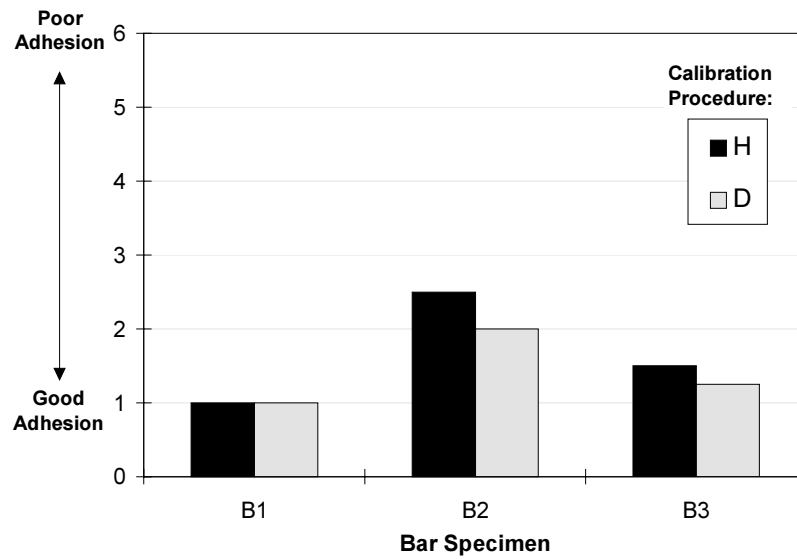
Figure 3.8 Effect of procedures to calibrate knife force on adhesion test results (samples from coater *B*).

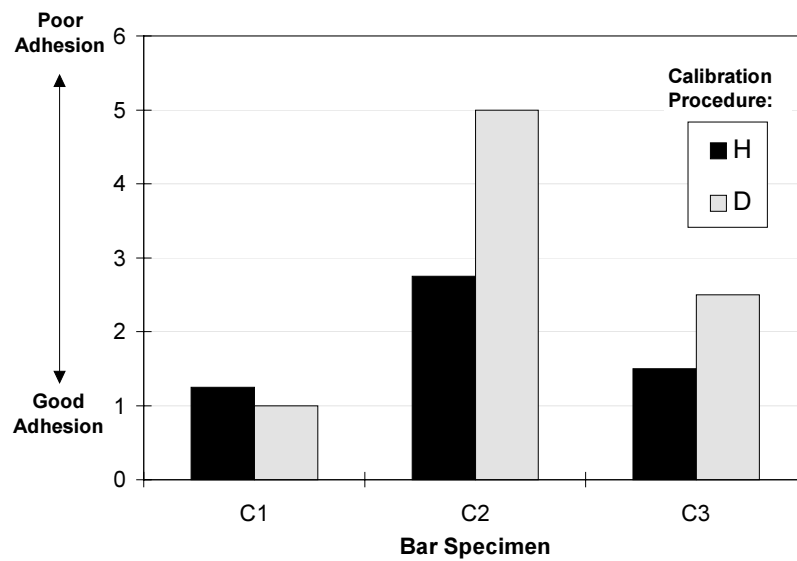
Figure 3.9 Effect of procedures to calibrate knife force on adhesion test results (samples from coater *C*).

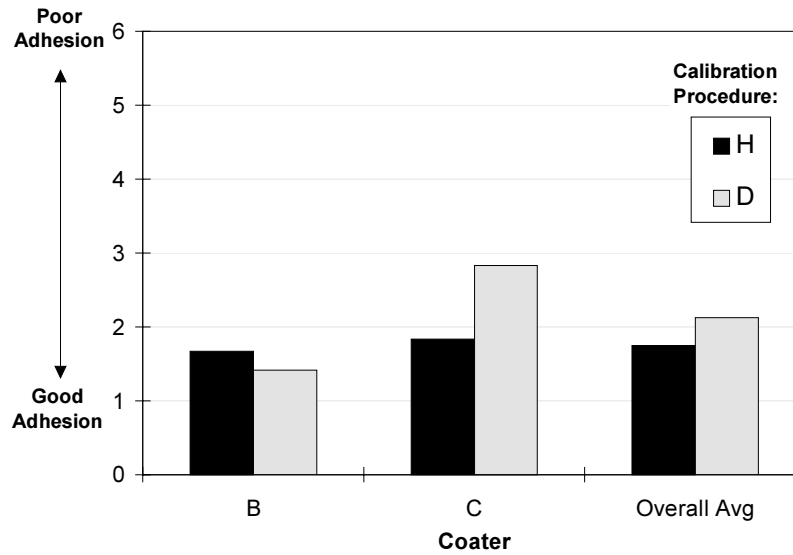
**Figure 3.10** Effect of procedures to calibrate knife force on adhesion test results (all samples).
