# **ADHESION TESTING OF EPOXY COATING**

**Research Report No. 1265-6**

*Structural Integrity of Epoxy-Coated Bars*

**TEXAS DEPARTMENT OF TRANSPORTATION**

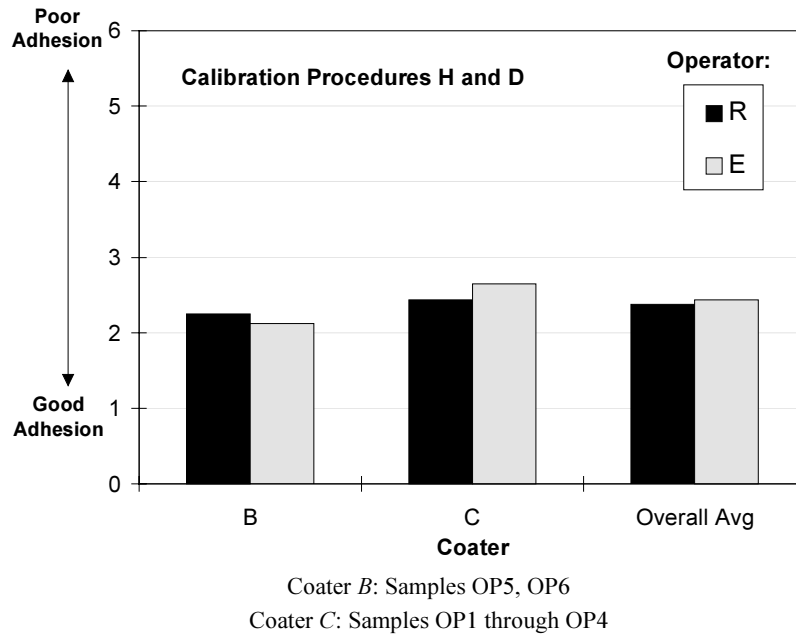
**Figure 3.11 Overall mean adhesion ratings for test operators *R* and *E*.**

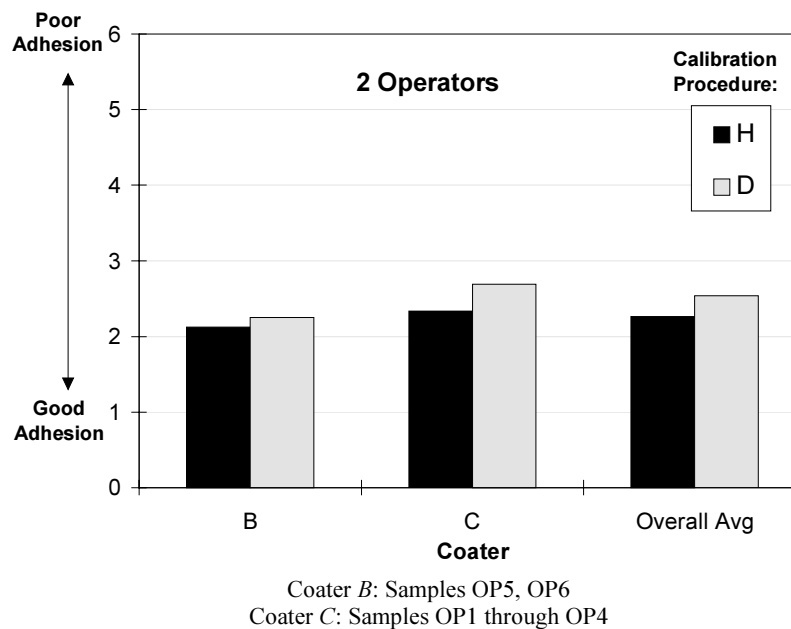
**Figure 3.12 Overall mean adhesion ratings of calibration procedures *H* and *D* (tests performed by two operators).**

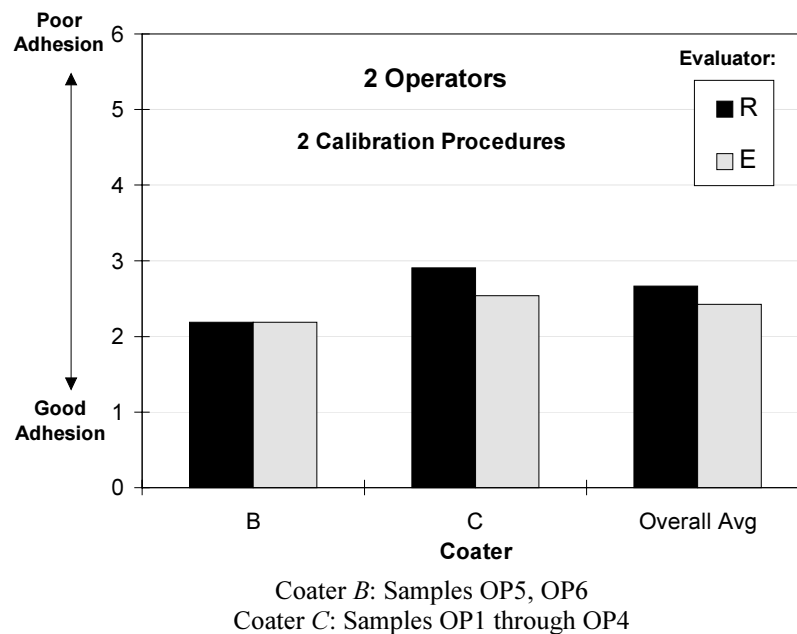
**Figure 3.13 Overall mean coating adhesion of specimens rated by two evaluators (specimens tested by two operators following two calibrating procedures to control knife force).**

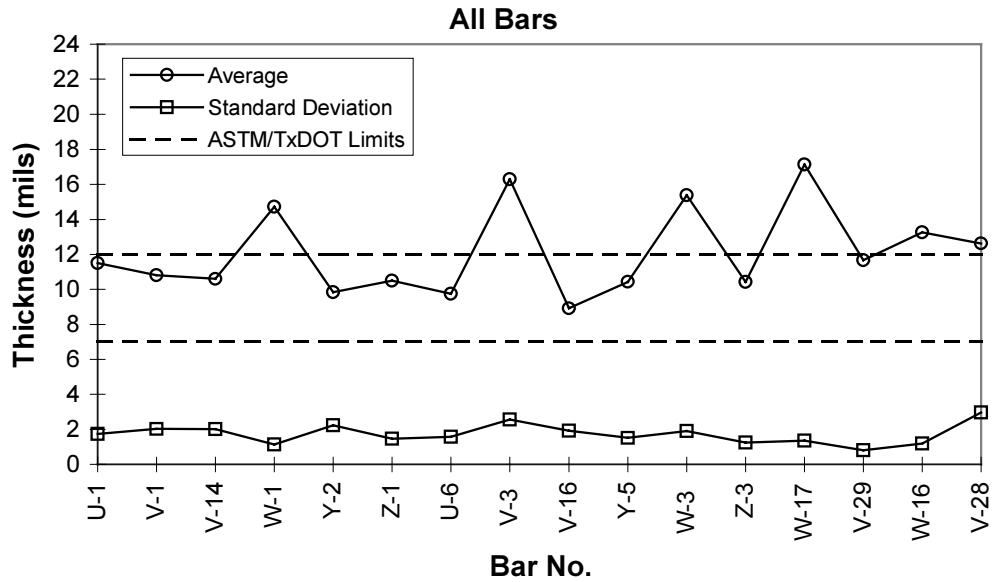
**Figure 4.1** Average coating thickness of all bars from 5 coating applicators.

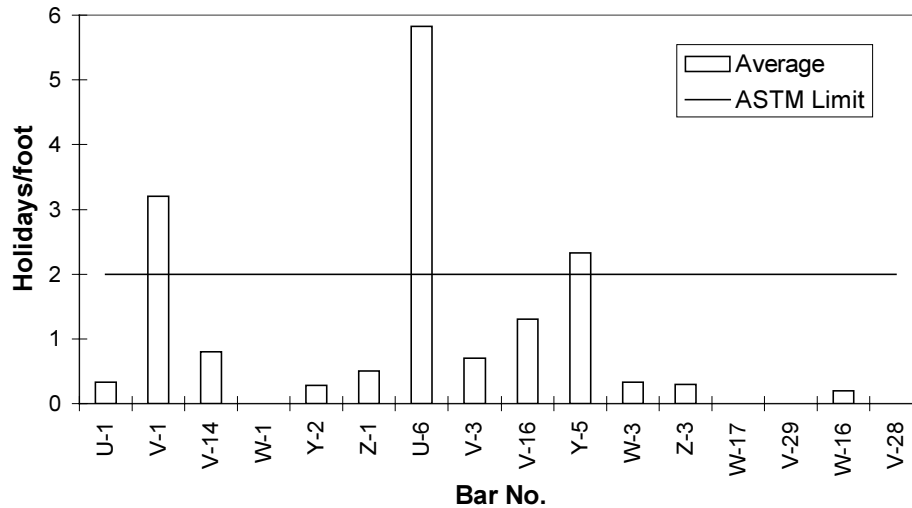
**Figure 4.2 Average holiday count for all bars.**

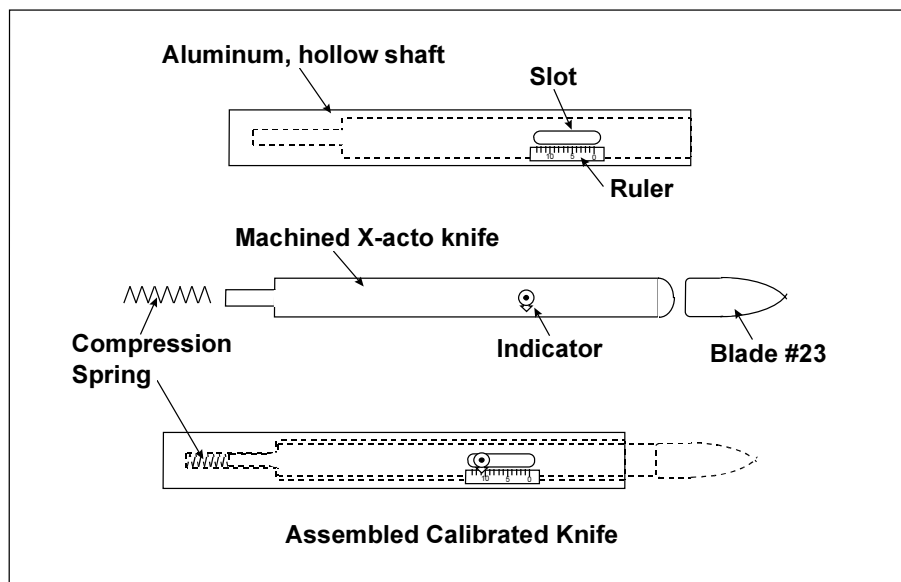
**Figure 4.3 Calibrated Knife.**

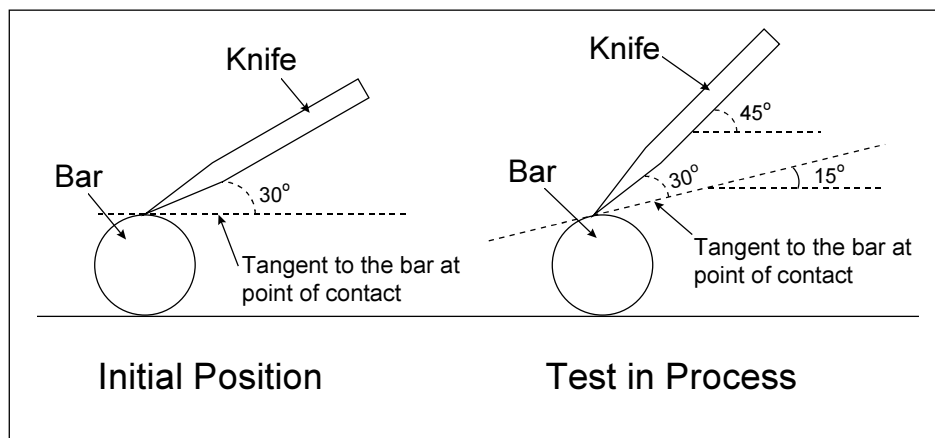
**Figure 4.4 Angle of knife during adhesion testing.**

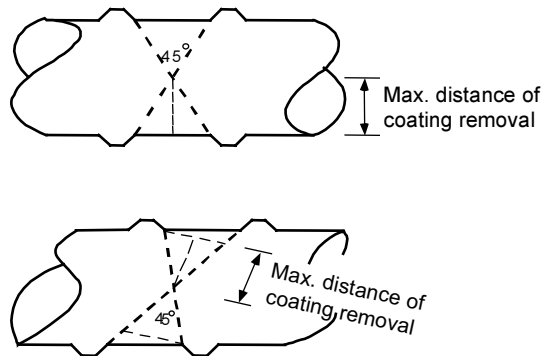
**Figure 4.5 Length of cut for bamboo and diagonal deformation patterns.**

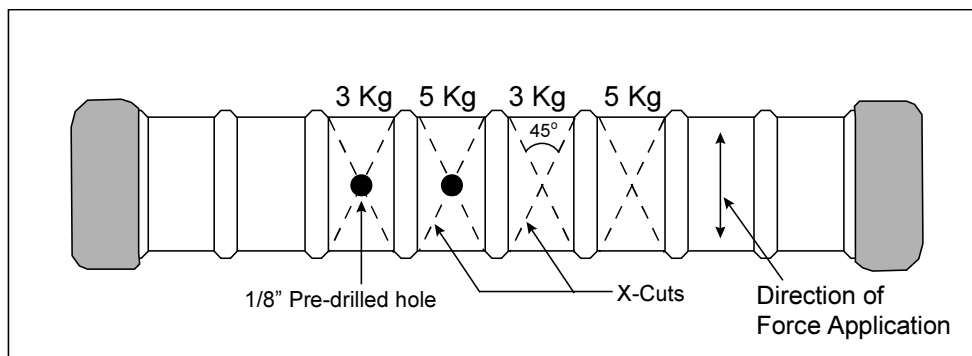
**Figure 4.6** Test locations on 5-inch-long epoxy-coated bar specimens for preliminary adhesion tests.

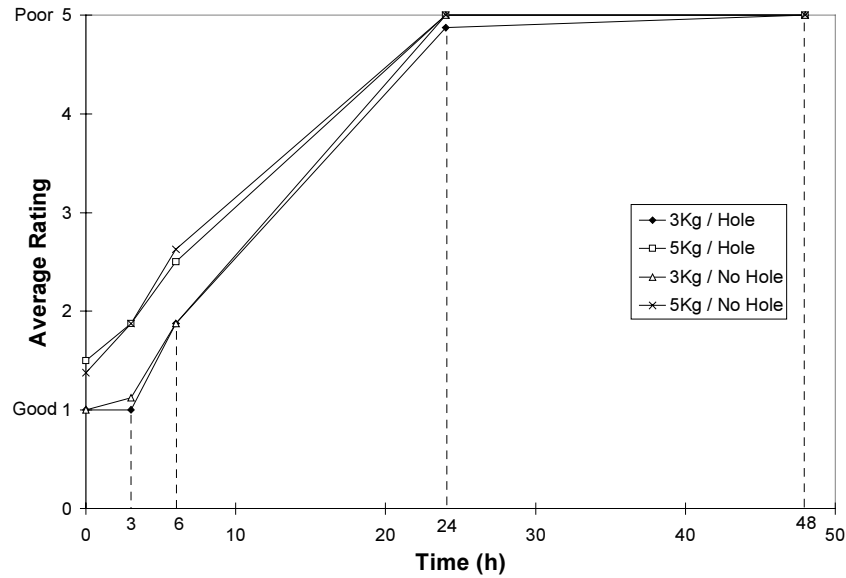
Figure 4.7 Effect of immersion time for bar No. A-1 exposed to 75°C water.

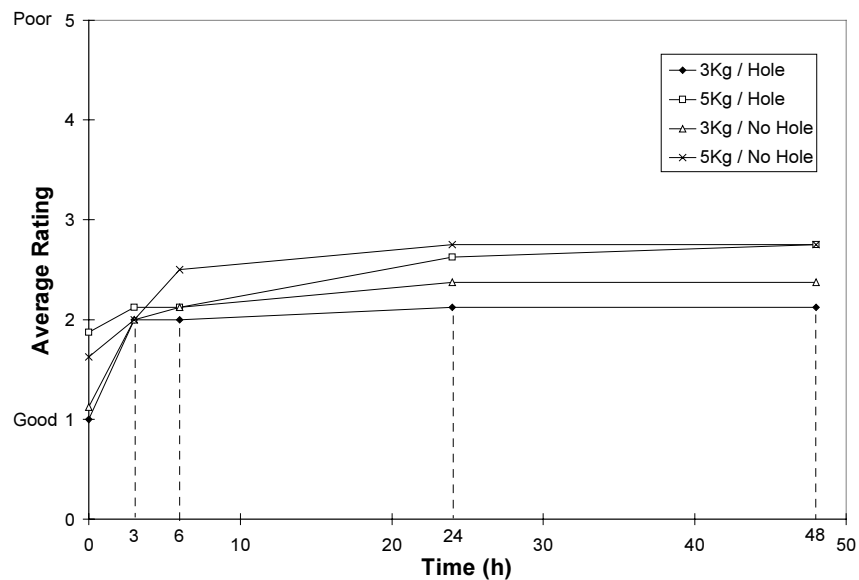
Figure 4.8 Effect of immersion time for bar No. S-1 exposed to 75°C water.

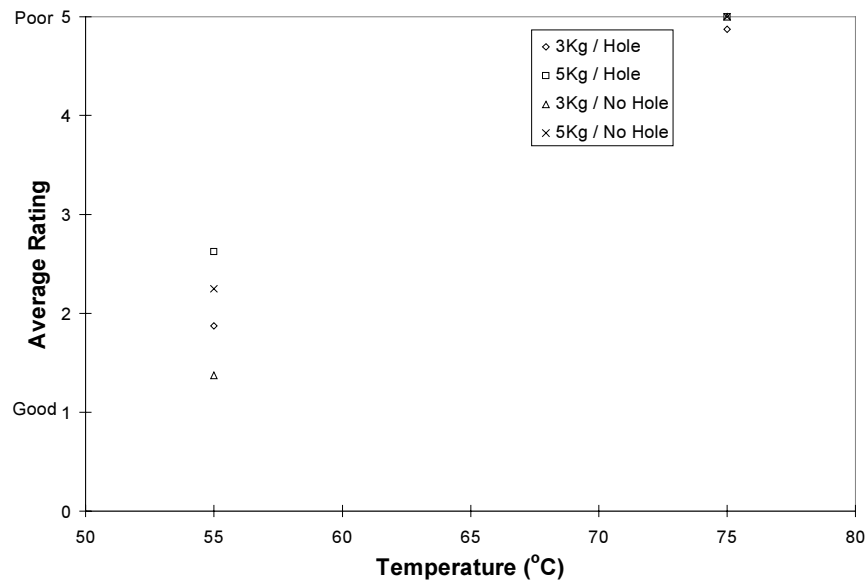
**Figure 4.9** Effect of temperature on bar No. A-1 after 24 hours of immersion.

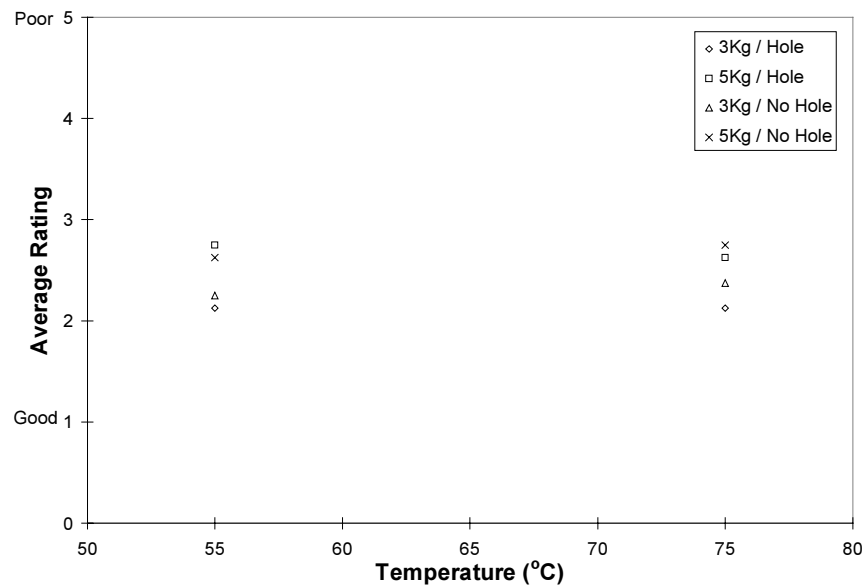
**Figure 4.10** Effect of temperature on bar No. S-1 after 24 hours of immersion.

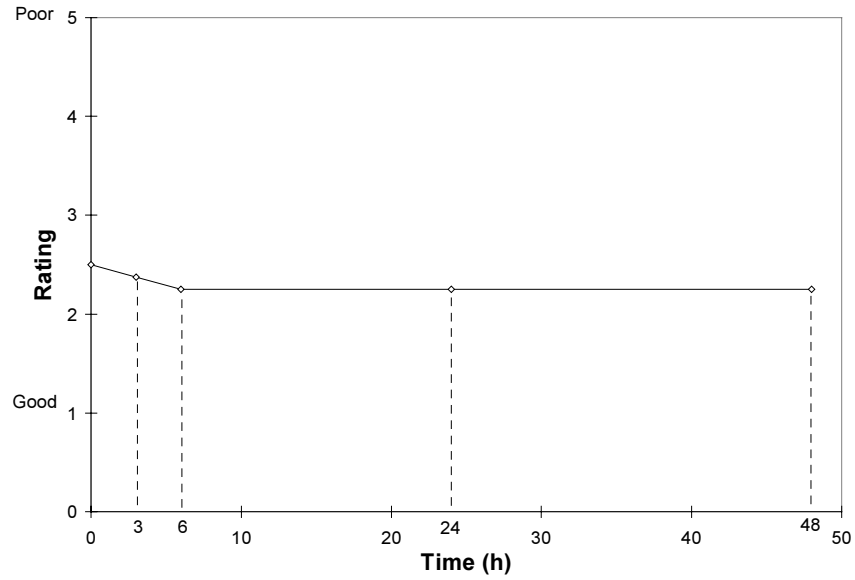
**Figure 4.11 Effect of post-immersion period on coating adhesion for bar No. A-1.**

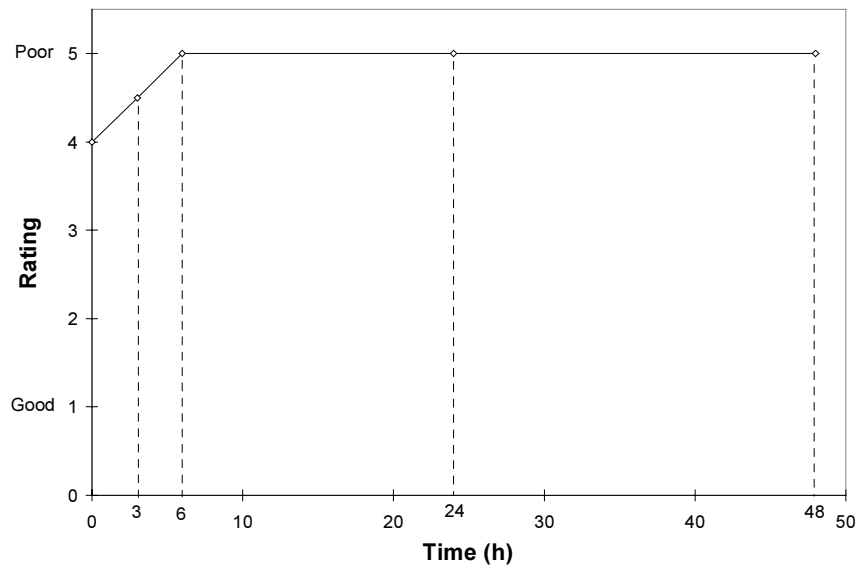
**Figure 4.12 Effect of post-immersion period on coating adhesion for bar No. S-1.**

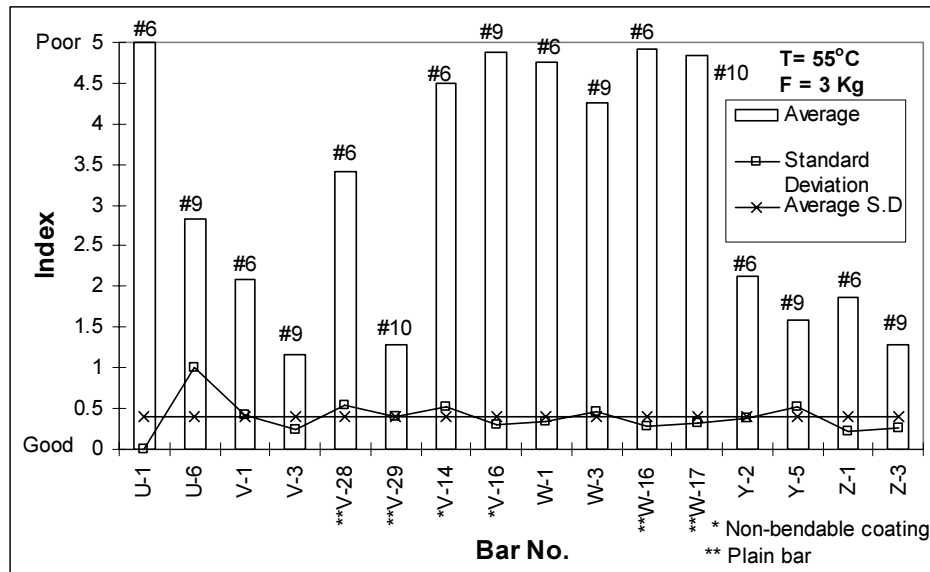
**Figure 4.13 Average adhesion rating of all bars in hot water tests.**

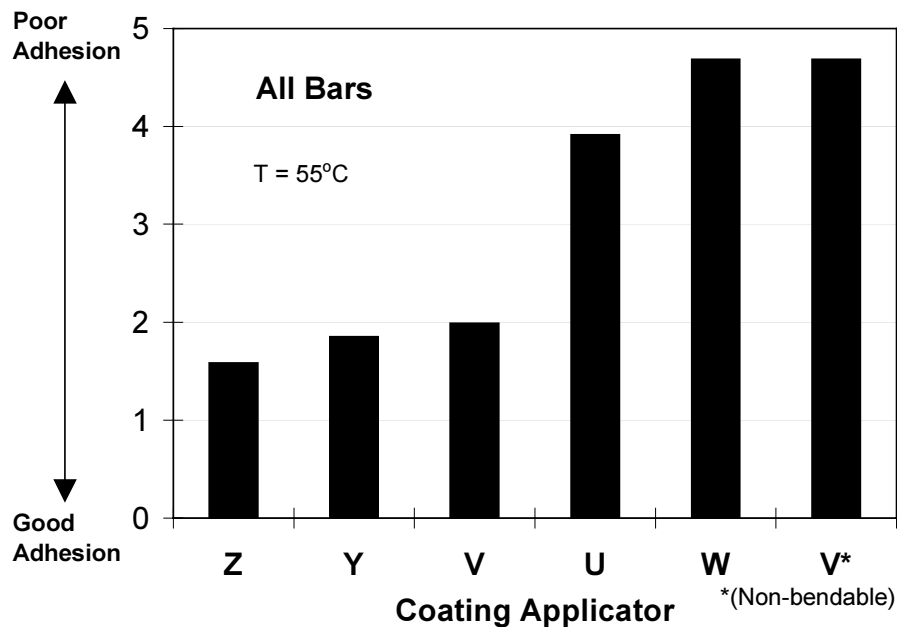
Figure 4.14 Coating applicator performance–Hot water tests.

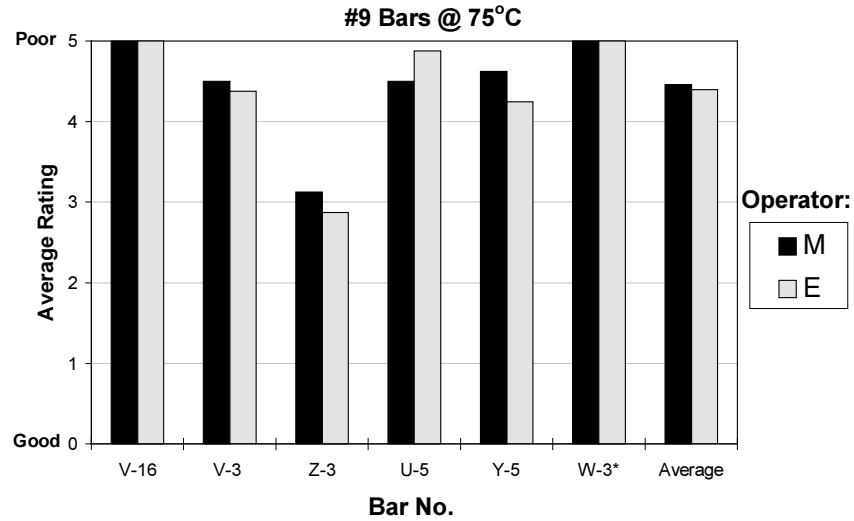
**Figure 4.15 Effect of operator (Hot water test, F= 3Kg).**

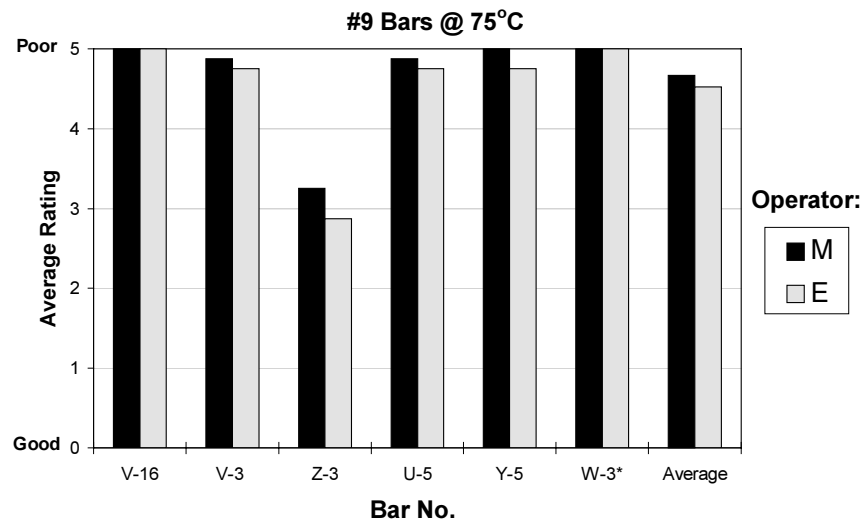
**Figure 4.16 Effect of operator (Hot water test, F= 4Kg).**

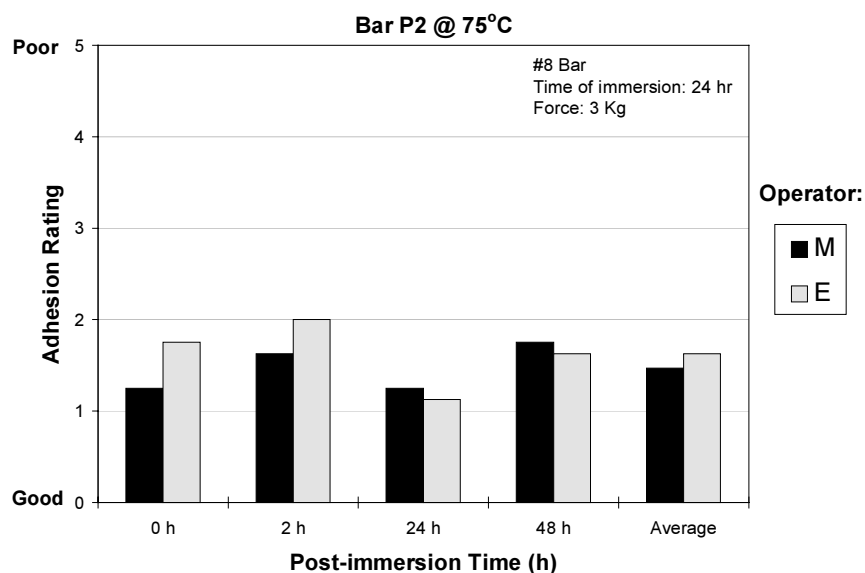
**Figure 4.17 Effect of operator (Hot water test on bar P2).**

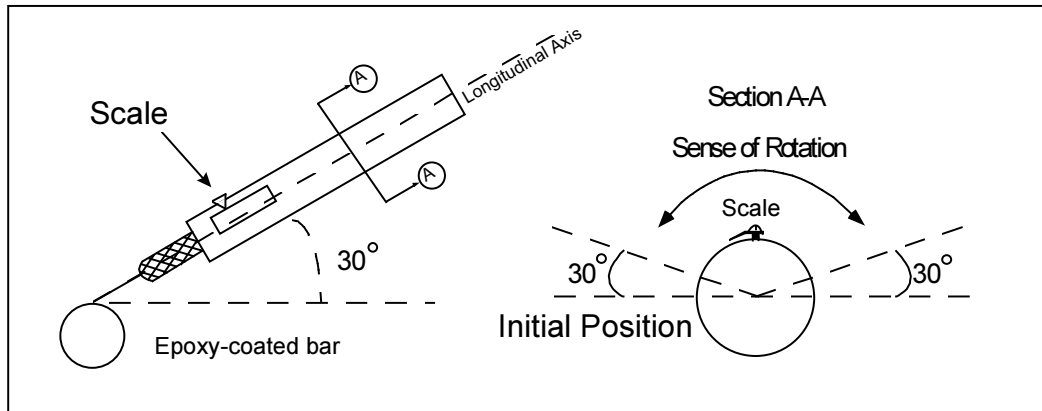
**Figure 4.18 Position of testing knife and rotating motion.**

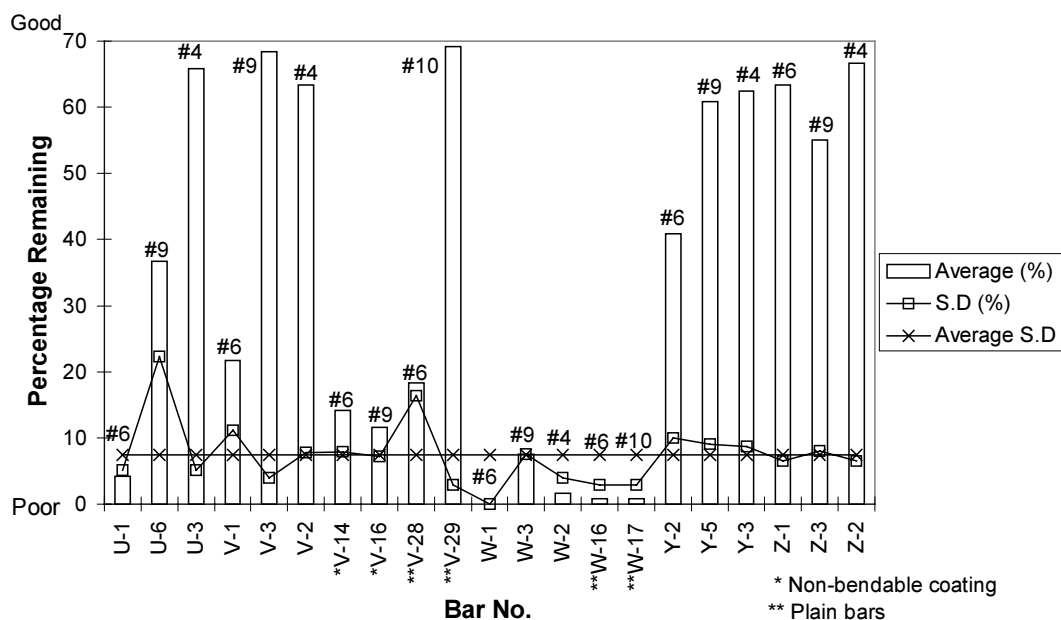
Figure 4.19 Average adhesion index of all bars in strip tests.

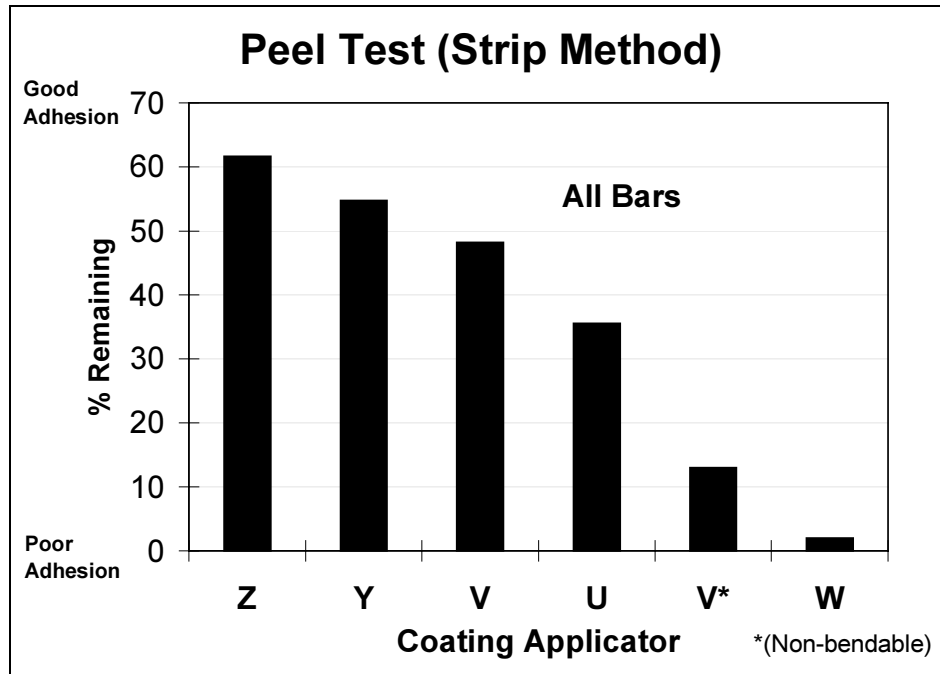
Figure 4.20 Coating applicator performance–Peel tests (strip method).

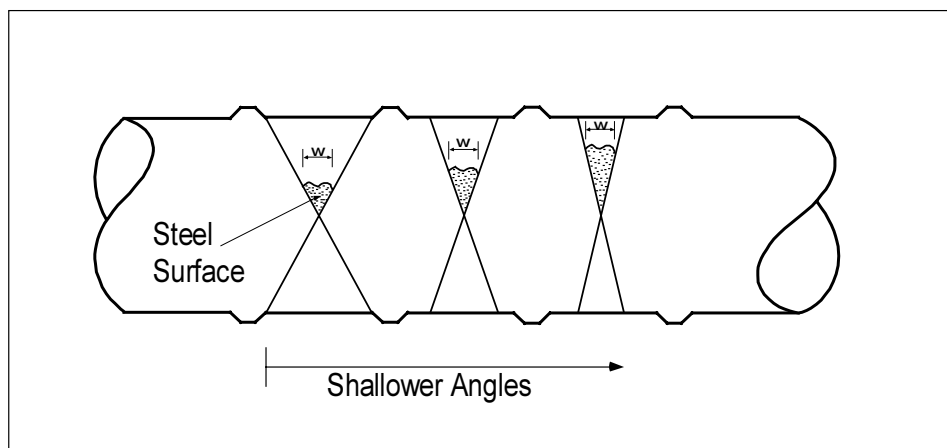
**Figure 4.21 Width of final section remains roughly equal as the angle of the X-cut becomes shallower.**

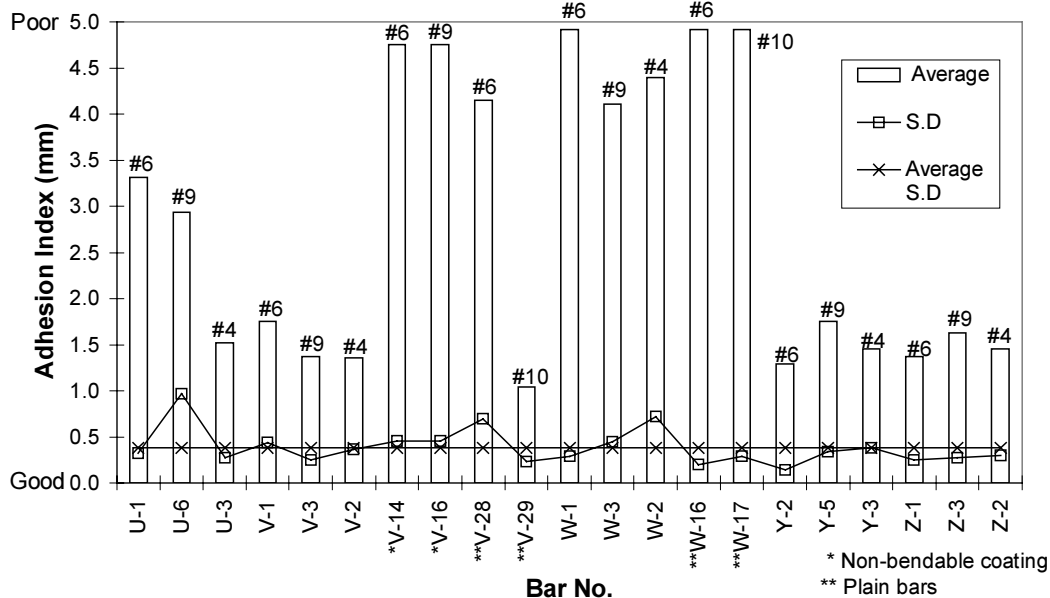
Figure 4.22 Average adhesion index of all bars in X-cut tests.

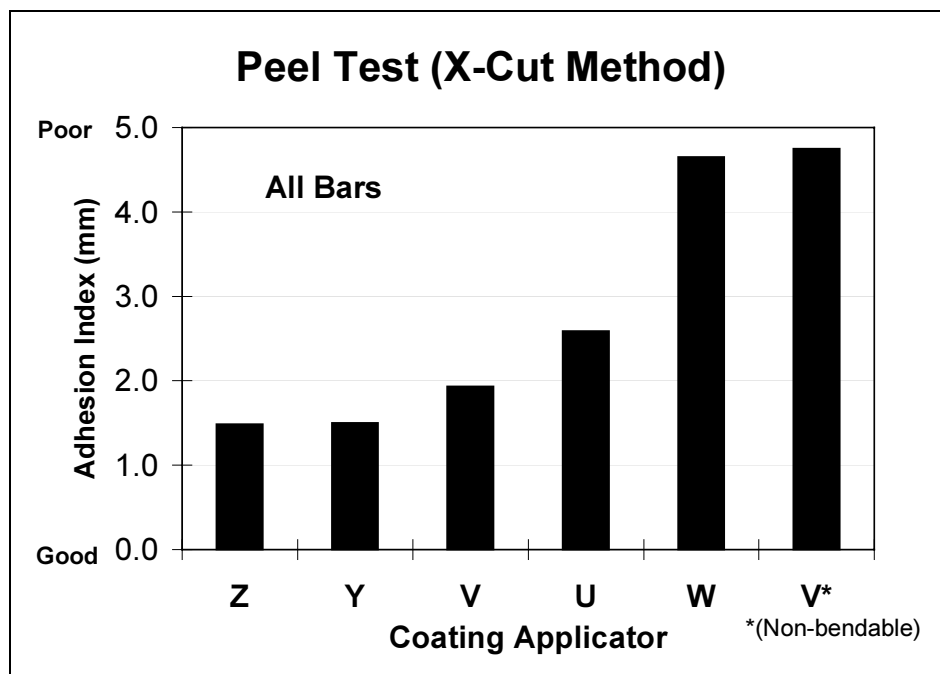
Figure 4.23 Coating applicator performance–Peel tests (X-cut method).

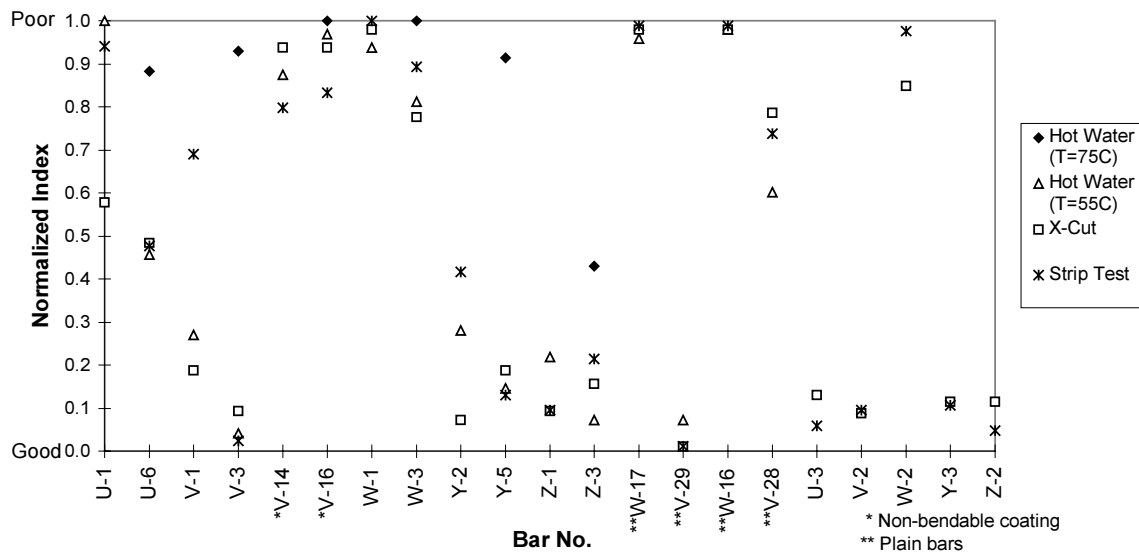
Figure 4.24 Relative adhesion values between all tests.

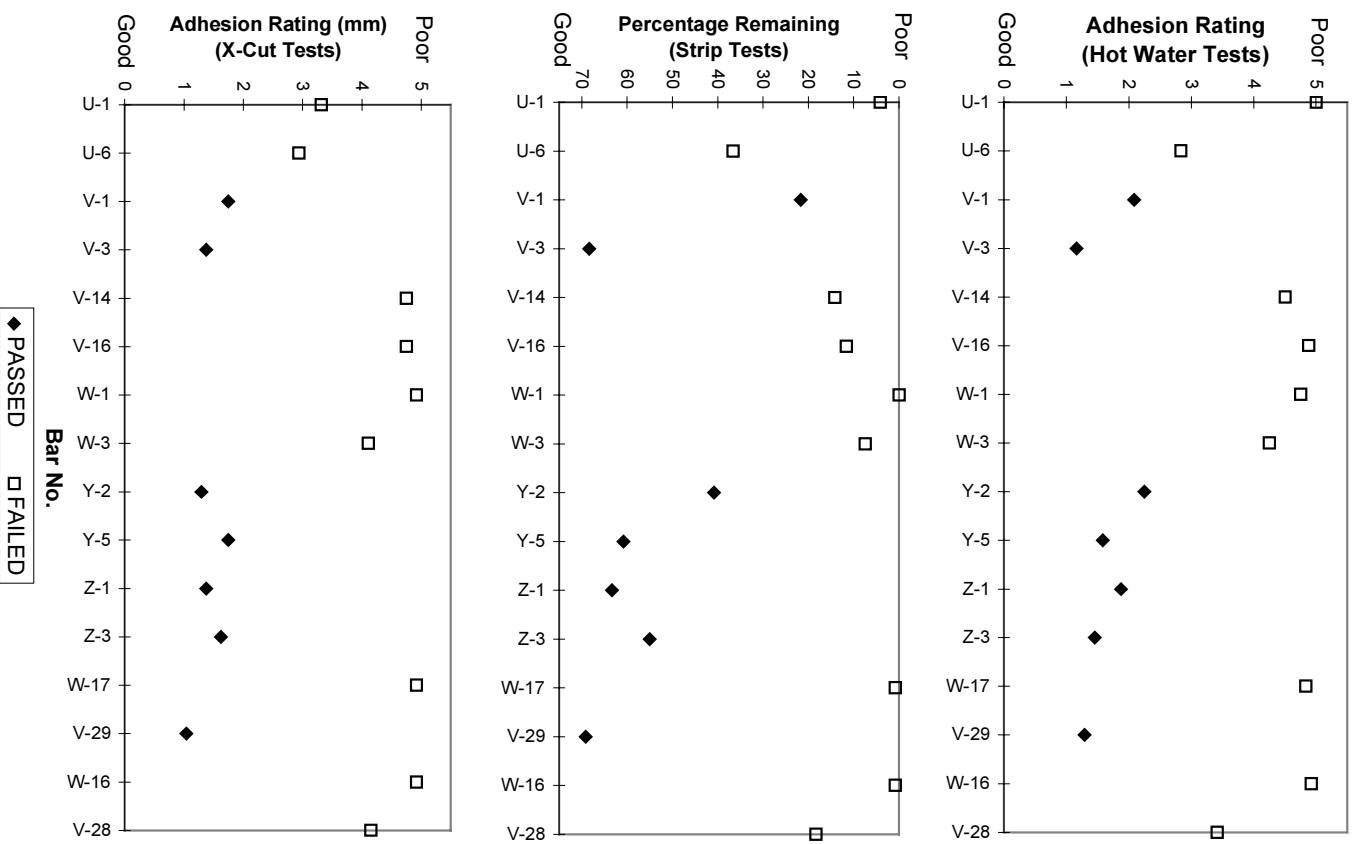
Figure 4.25 Adhesion test results from three test methods compared to TEX 739-I peel test rating.

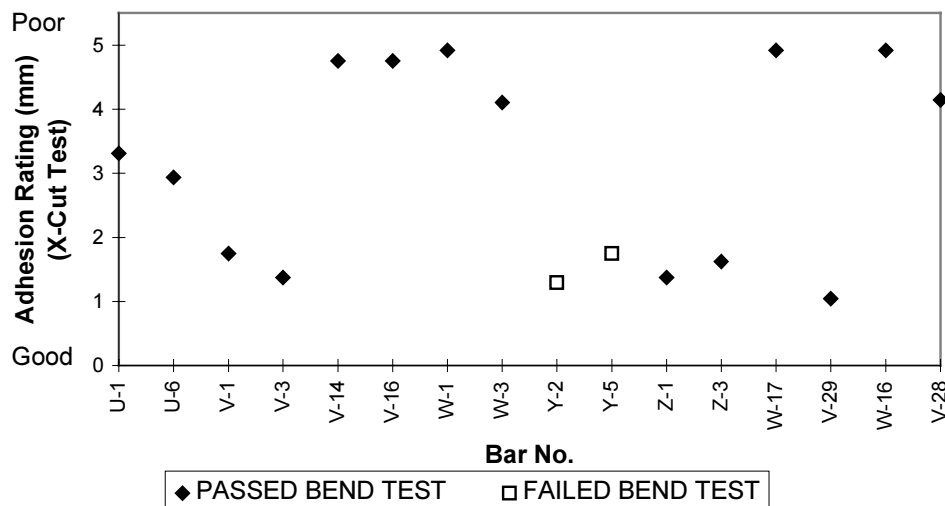
**Figure 4.26 Adhesion test results from X-cut method compared to bend test.**

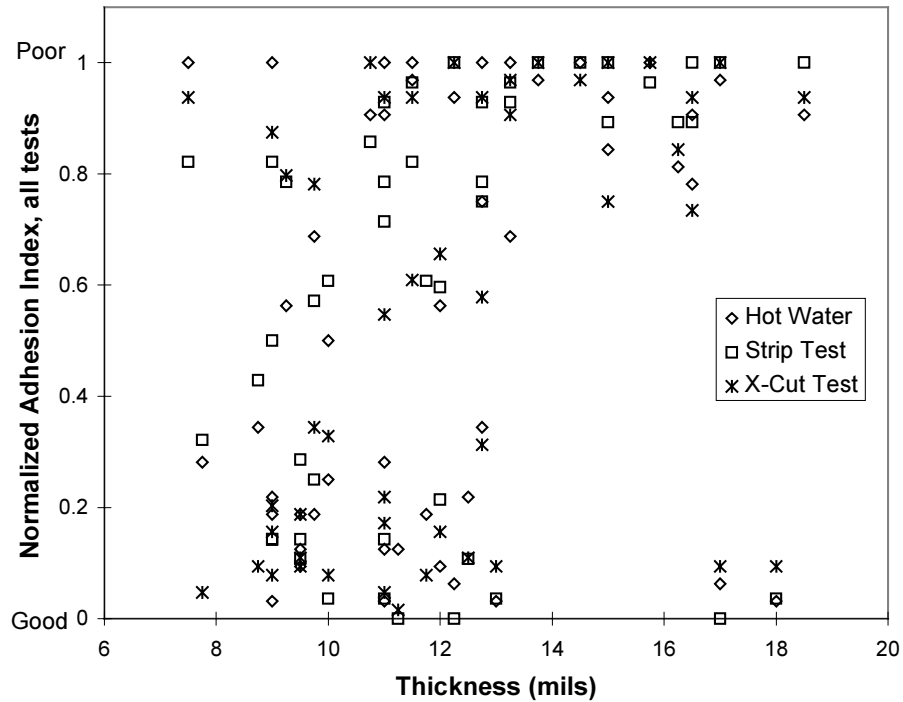
Figure 4.27 Coating thickness -vs- normalized adhesion index.

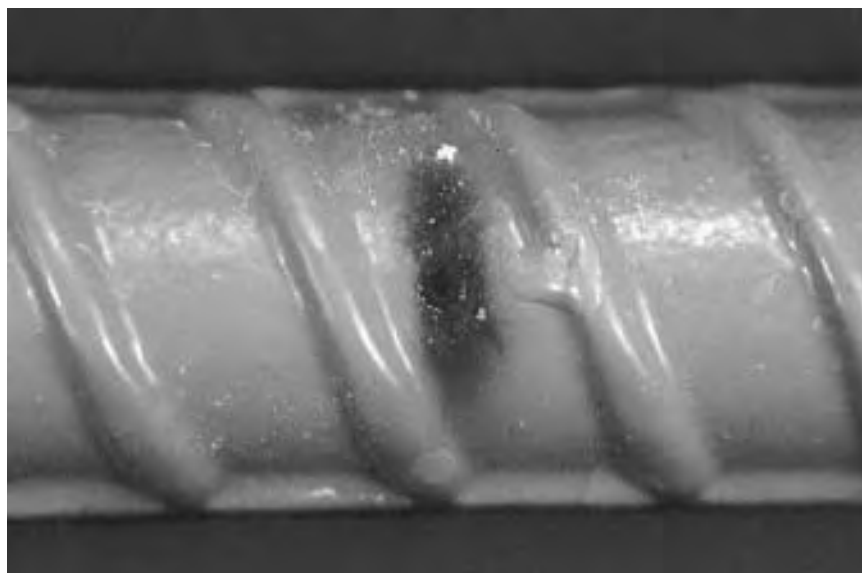
**Figure 4.28 General aspect of specimens after immersion.**

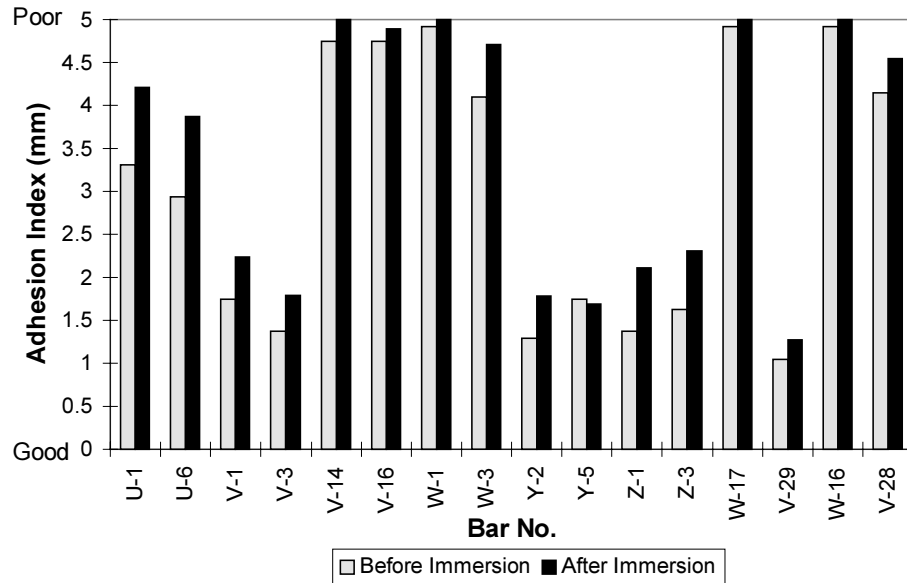
**Figure 4.29 Adhesion index before and after immersion for all bars.**

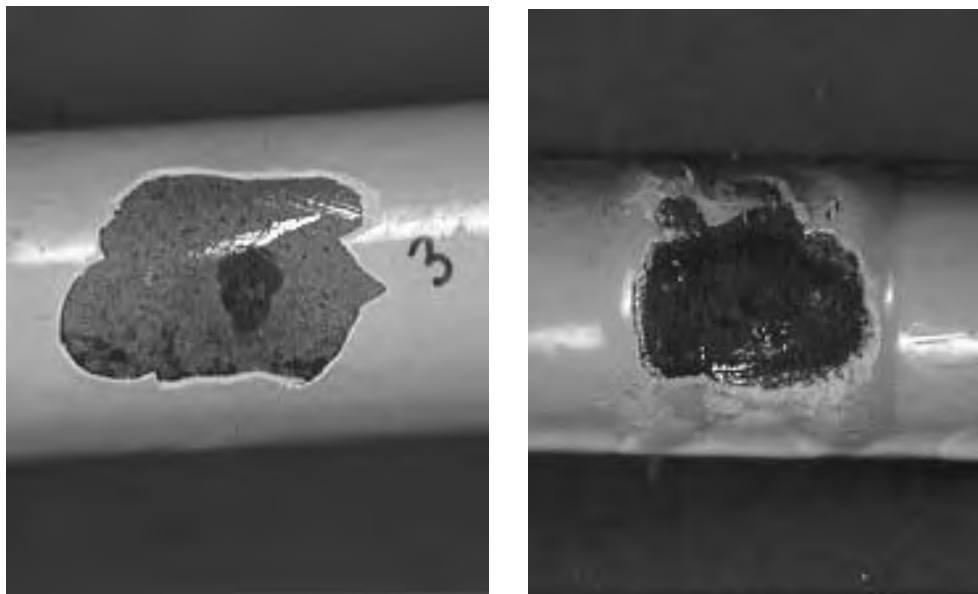
**Figure 4.30** Damaged area in samples with good (right) and poor (left) coating adhesion. Note that the dark corroded area on the sample with good adhesion is larger than that on the sample with poor adhesion.

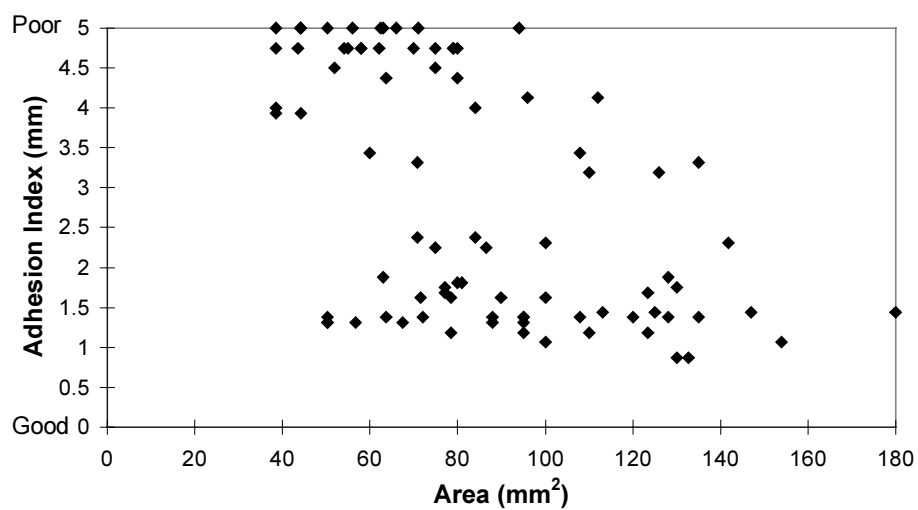
**Figure 4.31** Size of corroded area in relation to X-cut adhesion index.
