# Fair Wear & Tear

Guidelines for Cars

# Accepted by leading European leasing companies

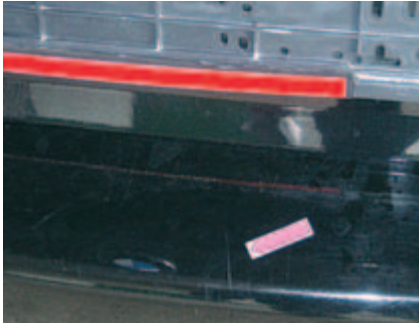
Light scratches (and scuffs/abrasions) up to 10 cm, which may be removed by mechanical polishing, provided the base coat has not been penetrated or any rust has developed.

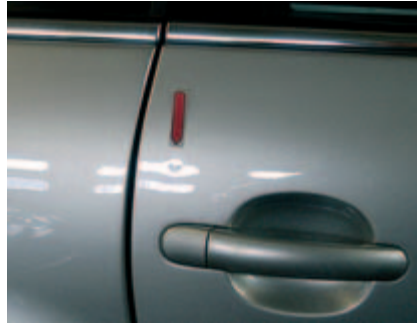
Up to 2 small “dings” per panel is acceptable (3 or more is regarded as multiple and therefore not acceptable).

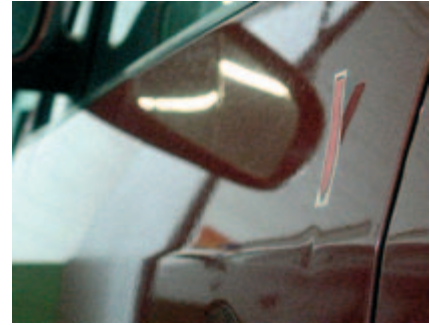
In all cases, damage greater than 2 cm is unacceptable, therefore this dent is acceptable as it is clearly within the 2 cm tolerance.

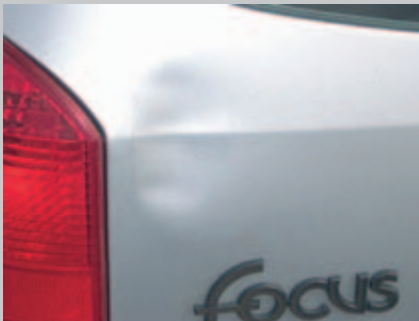
This panel has multiple dents and they are greater than 2 cm.

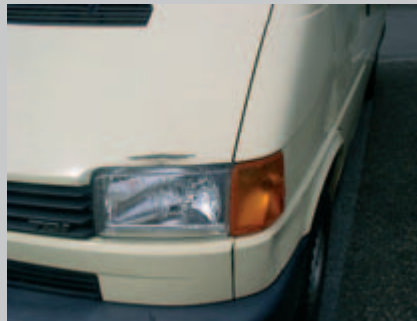
Dents with corrosion developing.

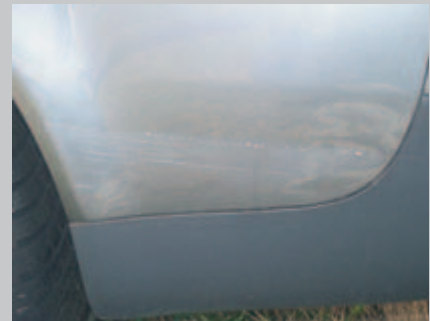
Scratches/multiple scratches or abrasions which (relative to age and Mileage) are over 10 cm in length, have penetrated the paint and cannot be removed via mechanical polishing.

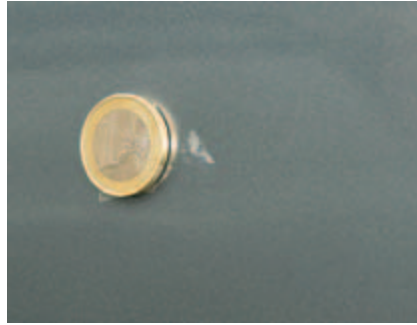
Here is a small paint chip that should be "touched up" prior to rust developing. Provided the correct materials are used, this is acceptable.

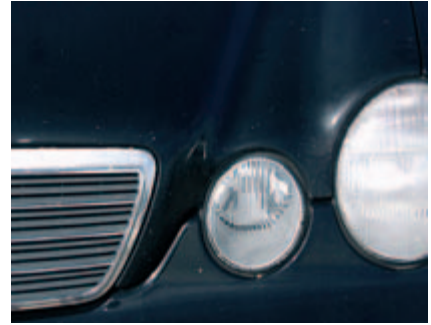
Light scuffing and scratches with a maximum depth of 0,1 cm. Also acceptable are small dents (up to 2 cm in diameter).

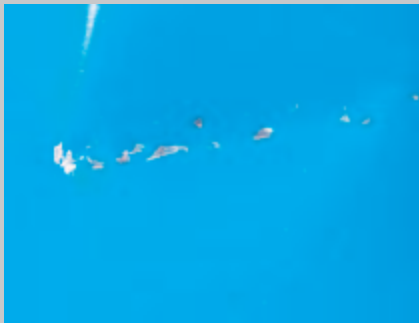
Scuffing and scratches, which have penetrated through to the base coat are not acceptable. Two or more scuffs or scratches on one panel/body part are not acceptable.

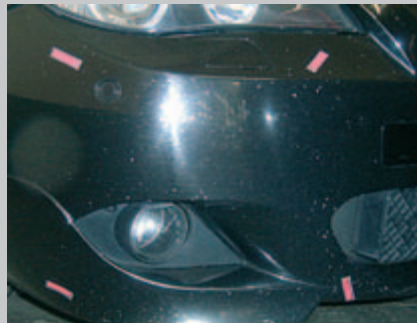
Excessive chipping (commensurate with the vehicles age and mileage) or chips which have penetrated through to the base coat or rusted.

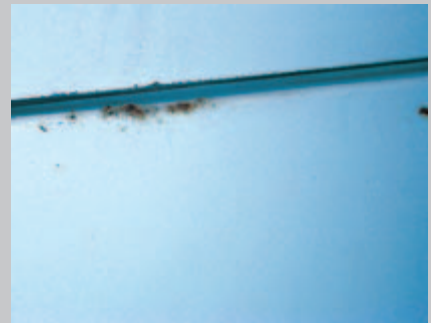
Dents, scrapes, scuffs and scratches with paint damaged through to the base coat/metal and showing signs of corrosion.

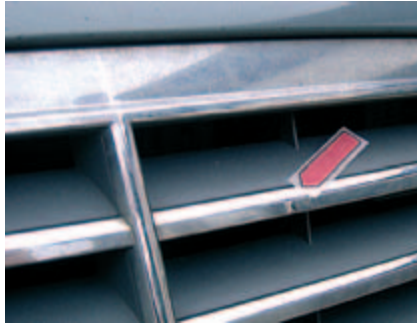
For painted bumpers – Light scuffing and scratches which have not penetrated the paint layer.

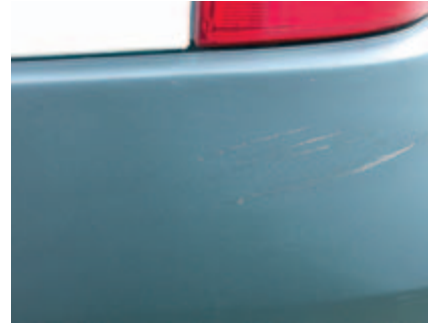
For textured and non-painted bumpers - Light scratches and scoring are acceptable. Also acceptable are small dents (up to 2 cm in diameter).

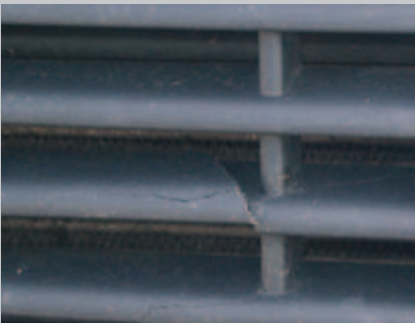
Broken, cracked or excessive scoring of grilles is not acceptable.

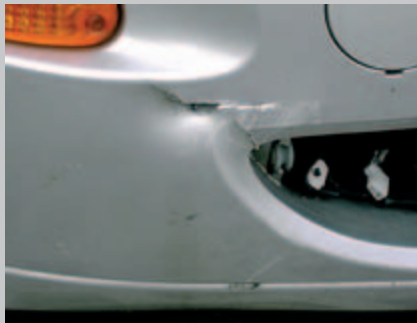
Excessive scratching, cracks or dents exceeding 20mm. (Tow bars – please ensure tow bar covers and pins are intact).

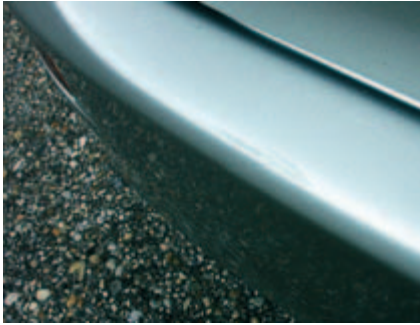
A maximum of two small areas of damage per bumper (provided there is no penetration of the base coat/rust).

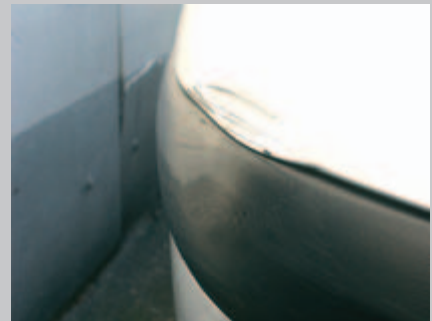
Excessive damage causing deformation of the panel/part.

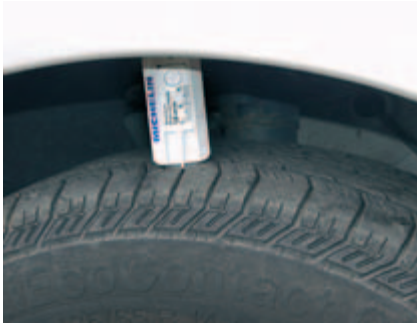
Tyres with a minimum tread of 2 mm or tyres that meet local legal requirements.

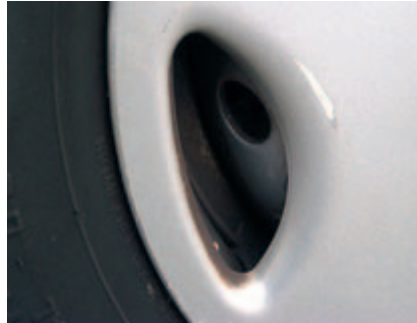
Light scuffing or scratches to the wheel trim/alloy.

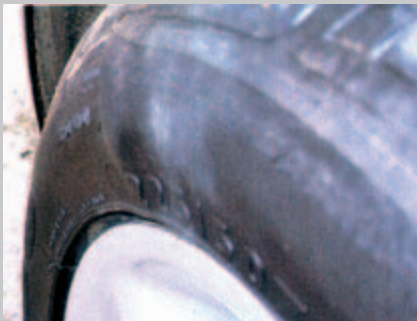
Tyres with damage caused by 'kerbing' or other abuse. Bald tyres are unacceptable.

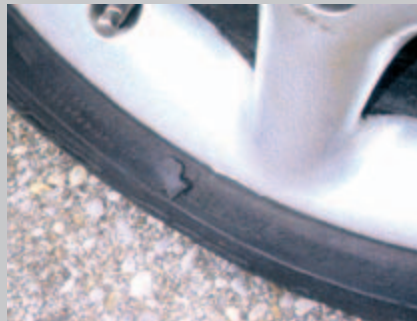
Bulges, cracks or cuts to the tyre or excess damage to the sidewalls or tread.

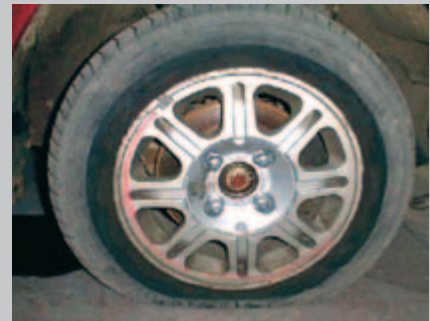
Flat tyres due to damage or penetration of a foreign object, and affecting the safety of the vehicle.

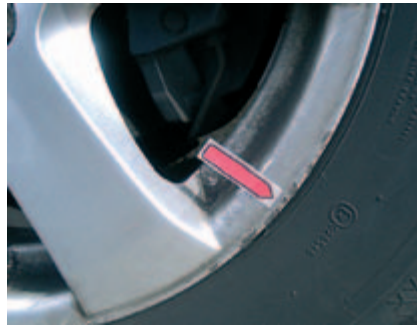
Scuffing, scratches or deposits on rims, if the rim is not deformed.

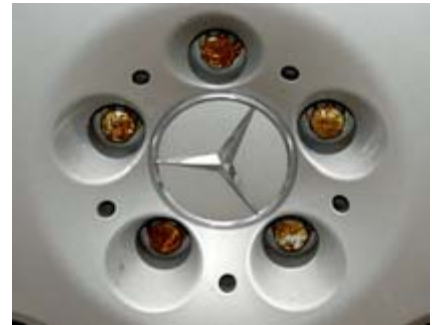
Wheel nuts that are rust and deformation free.

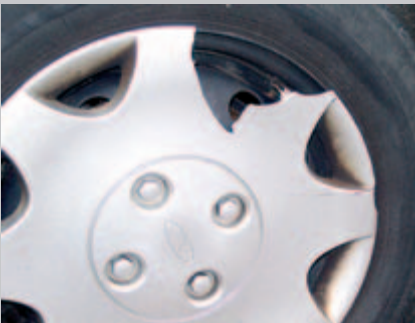
Deformed wheel trims due to breakages or scuffing. Cracks or breaks to the trim. Missing trims.

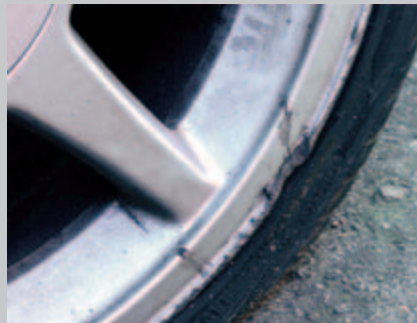
Rims with heavy damage, deformation of the rim or missing parts.

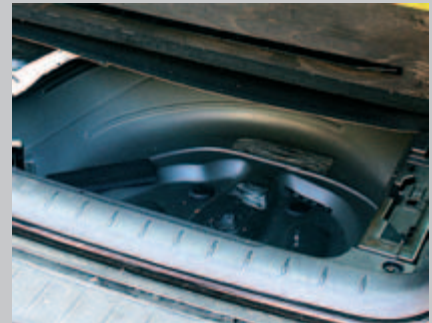
Missing spare wheel, if it is included as basic equipment, or a missing or only incomplete "Tyre Mobility Set."

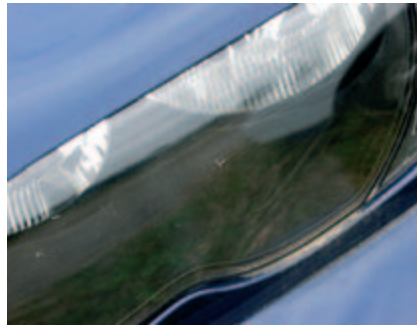
Stone chipping on the surface of head-lights, fog lights or indicators not breaking the glass and not harming the function.

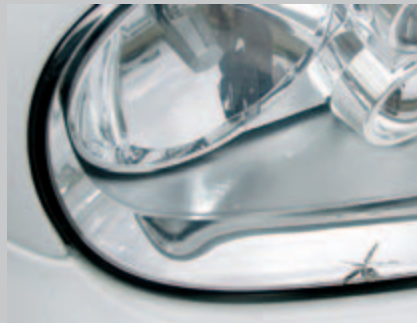
Cracks or chips which restrict the function of the light. Please note that all bulbs should be operational.

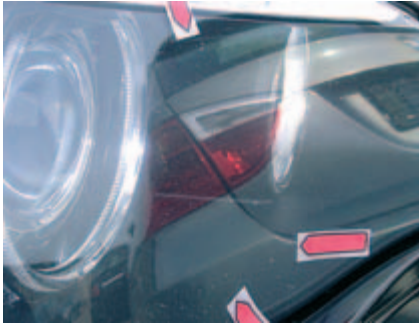
Scratches or chippings in the surface of headlights, fog lights or indicators, which do not break the glass and harm the function.

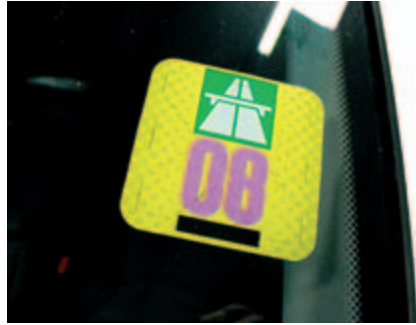
Small stickers on the glass.

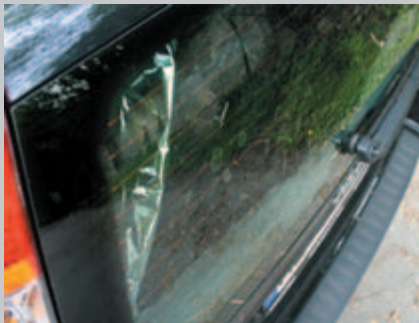
Self-applied sun protection or tinted strips must be completely removed from the windshield if they have not been professionally applied, are torn, or have begun to separate from the corners of the windshield.

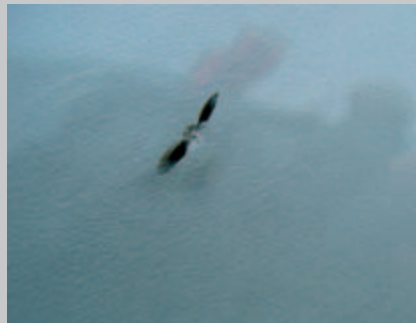
Cracks in the windscreen, or heavy stone chipping (1 cm per chip), which affects driving.

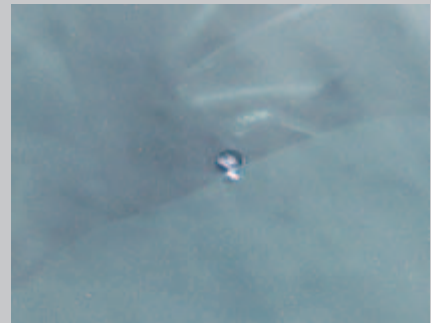
Excessive large chips, holes or cracks.

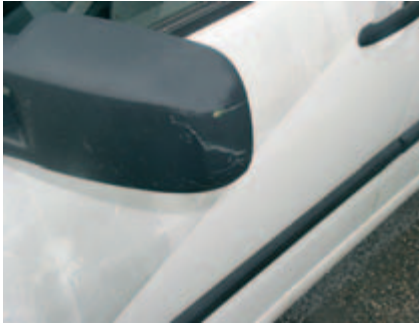
Light scuffing and scratches with a maximum length of 5 cm and a maximum depth of 0,1 cm. For painted mirror casings only scuffing and scratches which have not penetrated the base material, and where the function is not affected.

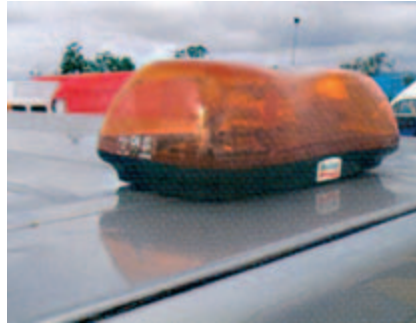
Fitted beacons or lights that are properly fitted and in full working order, without breaks in the glass. The lights must fully comply with the legal requirements and if legally necessary mentioned in the vehicle documents.

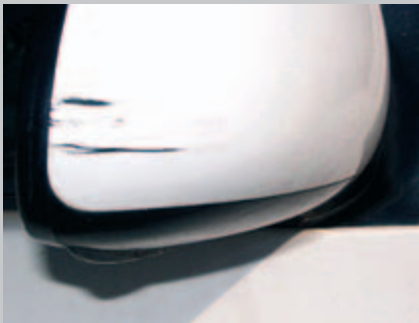
Scuffing and scratches which exceed a maximum length of 5 cm. For painted mirror casings scuffing and scratches which have penetrated the base material.

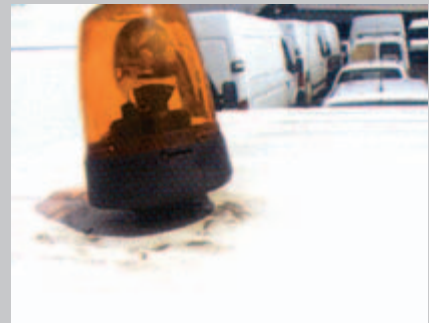
Beacons that have damaged the structure of the vehicle through their fitment are not acceptable.

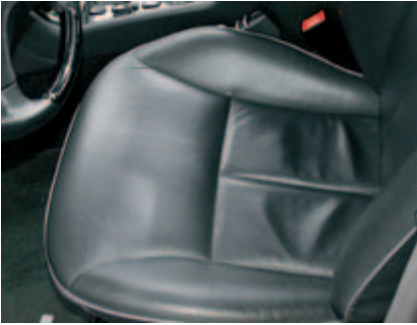
Seats showing wear through general usage i.e. getting in and out of the car.

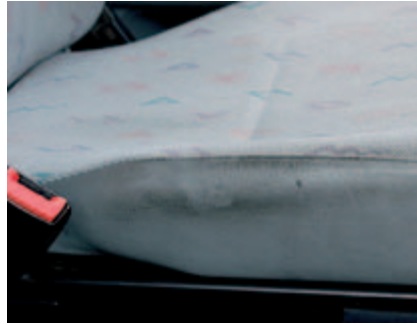
Indentation in the seat.

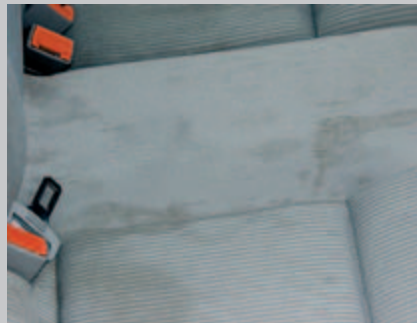
Excessive soiling and dirt which cannot be removed by general cleaning.

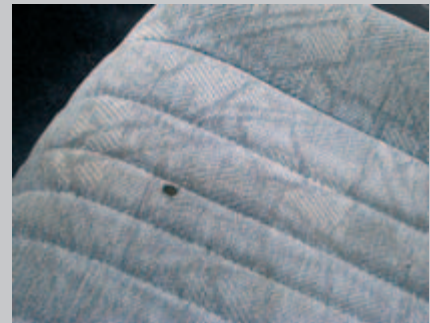
Torn upholstery or cigarette burns.

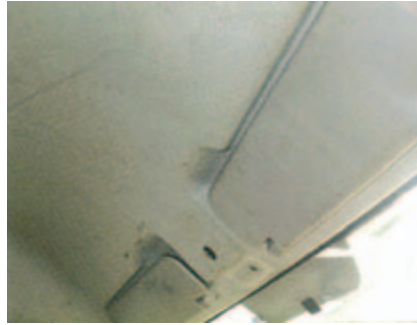
Headlining which has light abrasions or soiling.

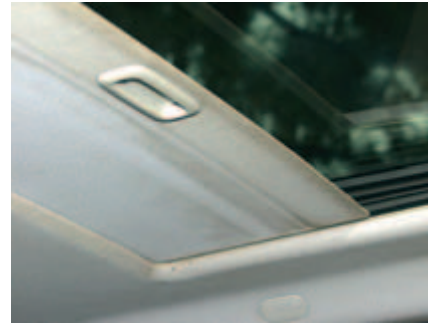
Slight panel discolouration through day to day usage and wear.

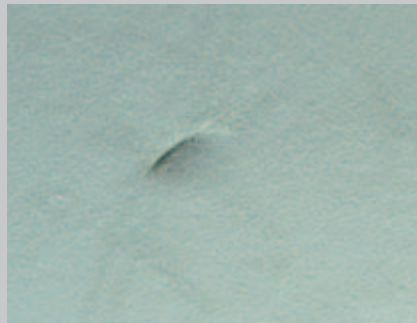
Deformation of the material, cuts, tears or heavy soiling.

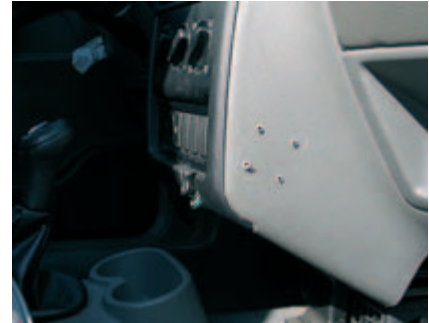
Holes left in the console (as a result of phone equipment being removed) may be left providing they are in a discreet area as shown above. These holes are on the side of the console.

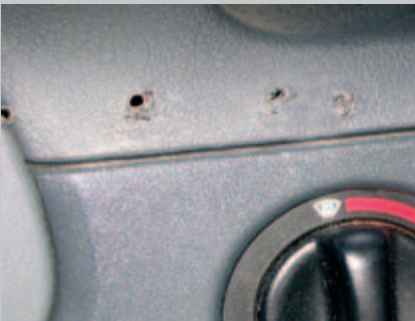
Here we are shown holes in the front of the console where accessories/ phone kits have been removed. These holes are clearly visible and should be repaired.

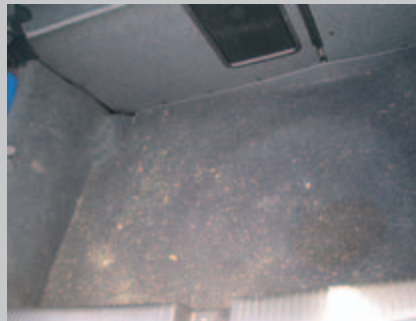
Excess soiling and staining of carpets that cannot be removed by normal cleaning is not acceptable. Excess soiling and staining of carpets that cannot be removed by normal cleaning is not acceptable.

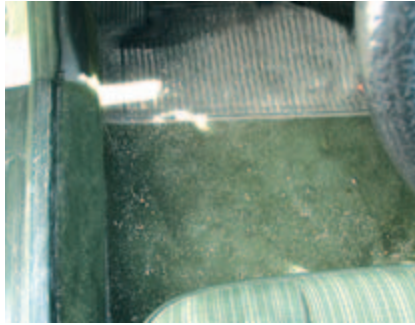
Signs of general usage where there is slight discolouration and scuffing.

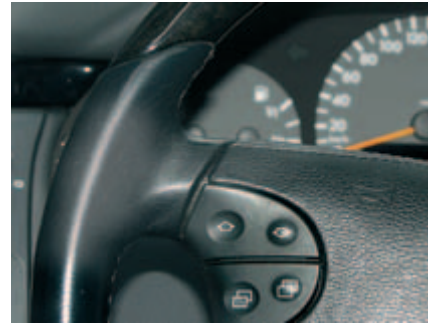
The steering wheel is slightly worn as a result of general use. (Torn material would not be acceptable).

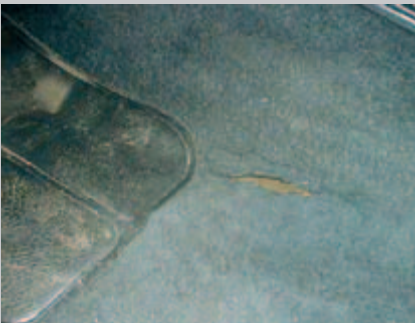
The carpet of the vehicle shows rips, tears or heavy stains.

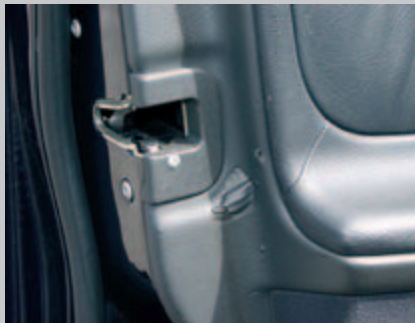
The interior lining is damaged by other than normal usage. Holes, tears or deforming are not acceptable.
