Preservation Plan
for the
Crosley Carriage House
(Garage and
Servant's Quarters)

at the
Crosley Museum
Sarasota, Florida

April 26, 2006

RENKER-EICH-PARKS
ARCHITECTS

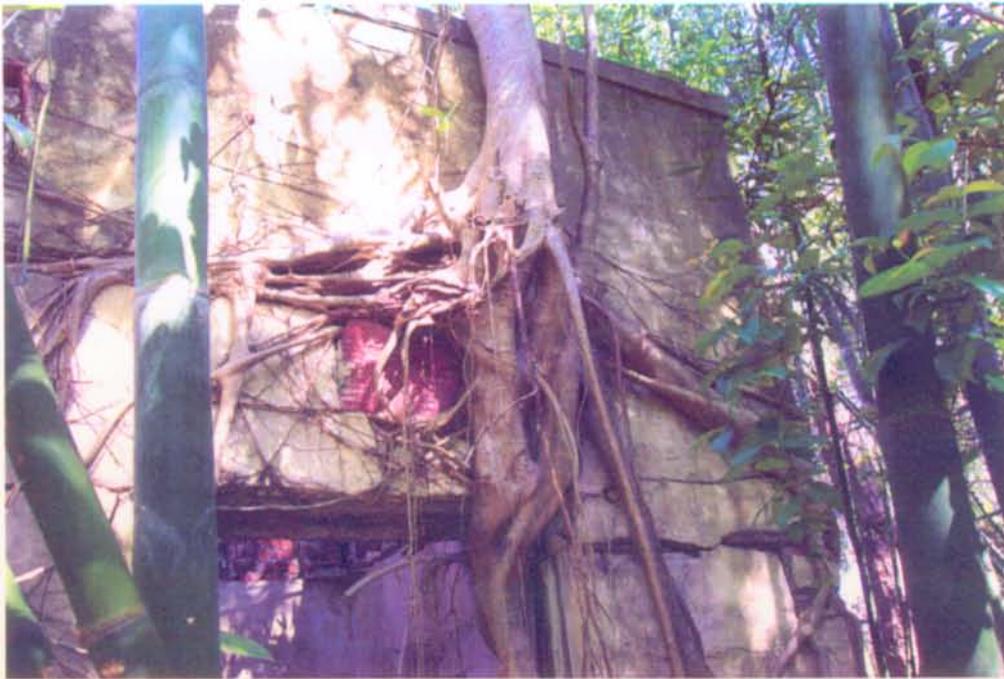
Photograph 3: DETAIL OF PARTIAL SOUTH ELEVATION SHOWING TREE GROWING FROM WALL WITH ROOTS EXTENDING TO SIDES AND DOWN.

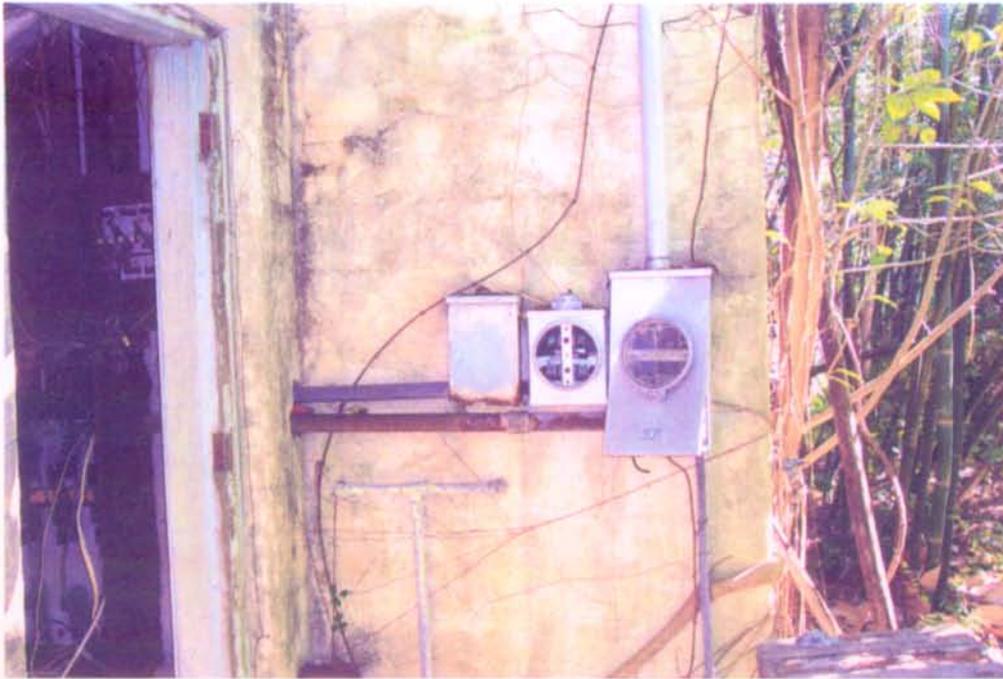
Photograph 5: DETAIL OF ELECTRICAL SERVICE ENTRY ON SOUTH ELEVATION.

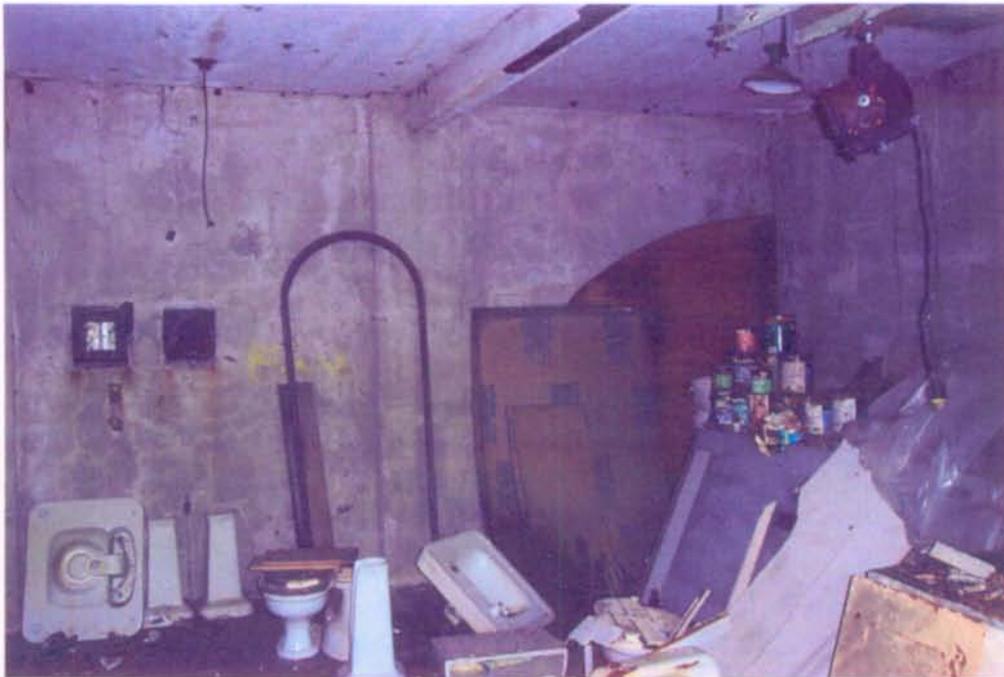
the wood framing and are covered with plaster matching the adjacent plaster ceiling. These beams are deteriorated and in poor condition, due to water penetration. The beams need to be replaced.

Photograph 9: INTERIOR ELEVATION OF SOUTH WALL OF GARAGE SHOWING ELECTRICAL PANELS AND BEAM IN CEILING.

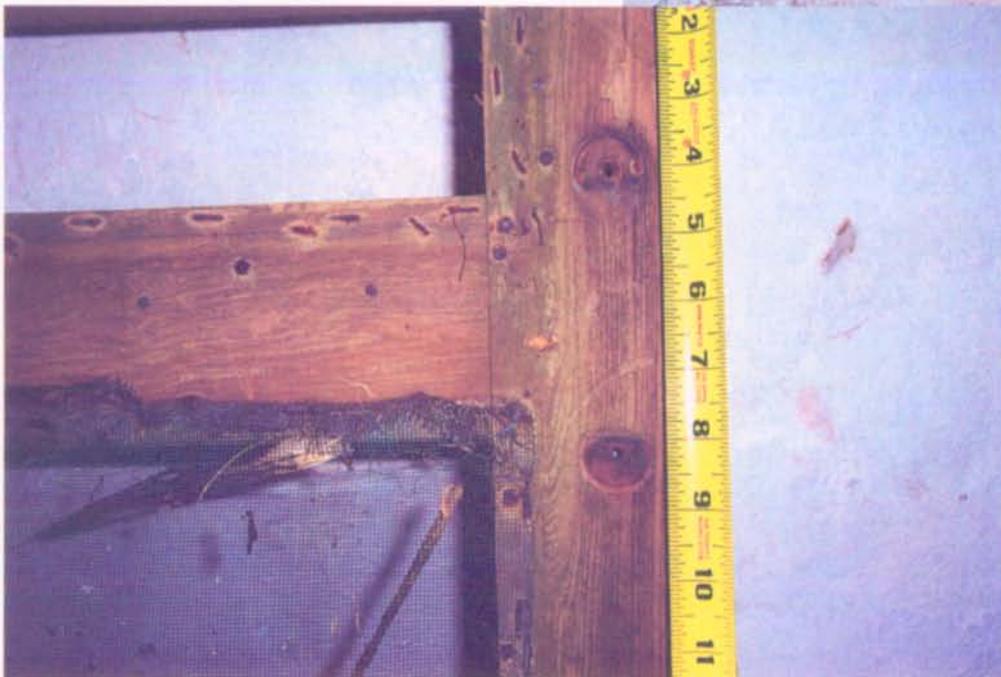
Photograph 16: DETAIL OF SCREEN DOOR SHOWING EVIDENCE OF DOOR HANDLE.

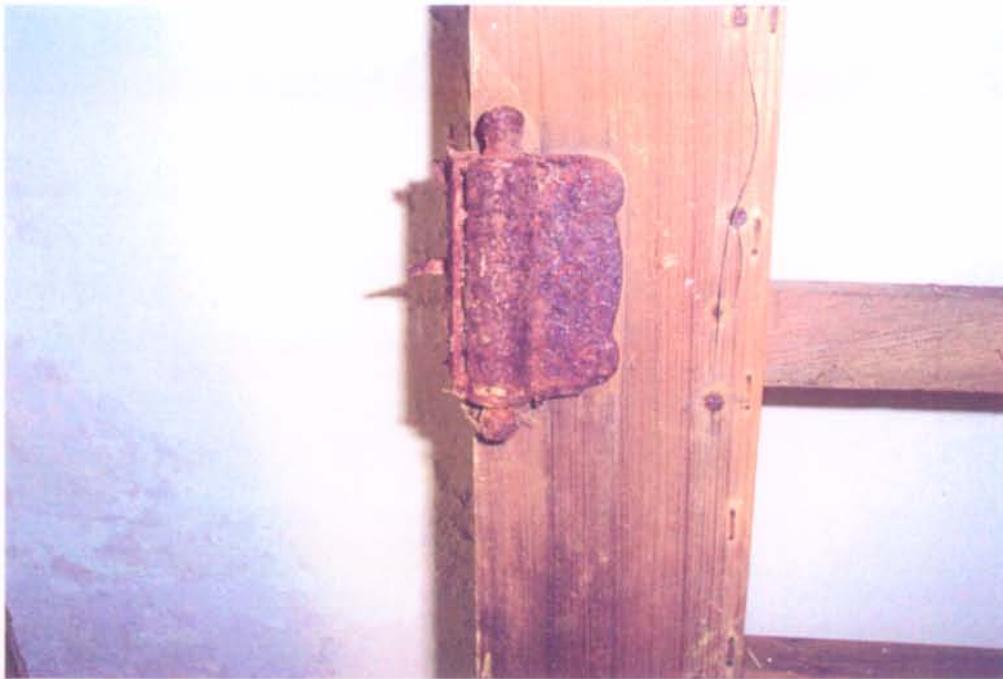
Photograph 17: DETAIL OF SELF CLOSING SCREEN DOOR HINGE.

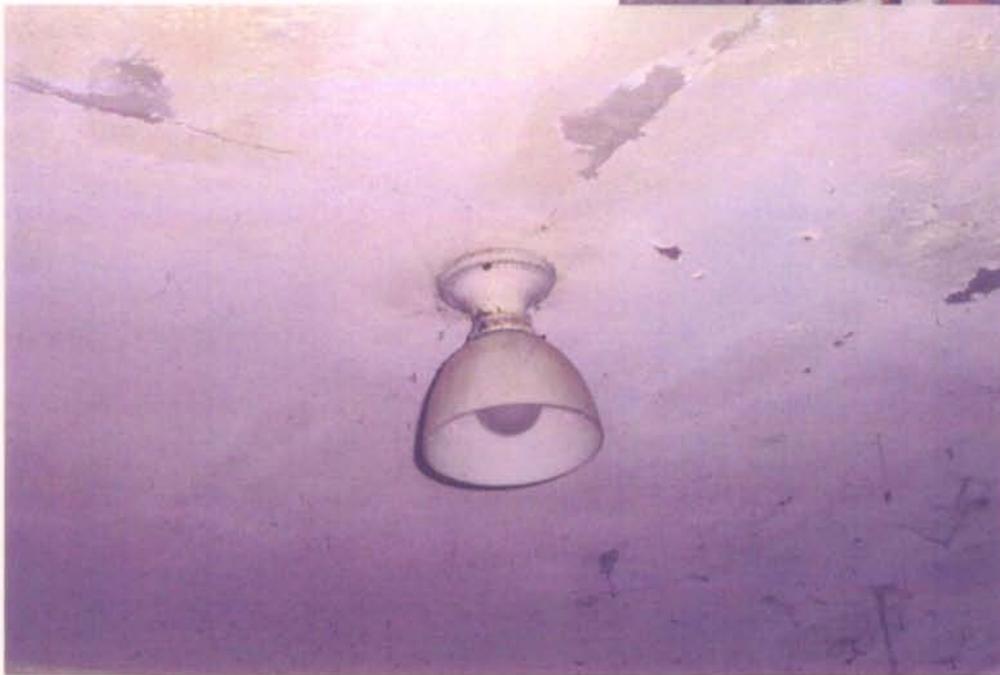
Photograph 20: DETAIL OF TYPICAL ORIGINAL ROOM LIGHT FIXTURE.

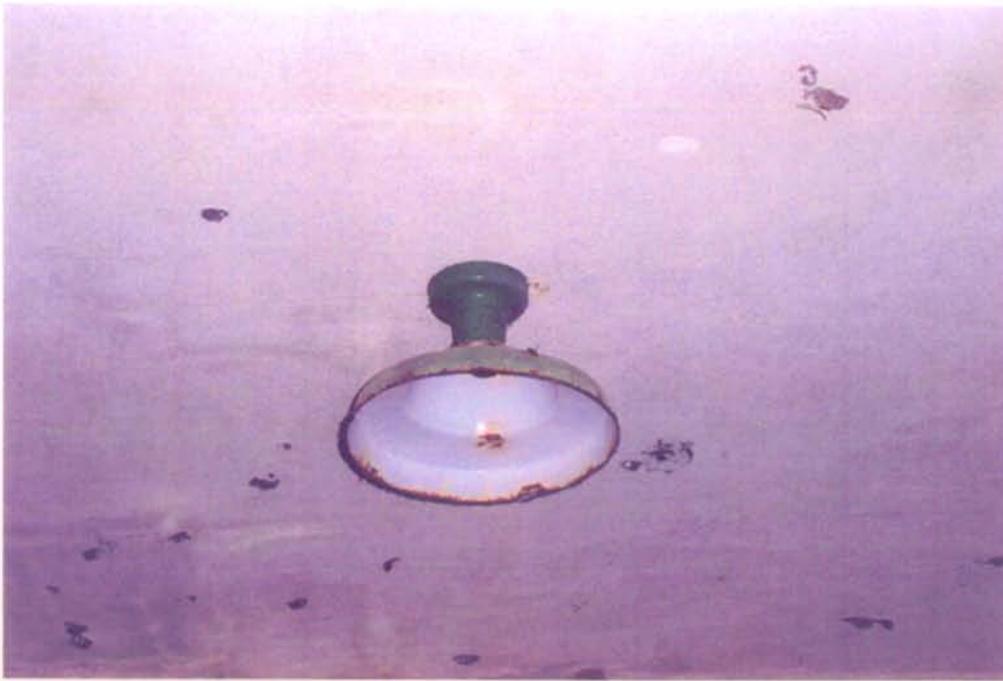
Photograph 21: DETAIL OF TYPICAL ORIGINAL GARAGE LIGHT FIXTURE.

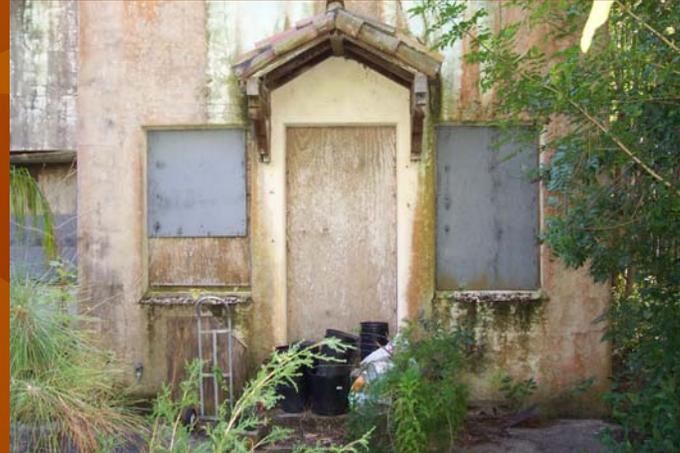
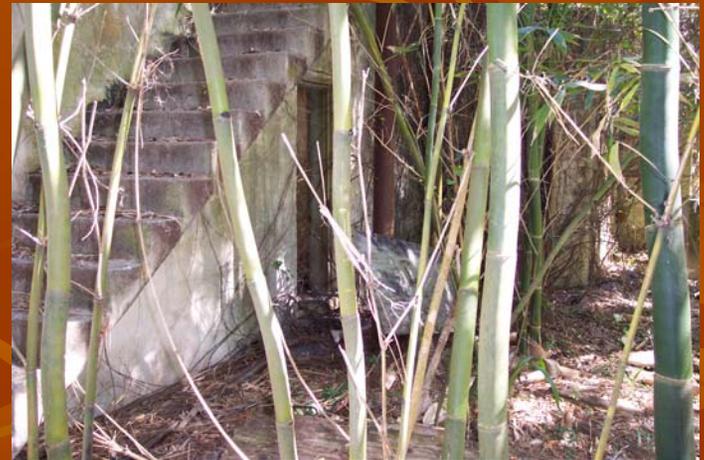
- Building Exterior
 - Red Clay Brick and Red Clay Tile Masonry Walls clad with Portland cement stucco
 - Terra Cotta Medallions and Clay Tile Details
 - Doors and Windows
 - Clay Tile Roof and Built Up Asphalt Roof and Systems

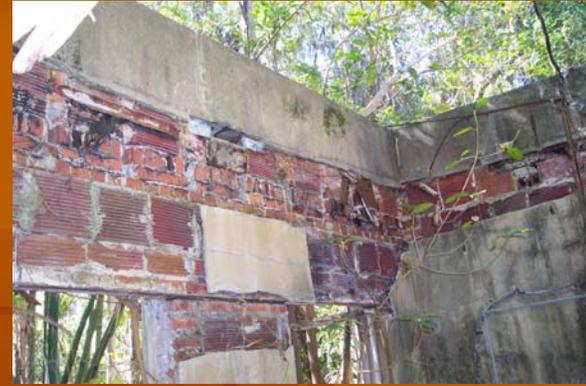
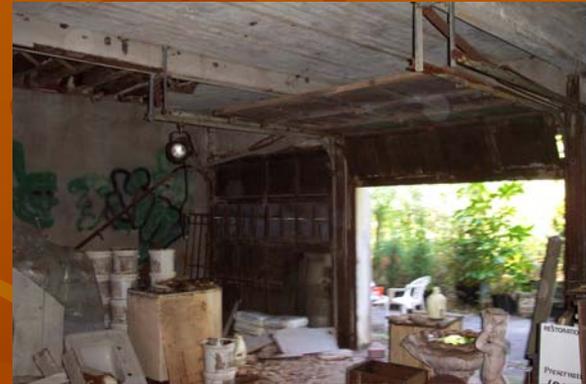
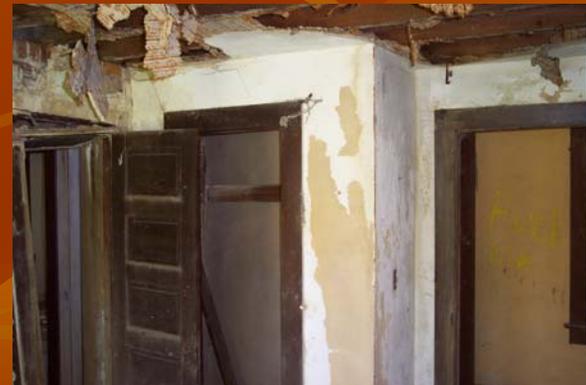
- Building Interior
- Deterioration from the failure of the roof, windows and exterior doors
- Collapse of portions of the roof and floors
- Deterioration of the plaster walls
- Enough original fabric is present to determine what the original details would have been

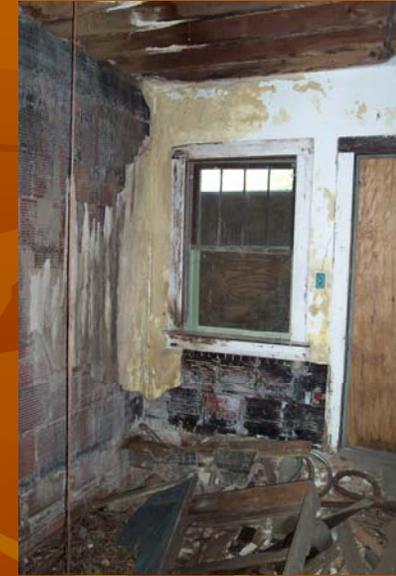
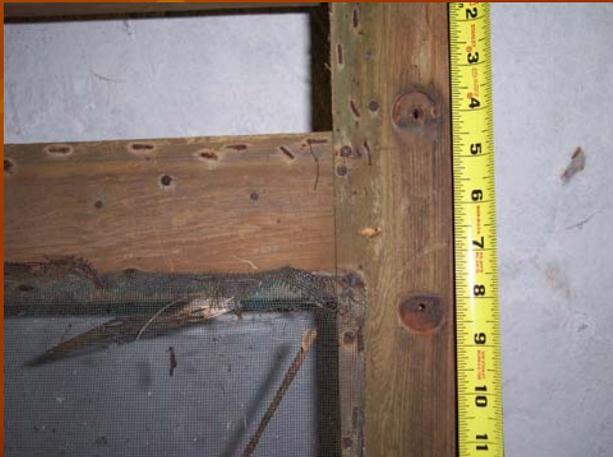
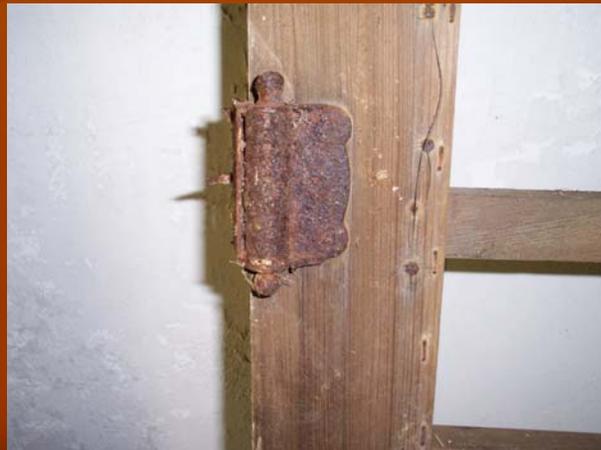
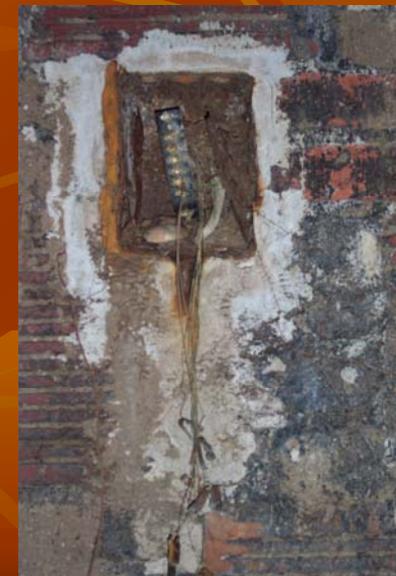
- Items to be restored or replaced are many and include:
 - Wood Trim and Moldings
 - Windows
 - Doors
- Finish, Door and Window Schedules in the Preservation Plan Report Detail the condition and suggested treatment for each item in every room
